APPENDIX C: SITE PHOTOS

Idas Valley erf 9445 s24G

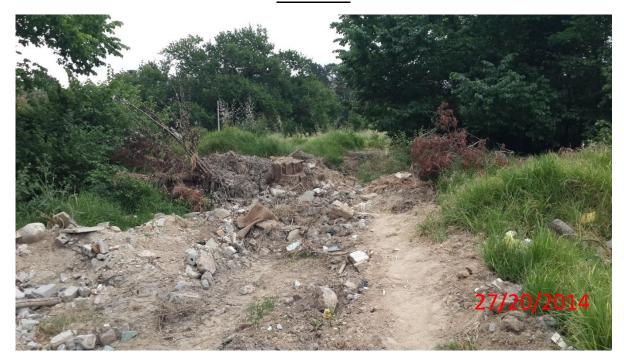
Photo1: BEFORE: Vehicle Bridge. Picture taken from east in a westerly direction.

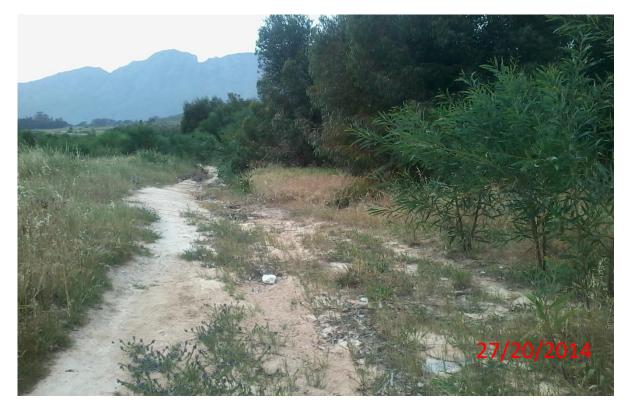
Photo2: BEFORE: River. Picture taken from west in a north-easterly direction.

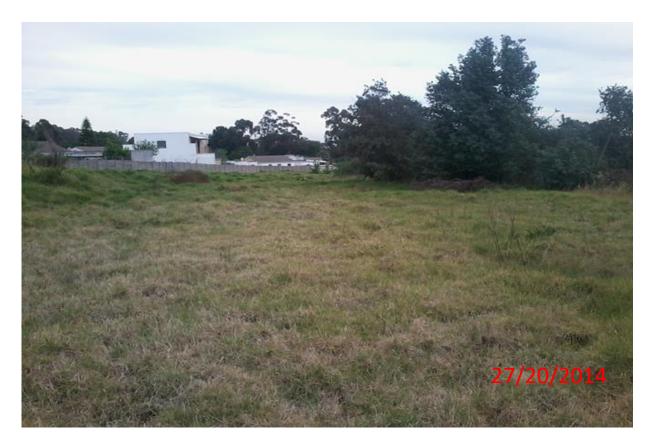
Photo3: BEFORE: River. Silted and covered with kikuyu grass.

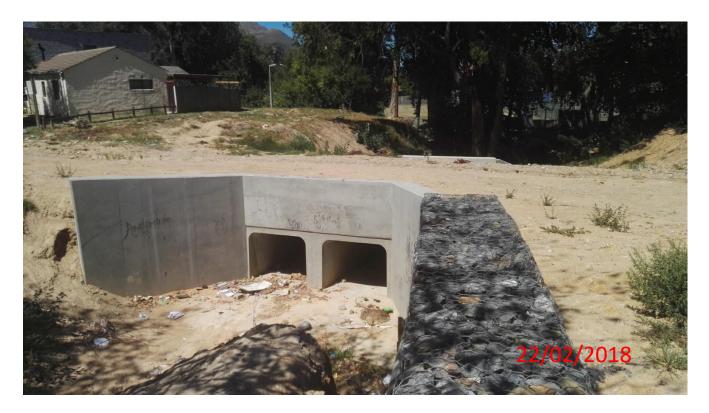
Photo 4: AFTER: Starting point of completed Gabion at Vehicle Bridge. Picture taken from east in a westerly direction

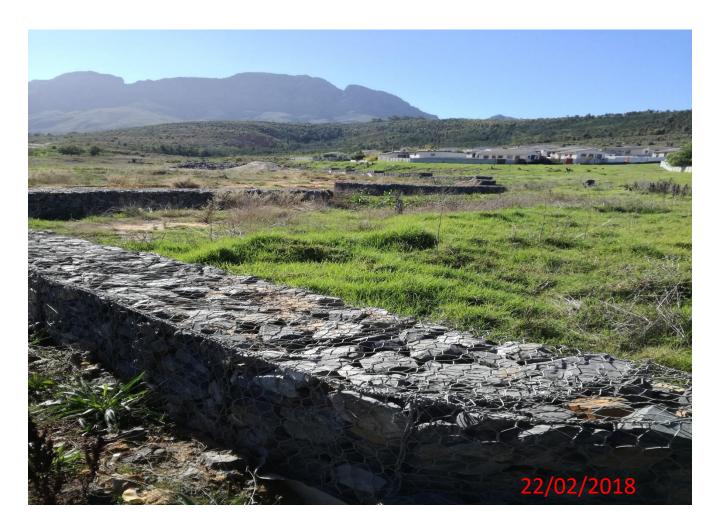
Photo 5: After: Completed Gabion. Picture taken from west in a north-easterly direction.

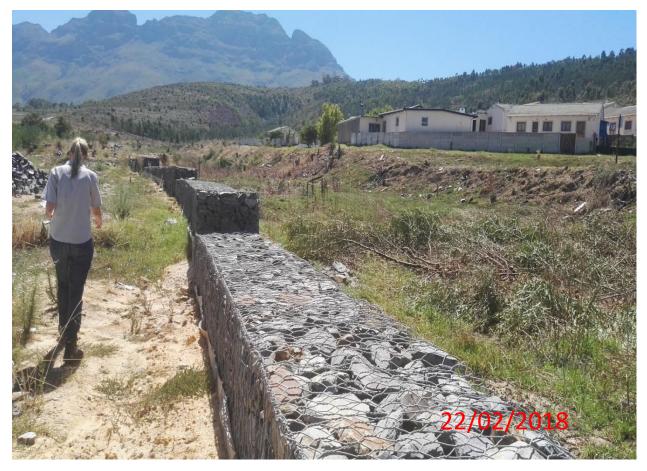
Photo 6: After: Completed Gabion. Picture taken from South in a north-easterly direction.

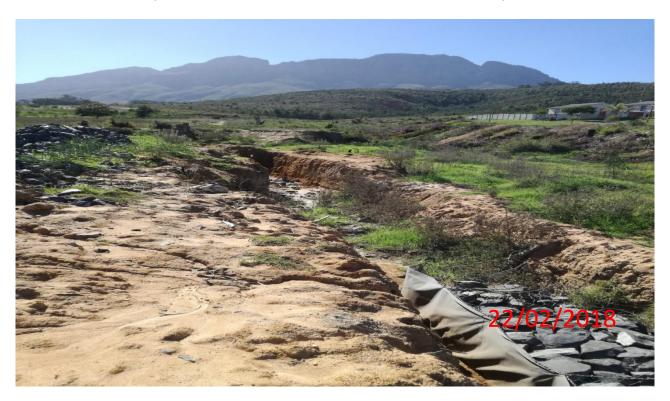
Photo 7: After: End of completed Gabion. Area with excavation (half-completed gabion construction). Picture taken from south in a north-easterly direction.

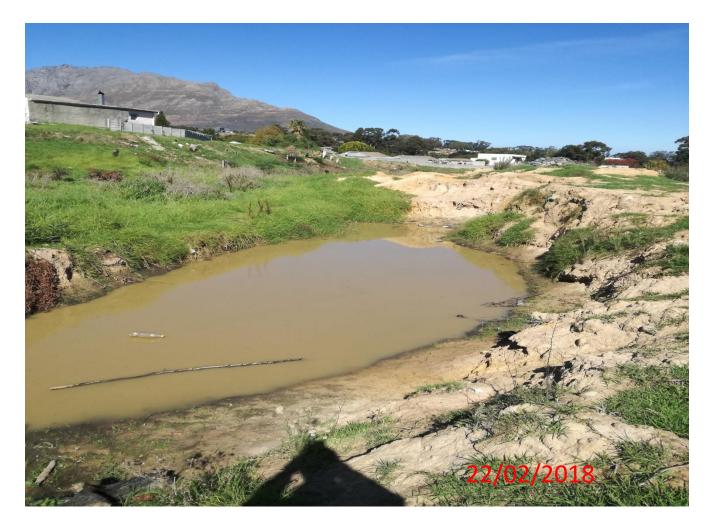
Photo 8: After: Proposed site where Gabion is still to be completed (clean, inspect and construct Gabion). Pooling of water due to excavation that has taken place. Picture taken from north-east in a south-westerly direction.
