APPENDIX C - SITE PHOTOGRAPHS

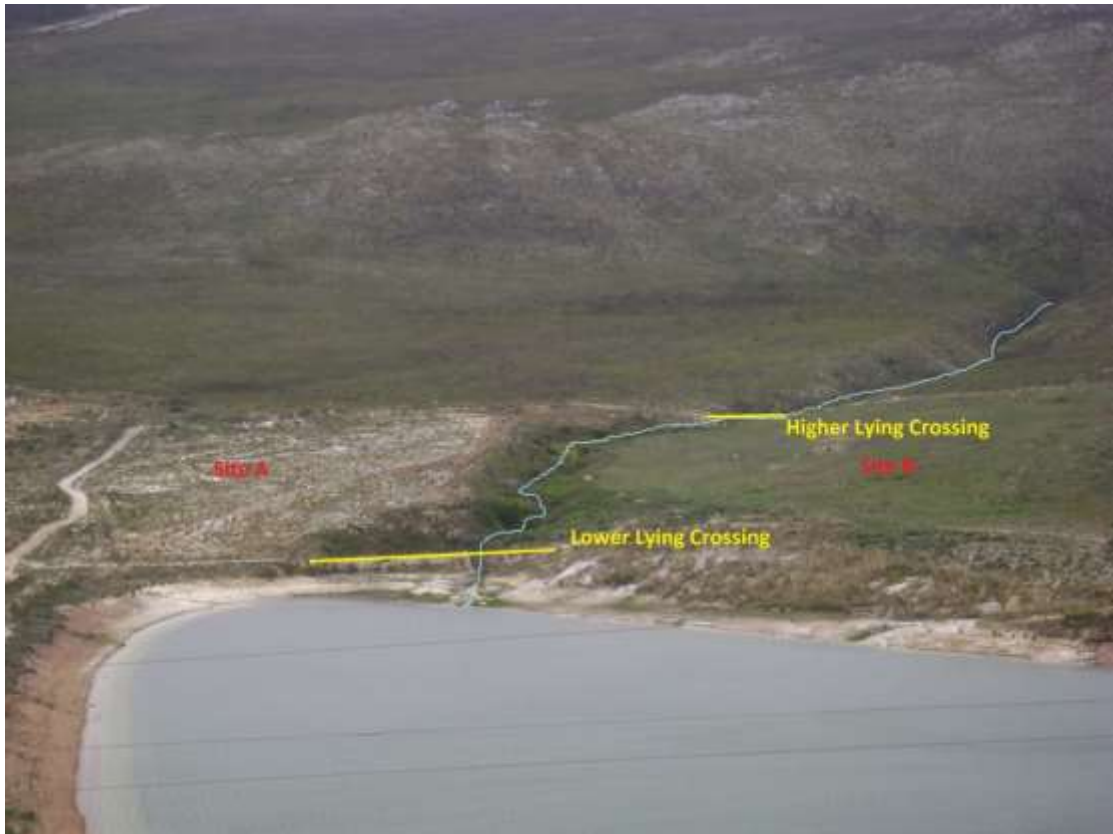
Photo 1.1: Drainage line and existing crossings (access roads) to site B.

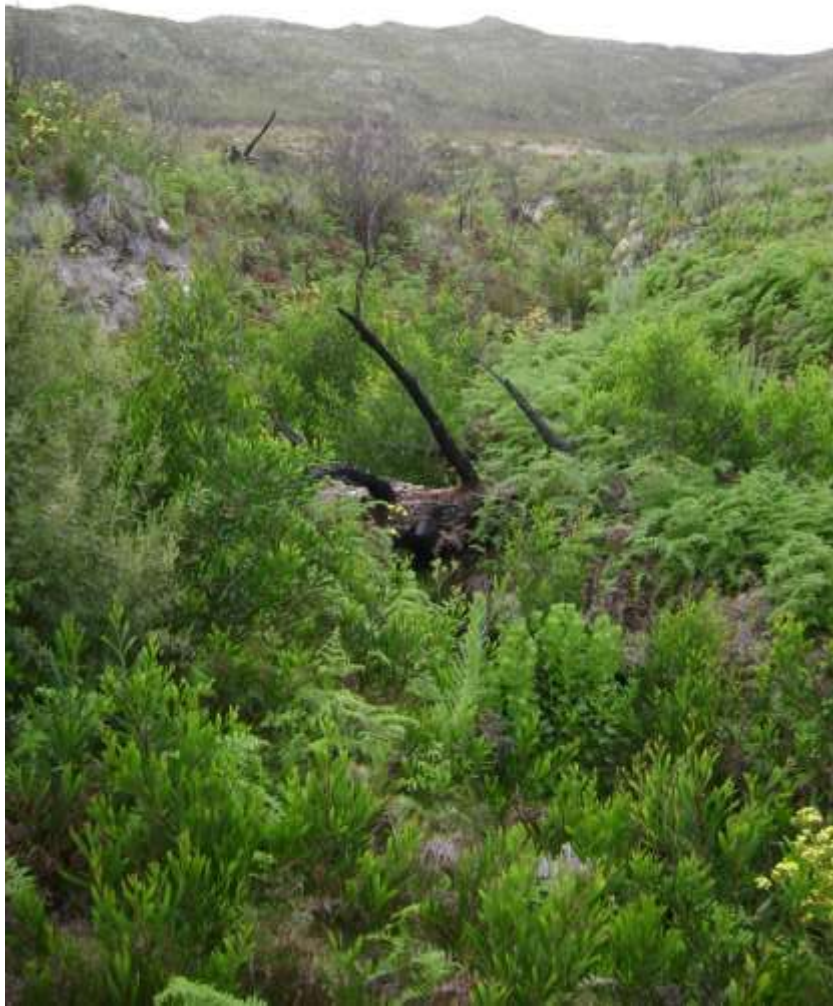
Photo 1.2: Instream and bank habitat at Site B drainage line.

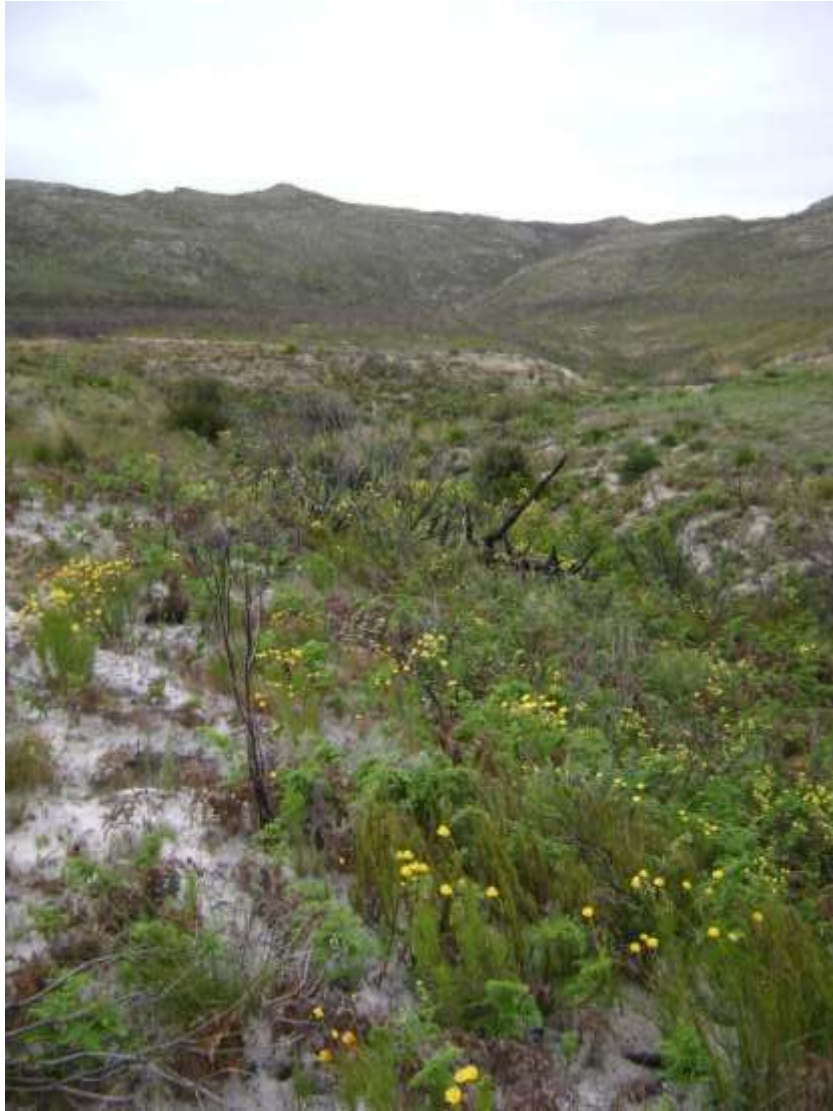
Photo 1.3: Instream and bank habitat at Site B drainage line.

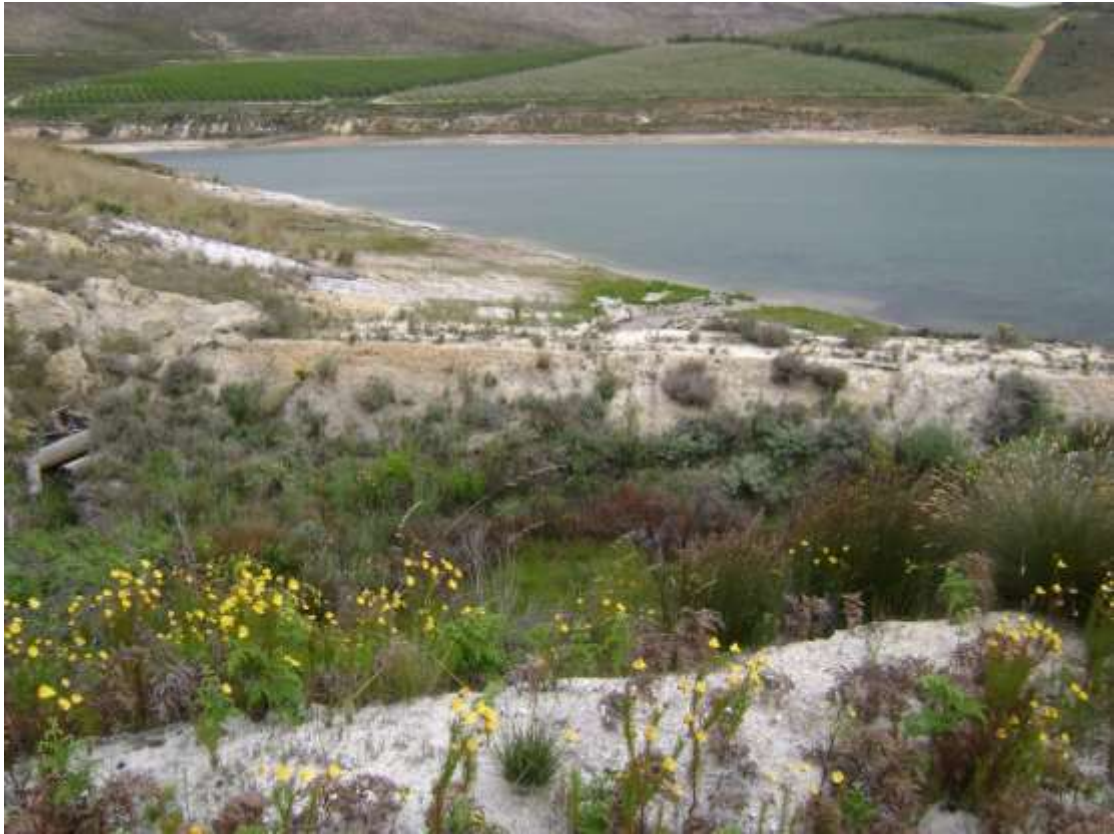
Photo 1.4: Lower lying crossing (not recommended to be used as a drainage line crossing)

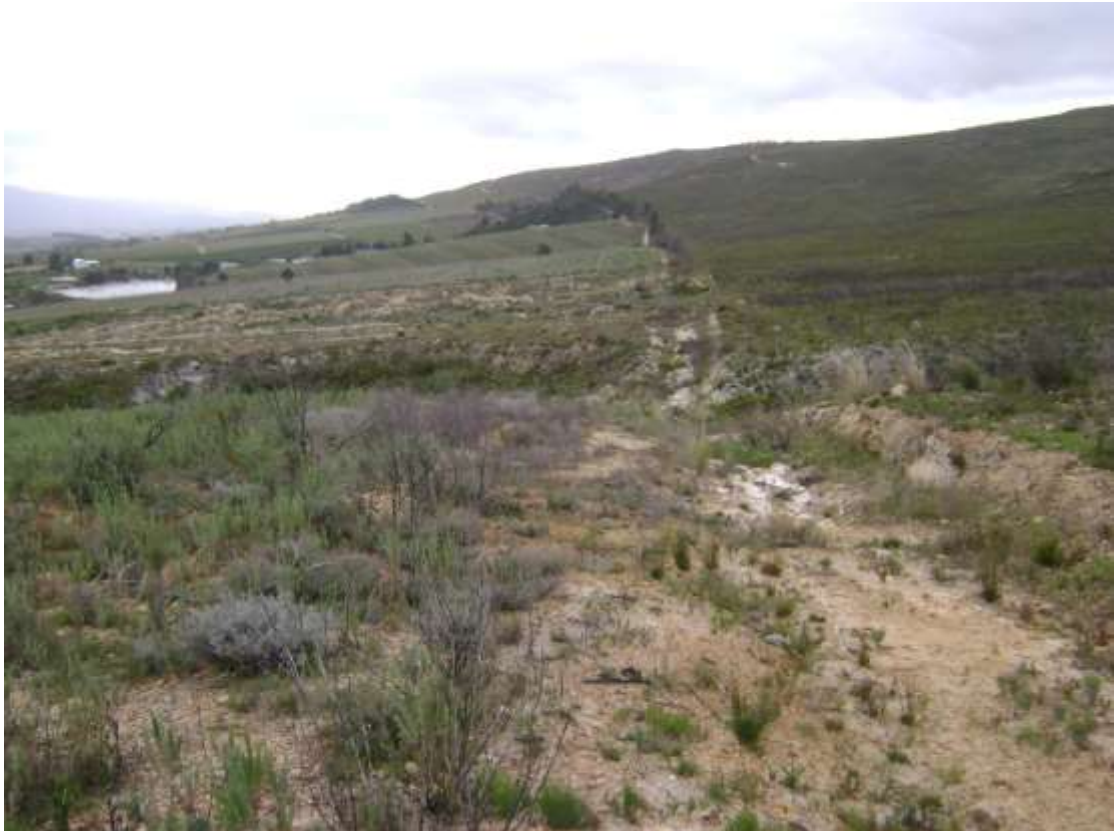
Photo 1.5: Higher lying crossing (recommended to be upgraded and used as a drainage crossing for access to site B)

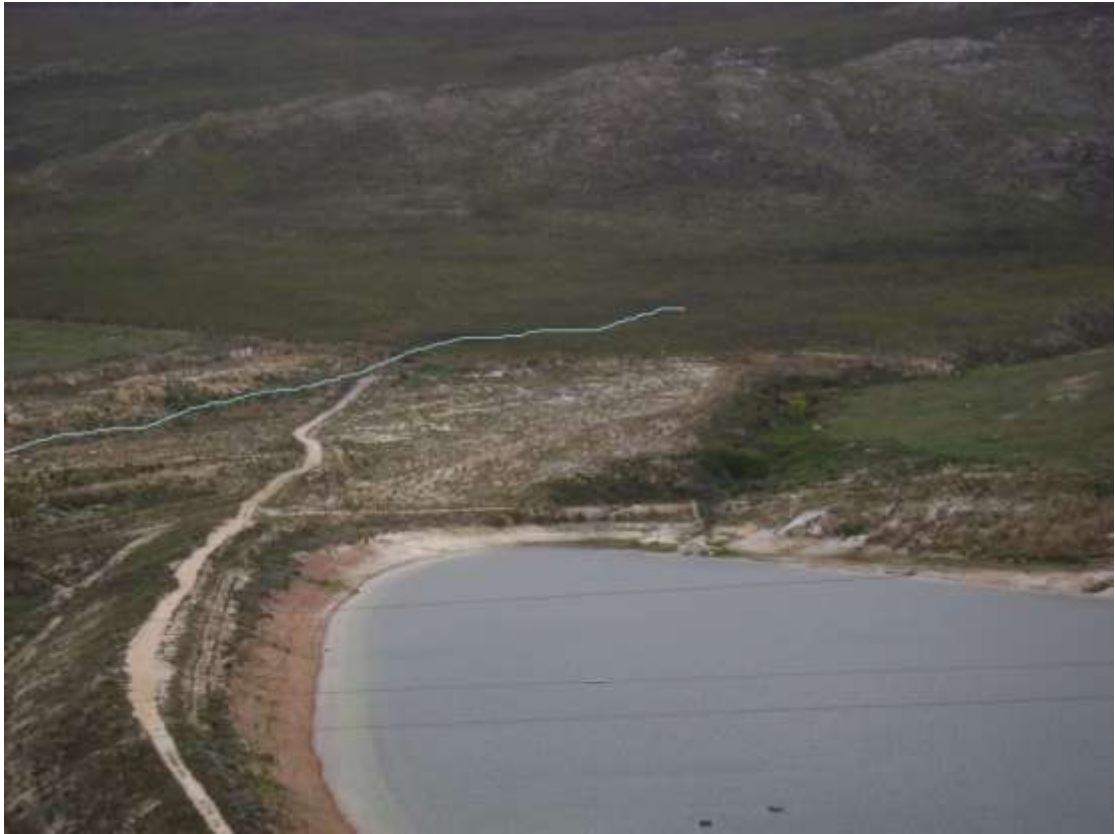
Photo 2.1 Upper reaches of transformed drainage line at site A.

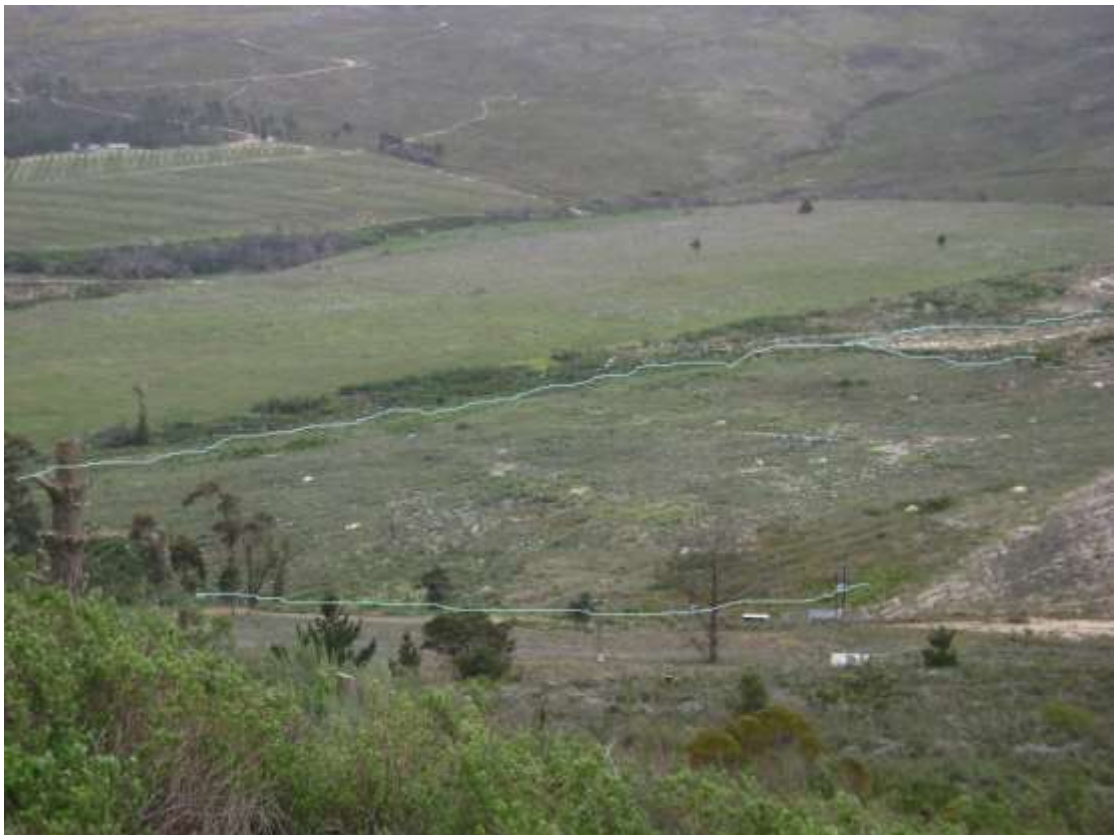
Photo 2.2 Lower reaches of transformed drainage line at site A.

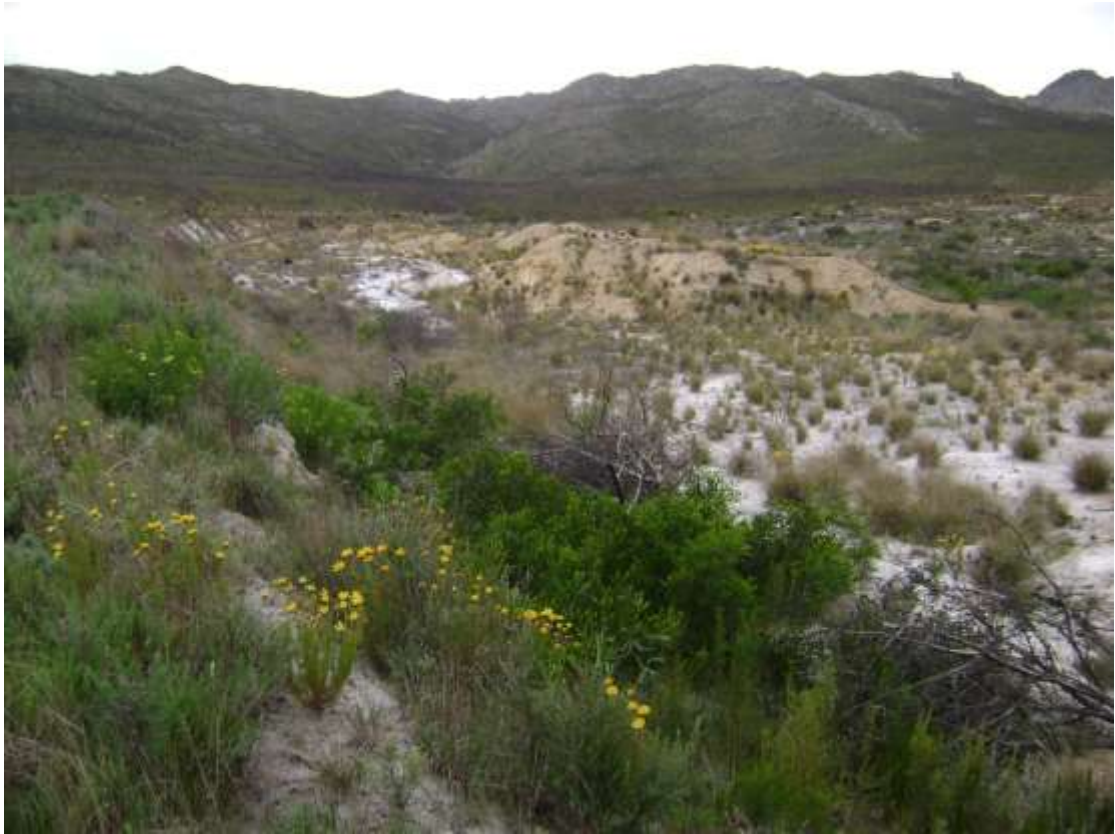
Photo 2.3 Instream habitat condition of upstream reaches of transformed/excavated drainage line at site A.

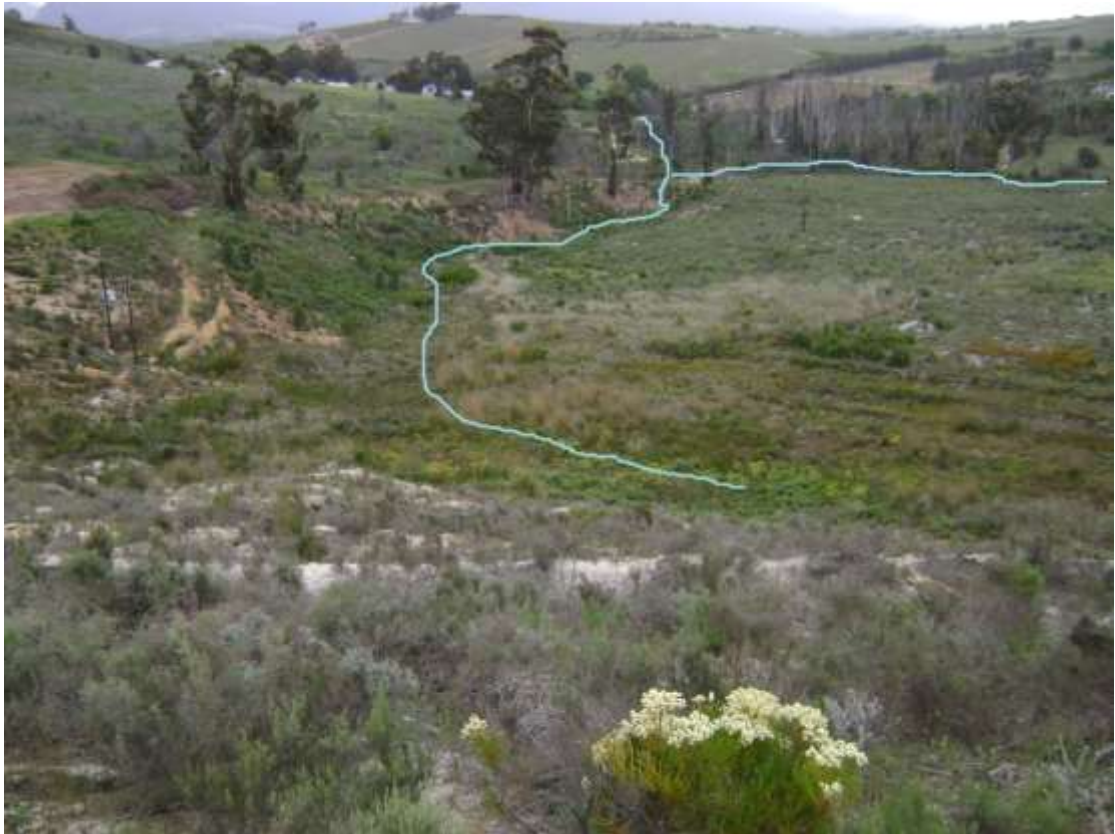
Photo 2.4 Instream habitat conditions of downstream reaches of transformed drainage line and wetland area below dam wall at site A.

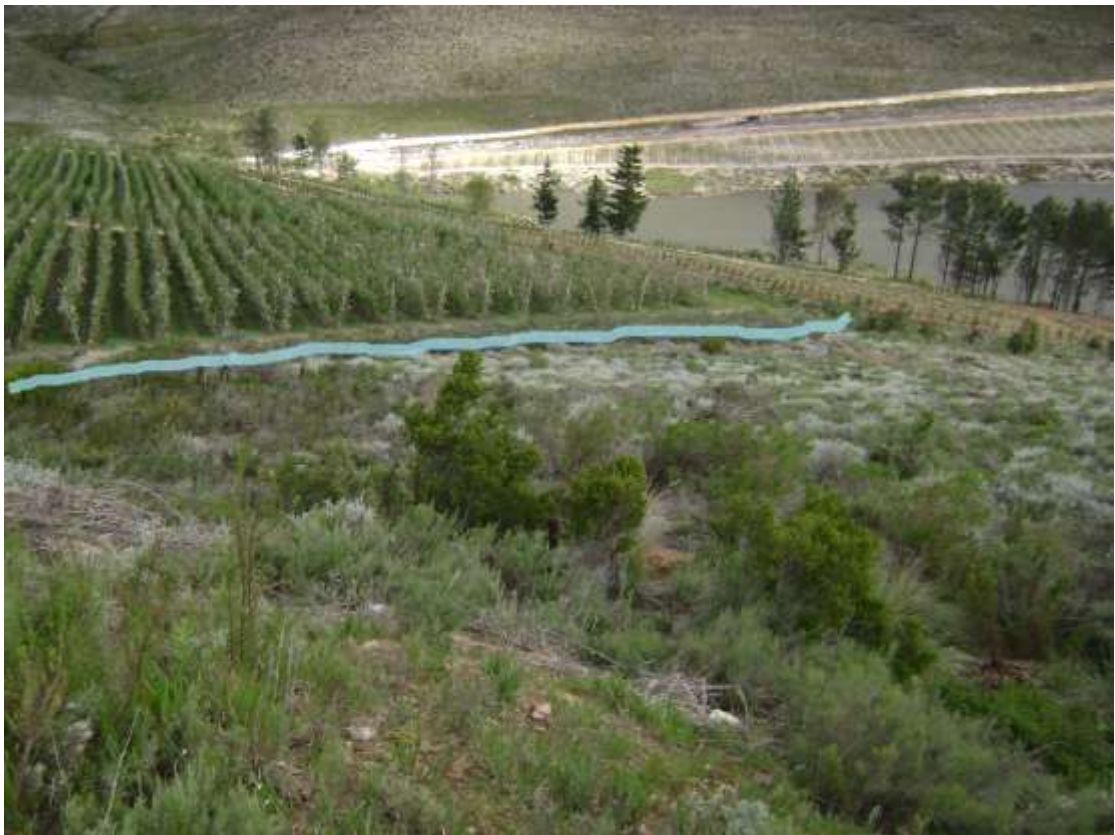
Photo 4.1: Channeled drainage line along southeastern border of site D.

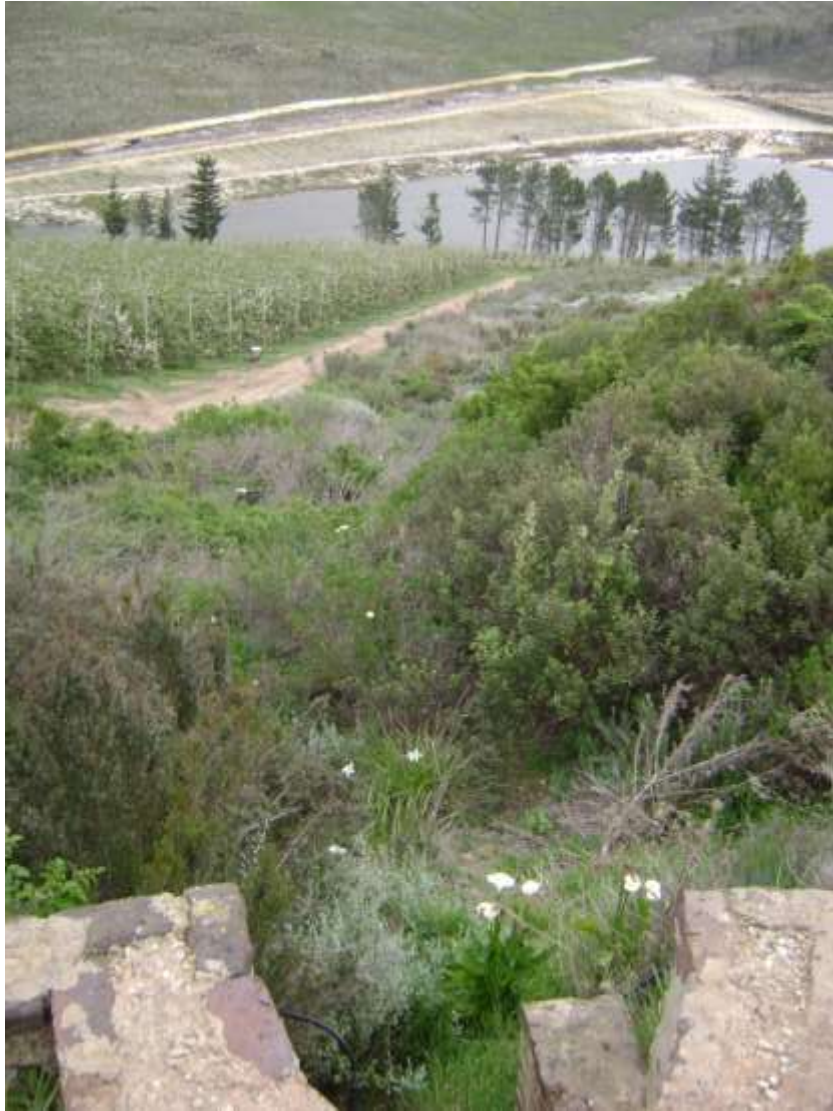
Photo 4.2: Instream habitat condition of channeled drainage line along southeastern border of site D.
