PHASE I
GEOTECHNICAL SITE INVESTIGATION

LOUWVILLE HOUSING
ERF 7752 AND PORTION OF ERF 1003
VREDENBURG

iX ENGINEERS

Project no: 016-19

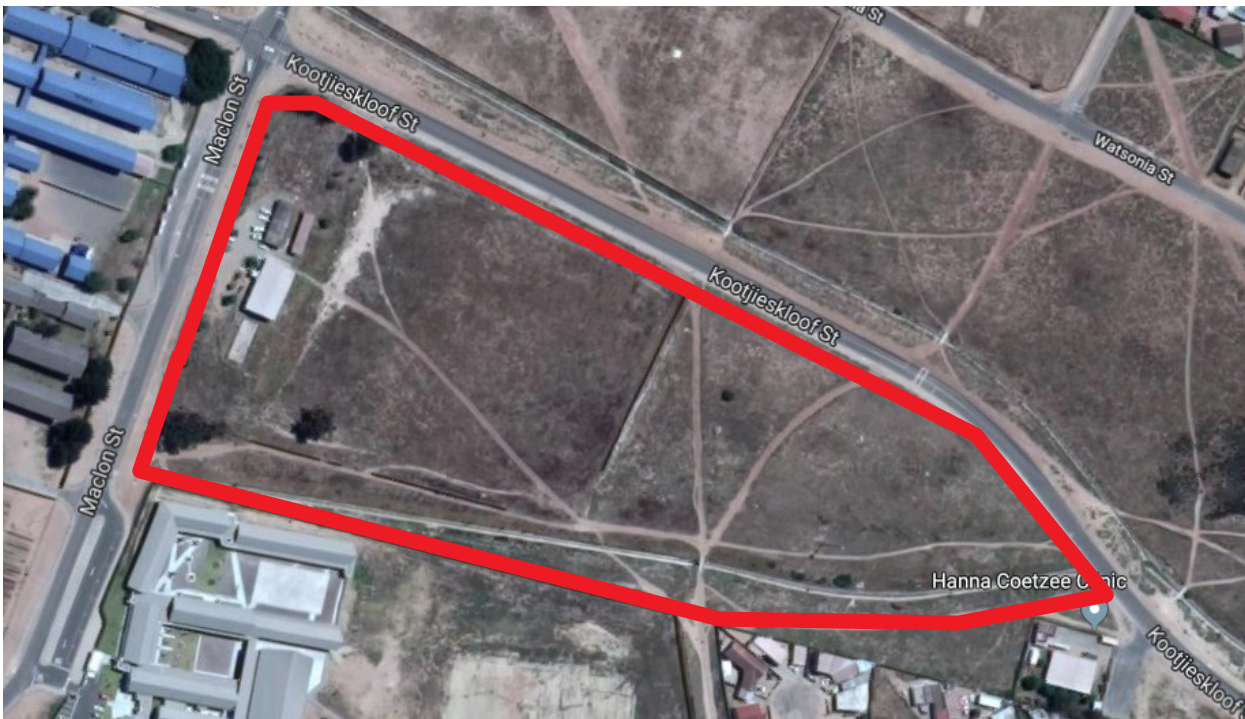
Figure 3.2: Physiological features of the site

The investigated site is roughly a triangular-shaped piece of land approximately 5.1 ha in area, located in the Vredenburg suburb of Louwville. It is bordered by Klooitjieskloof Street to the north, Maclons Street to the west and Louwville High School to the south. The site is currently undeveloped. Vegetation consists of mostly small shrubs, grasses and weeds.

In terms of topography, the site is fairly flat lying with a slight slope down from the west towards the south-east. A stormwater channel lies to the south of the site and forms the boundary between Louwville High School and the investigated site. There is a moderate drop in elevation on the western part of the site with a moderate steep slope separating the two levels.

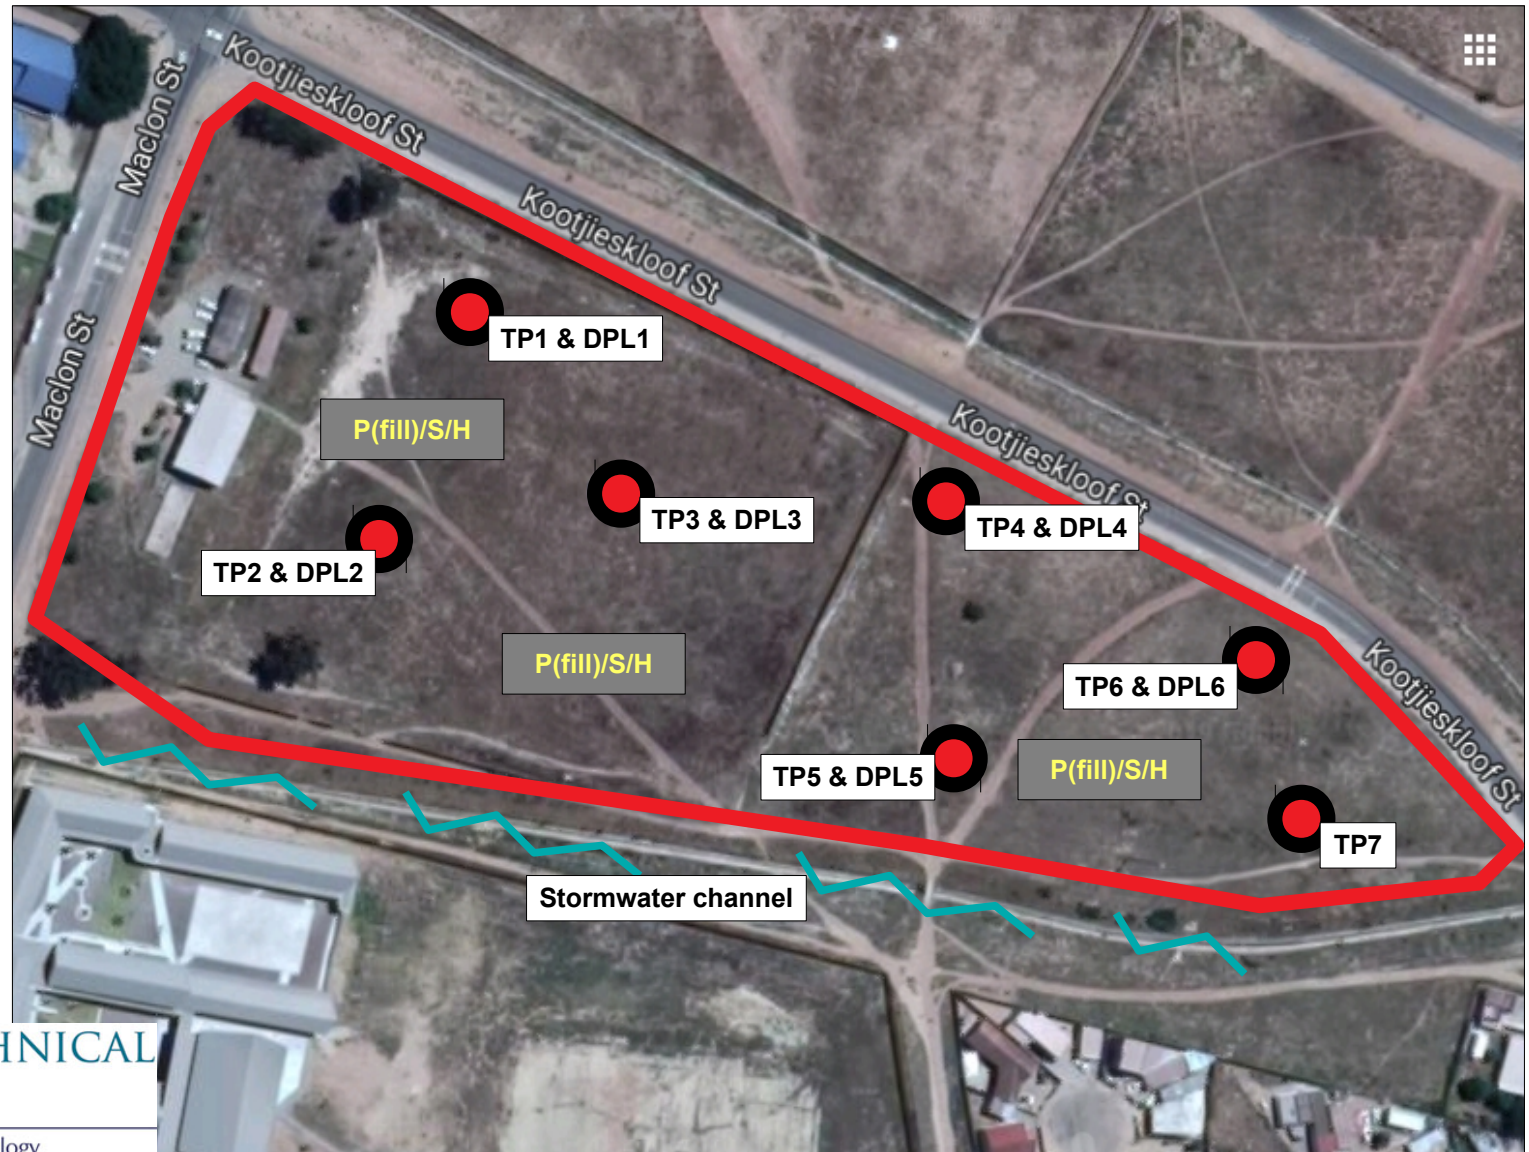
Client:	IX Engineers								
Project:	Vredenburg Louwville Housing								
Title:	Phase-1 Geotechnical Investigation								
Date:	Mar 19	Traced by:	JS	Scale:	NTS	Fig no.:	1	Job no.:	016-19

SITE PLAN AND CLASSIFICATION

P(fill)/S/H

Uncontrolled compressible fill
overlying compressible sandy soils
– for the entire site

The Residential Site Class Designation (after Watermeyer & Tromp and the Joint Structural Division) is set out in Table 7.1. The areal extent of classified areas is shown in the site plan in Appendix A.

The entire site is classified as P(fill)/S/H, that is, compressible sandy fill material which in turn overlie moderately compressible sandy and clayey transported soils.

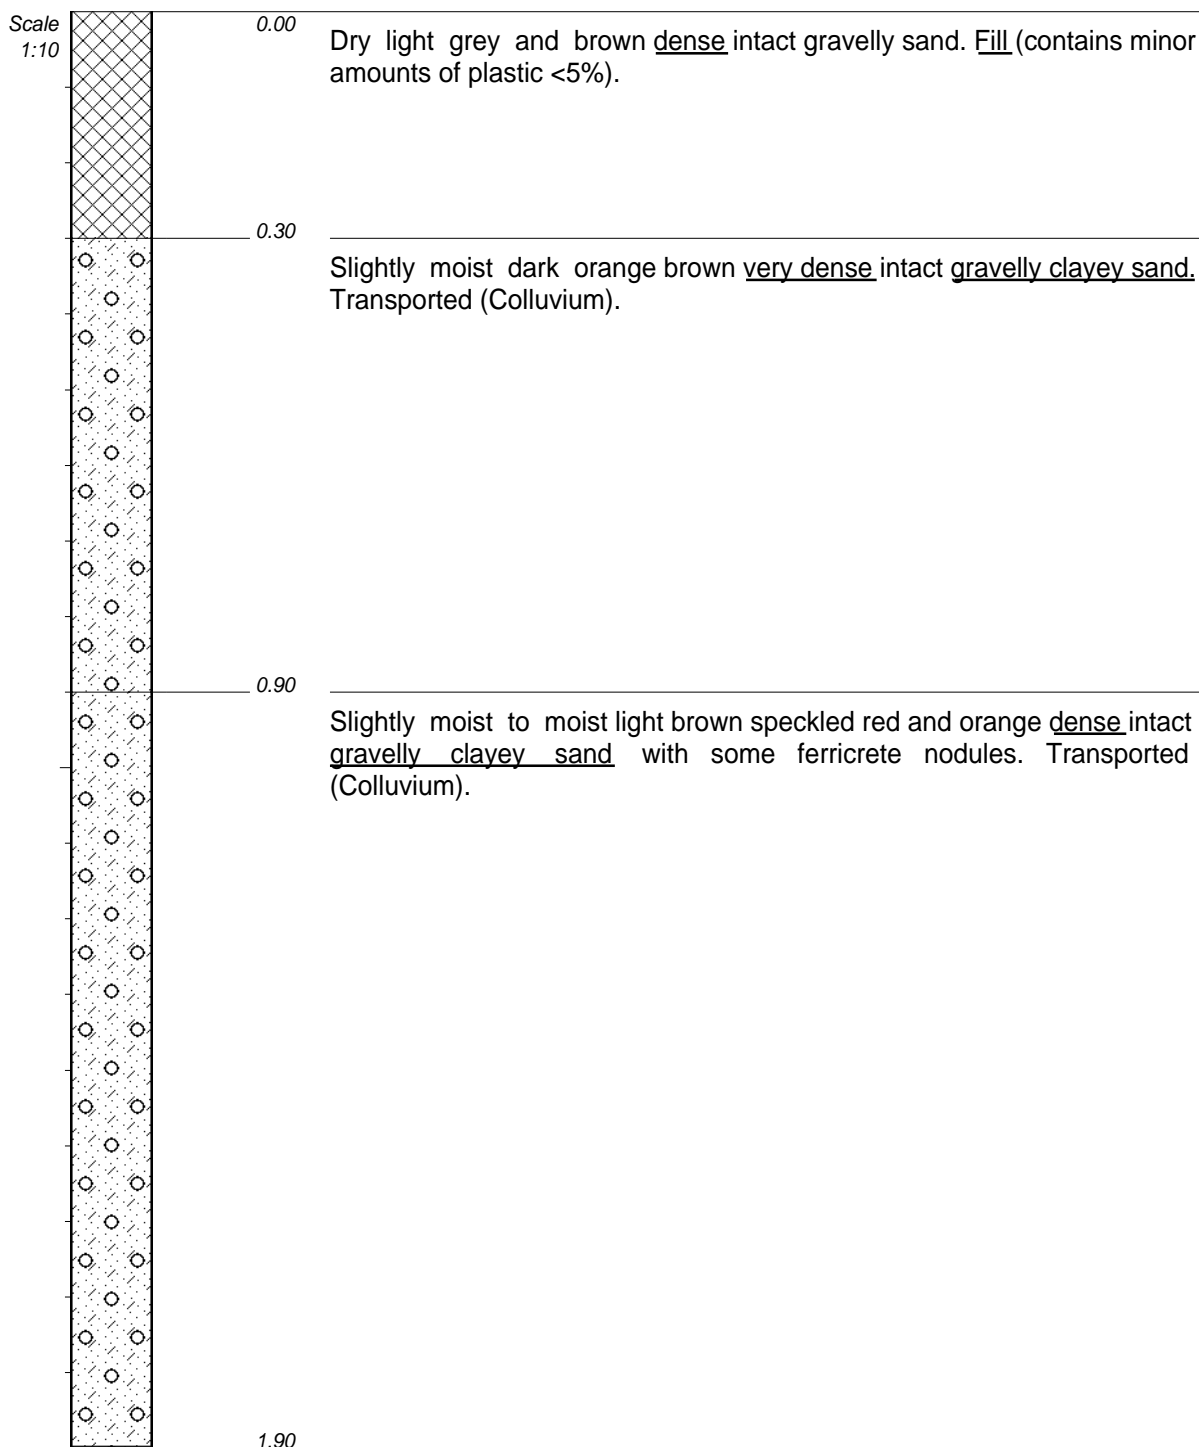
HOLE No: TP01

- 1) No seepage.
- 2) No sidewall collapse.
- 3) Near refusal.

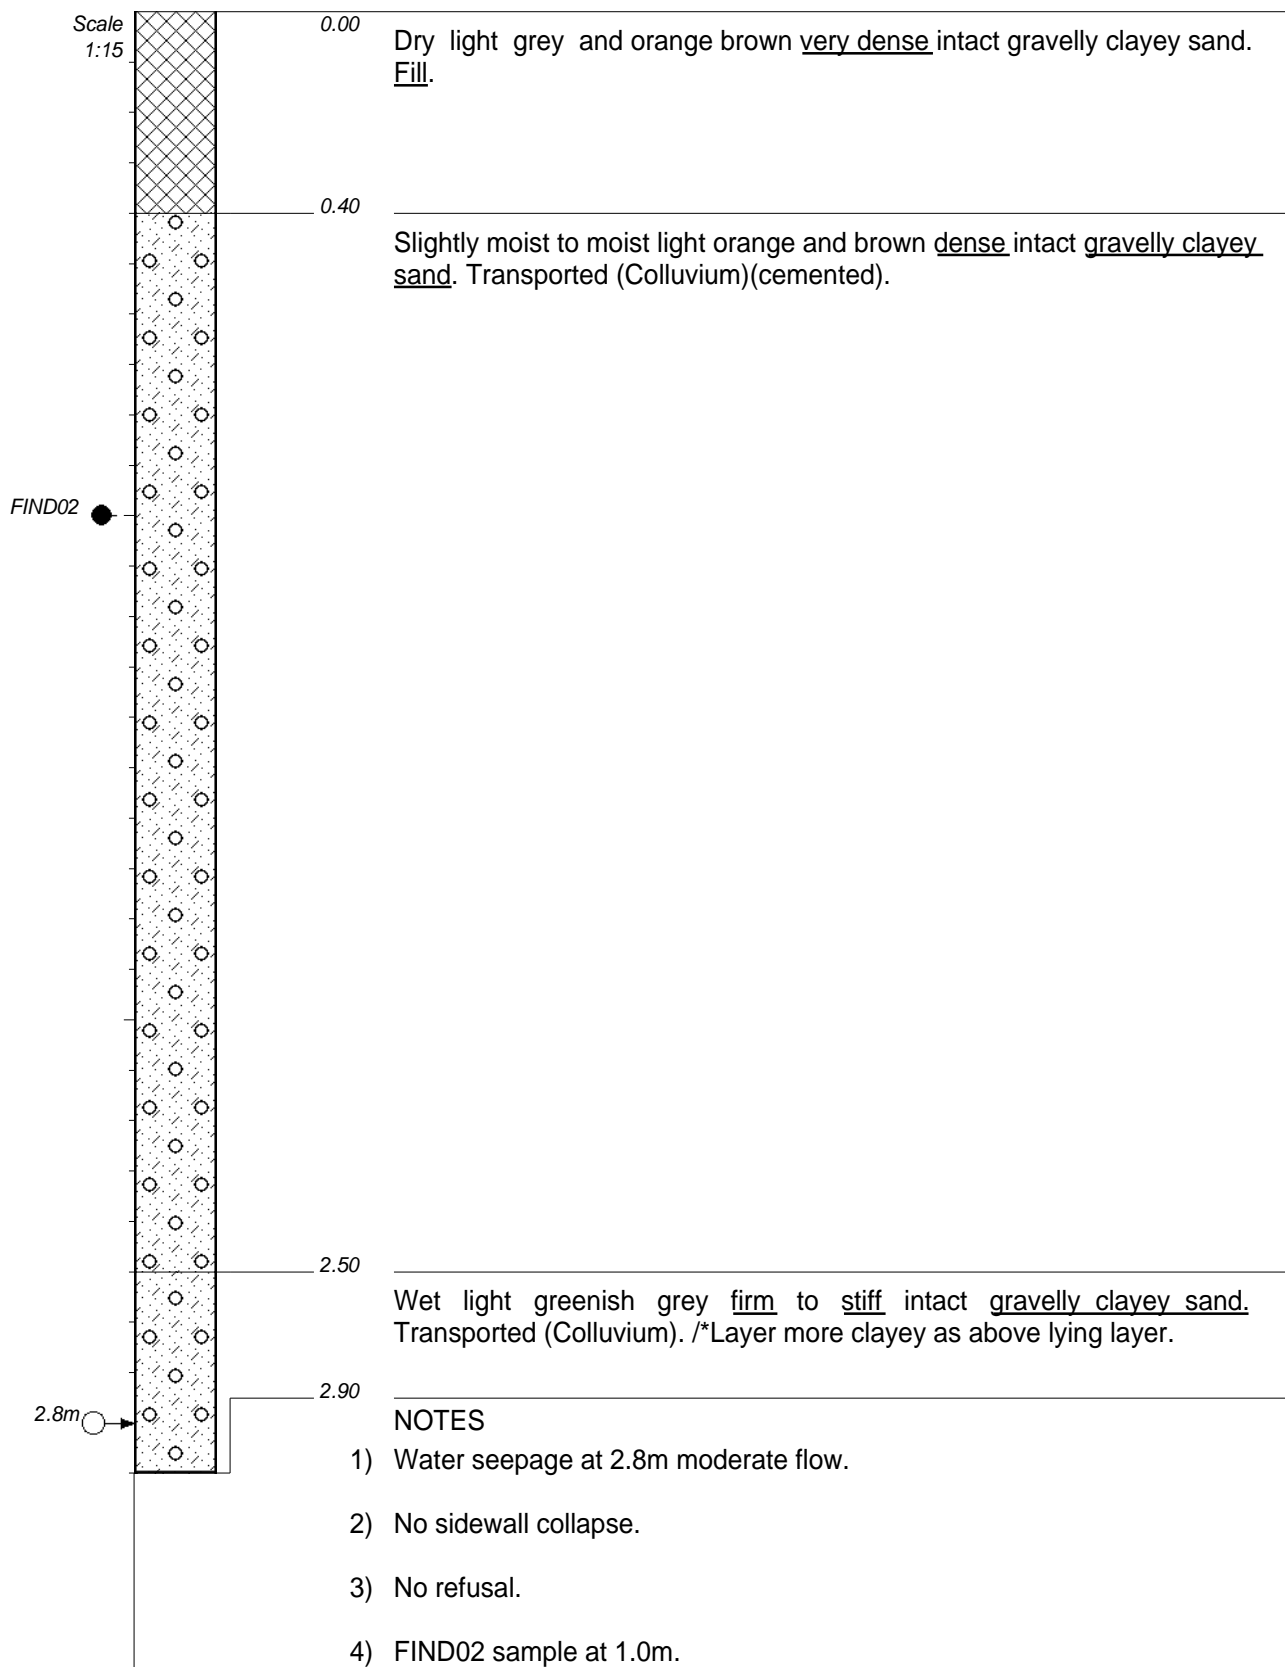
HOLE No: TP02

Groundwater was encountered in TP2 at a depth of 2.8 m bgl. TP2 was located in the south-western corner of the site and is near the stormwater channel indicated earlier. The water in TP2 is potentially seepage from the nearby channel. Groundwater was not encountered in any of the other test pits.

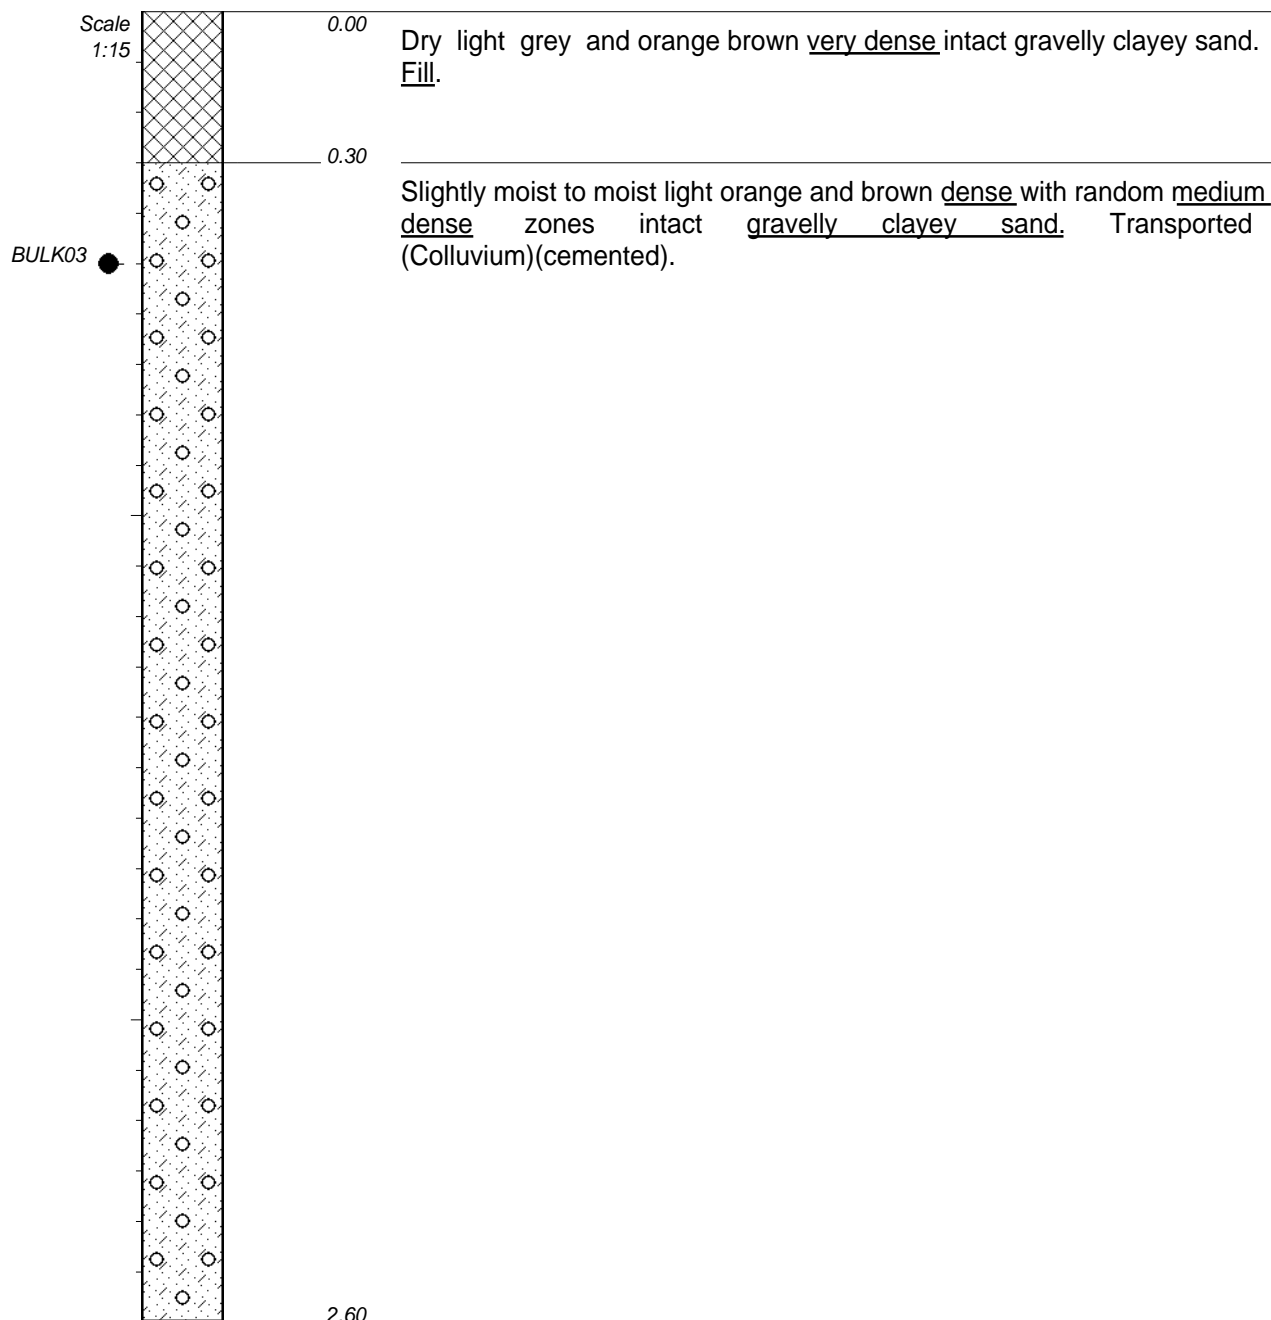
HOLE No: TP03

- 1) No seepage.
- 2) No sidewall collapse.
- 3) No refusal.
- 4) BULK03 sample at 0.5m.

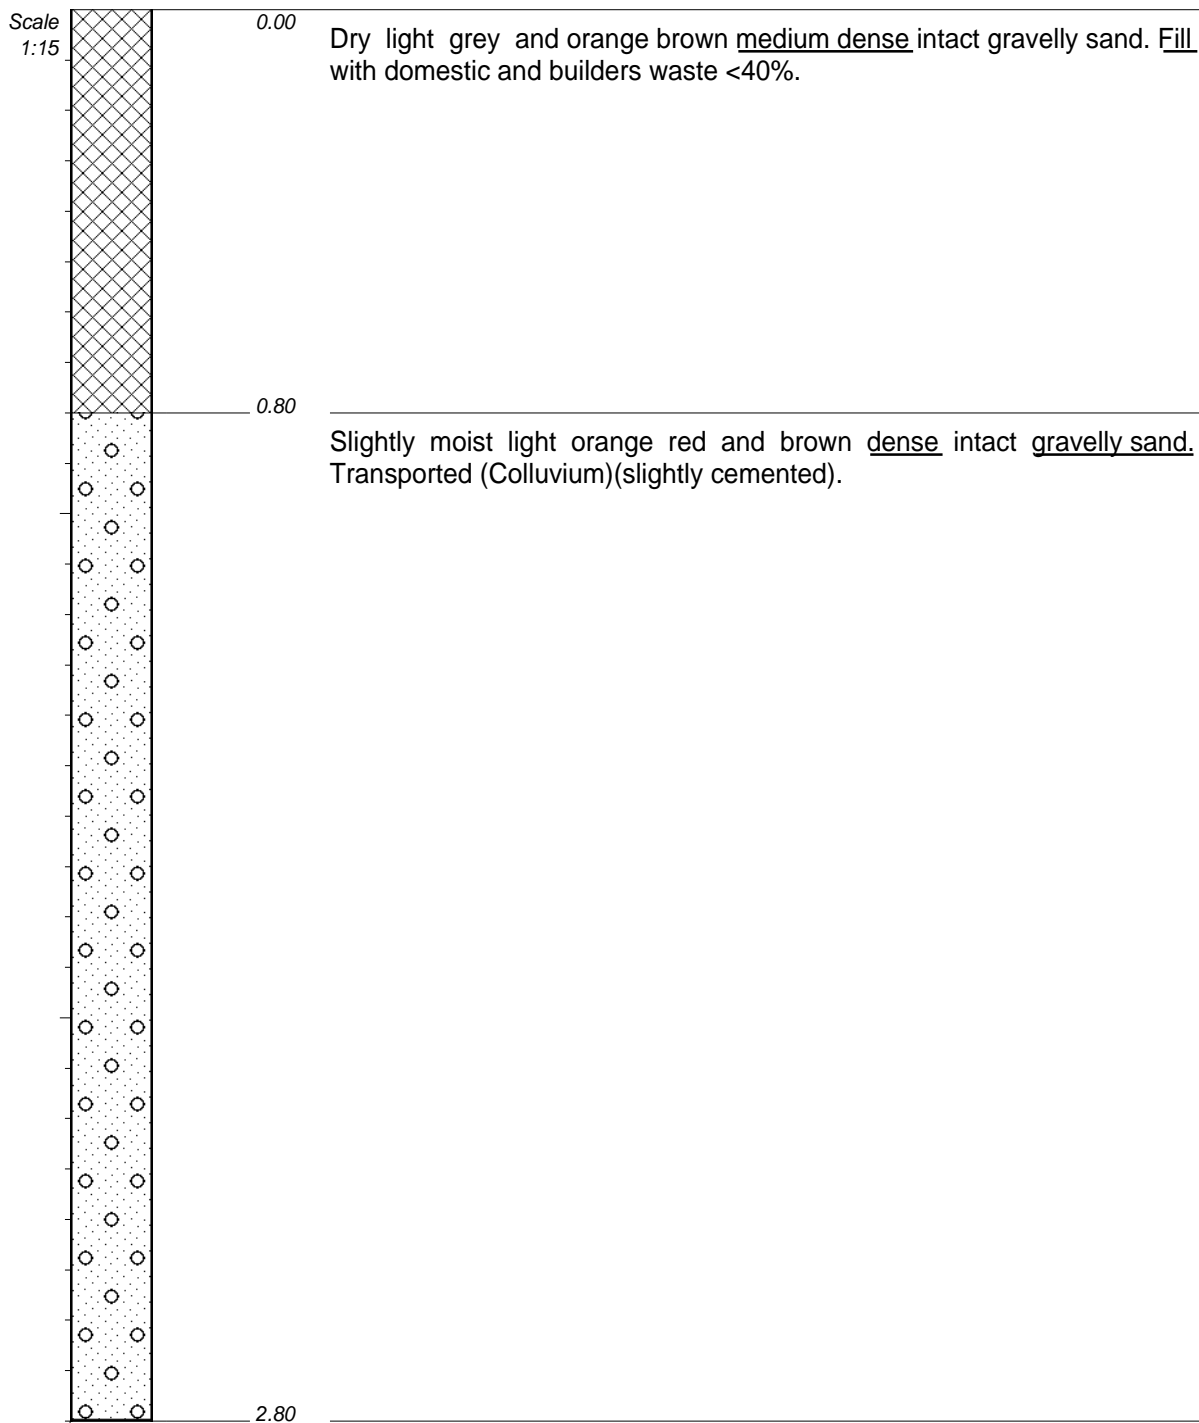
HOLE No: TP04

- 1) No seepage.
- 2) No sidewall collapse.
- 3) No refusal.

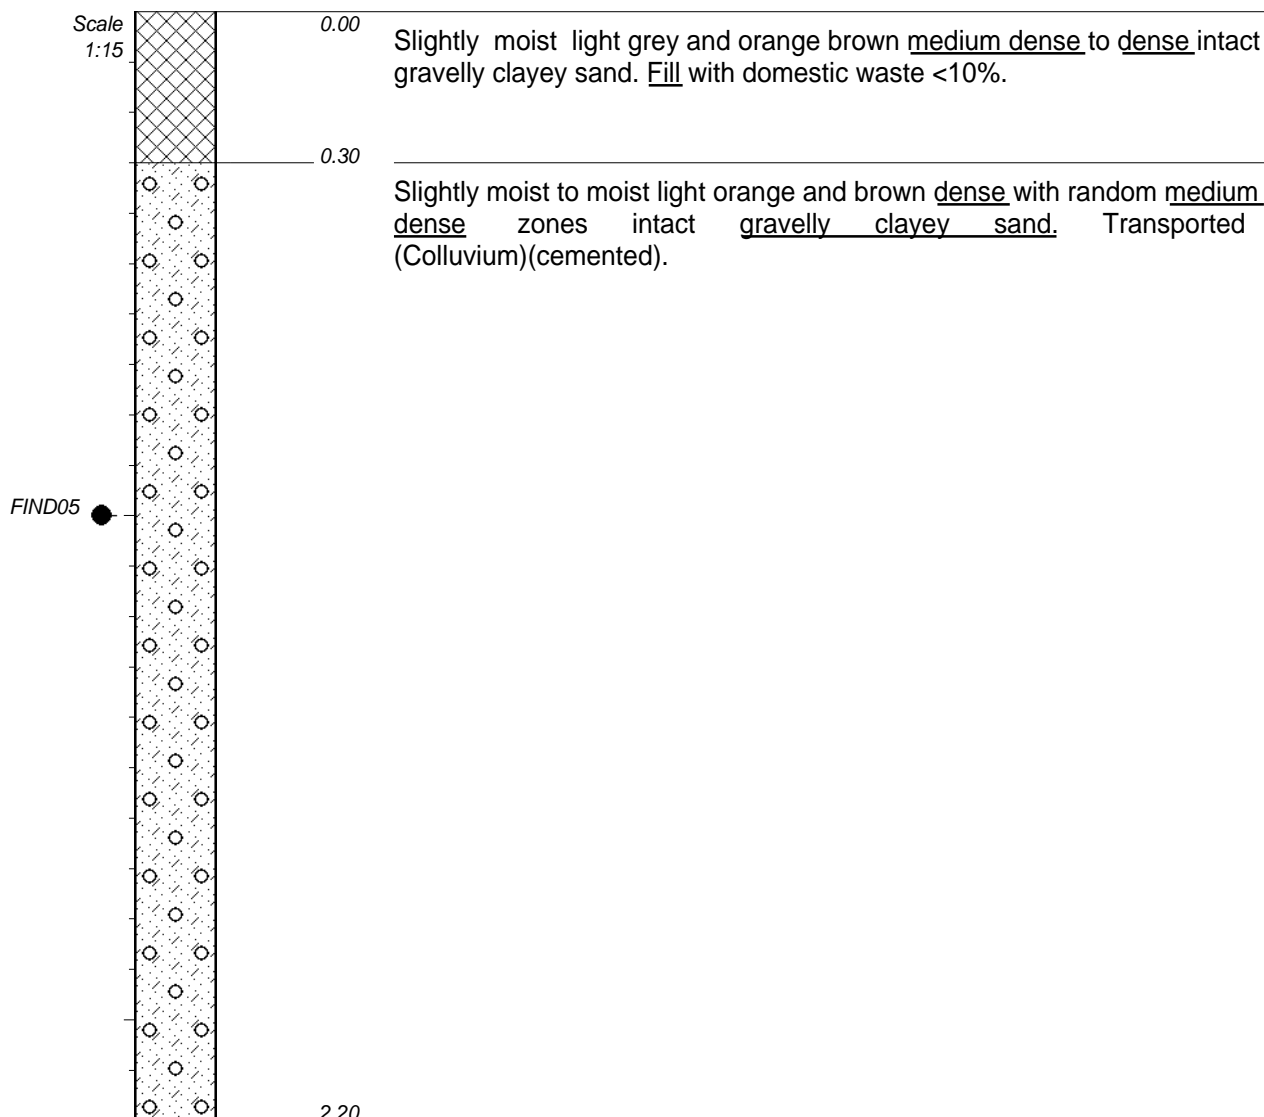
HOLE No: TP05

- 1) No seepage.
- 2) No sidewall collapse.
- 3) No refusal.
- 4) FIND05 sample at 1.0m.

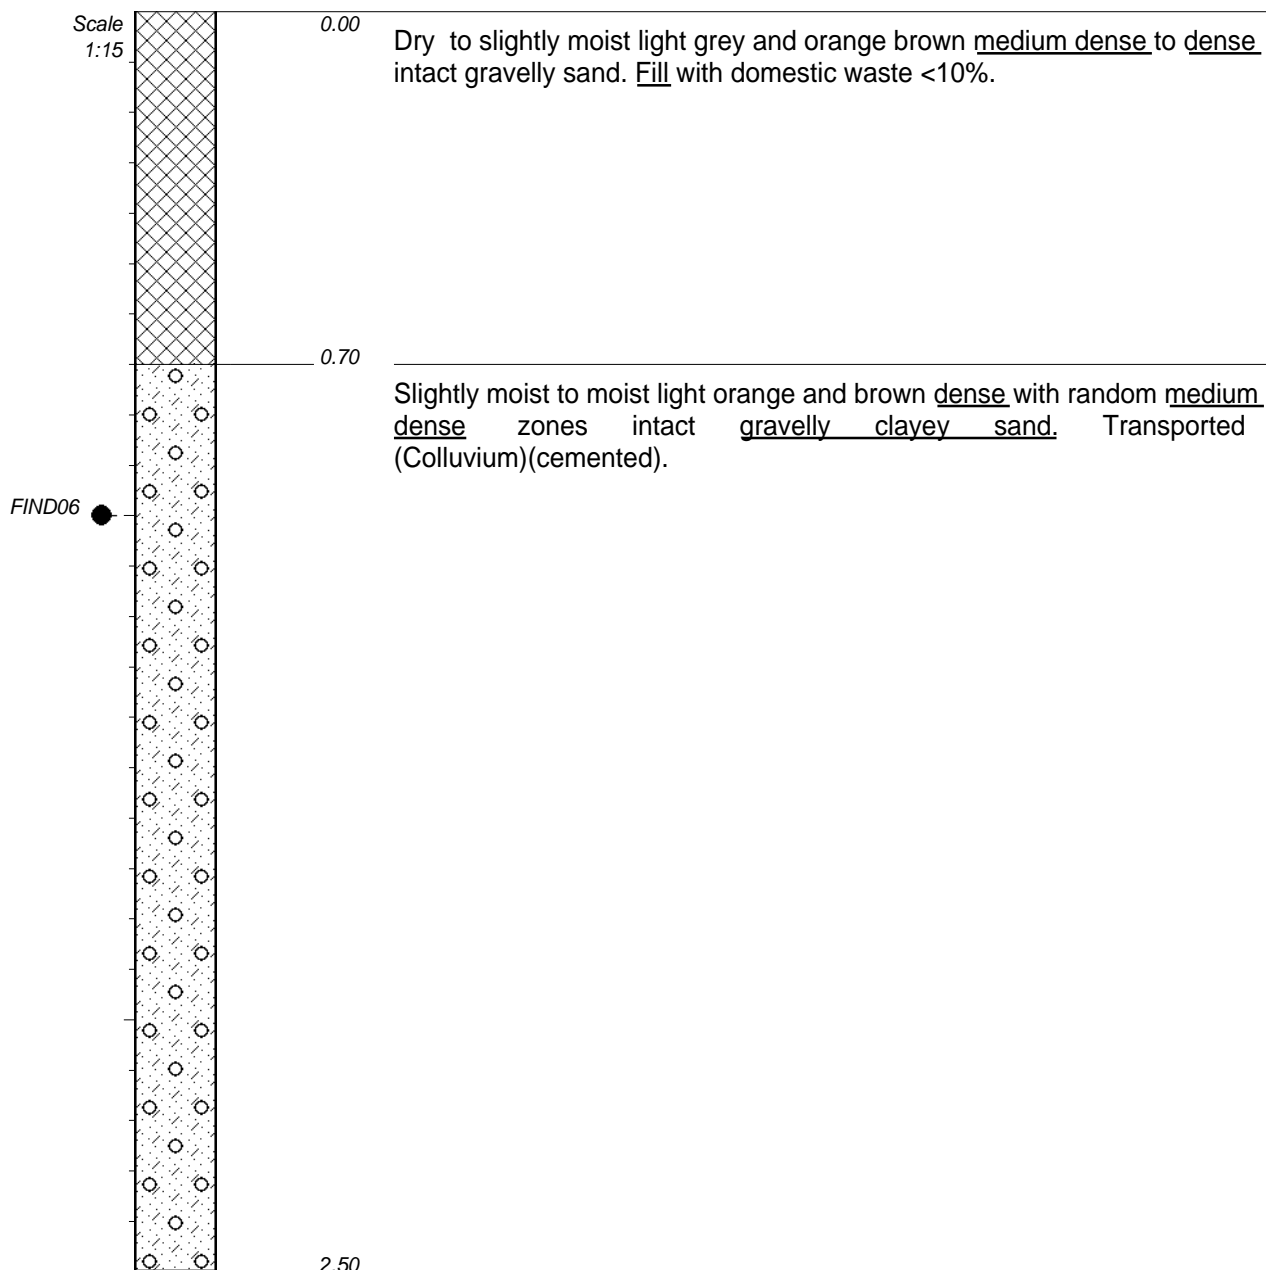
HOLE No: TP06

- 1) No seepage.
- 2) No sidewall collapse.
- 3) No refusal.
- 4) FIND06 sample at 1.0m.

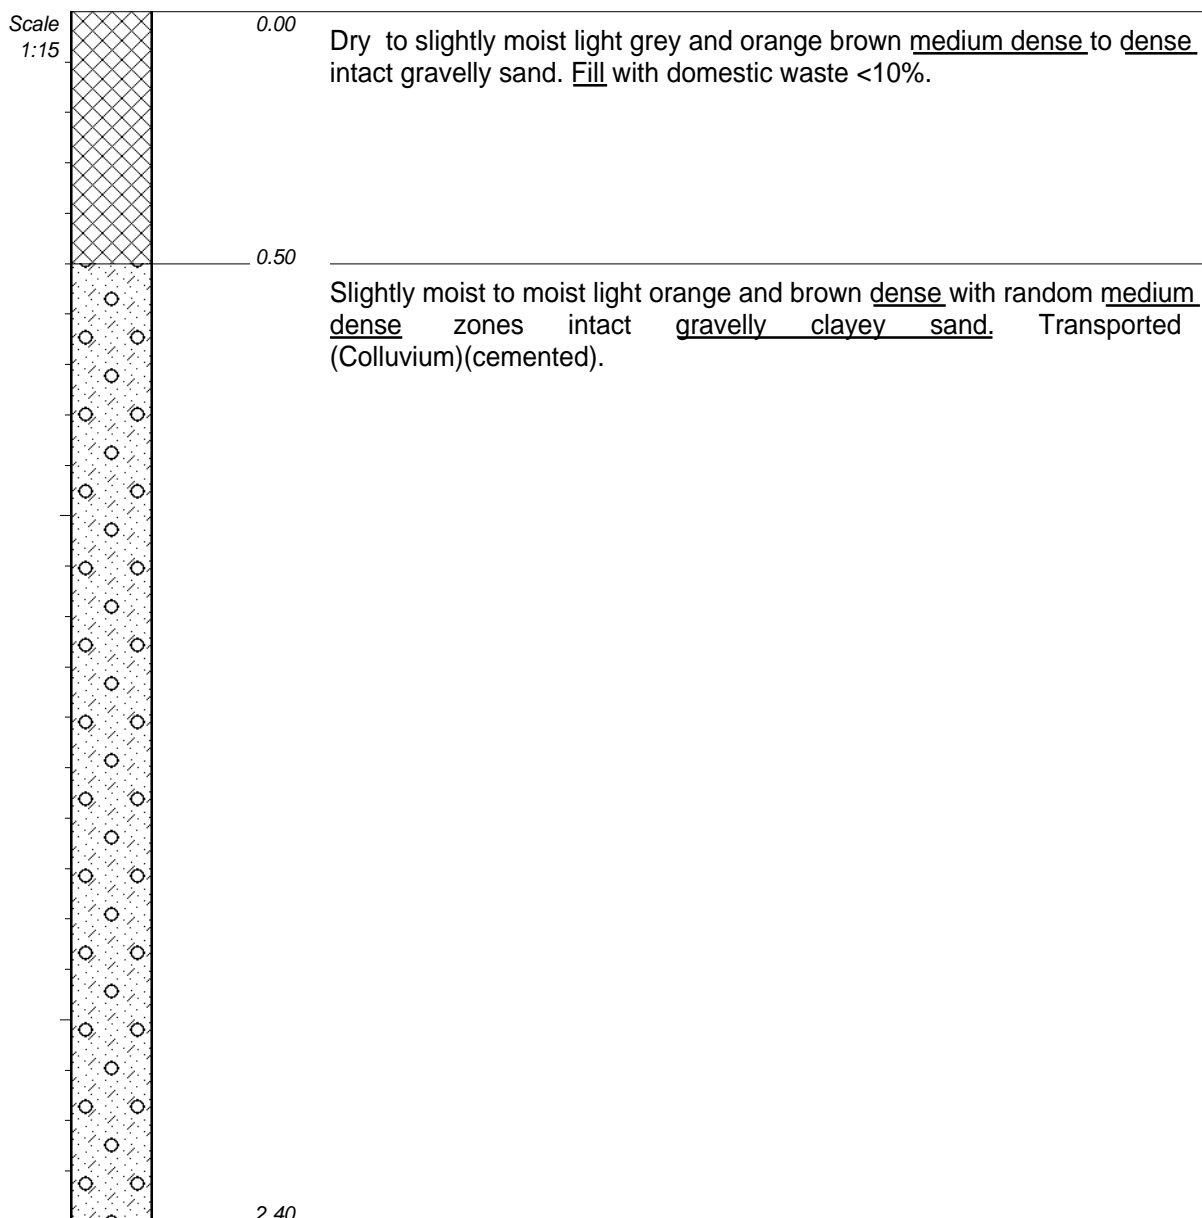
- 1) No seepage.
- 2) No sidewall collapse.
- 3) No refusal.
