PHASE I
GEOTECHNICAL SITE INVESTIGATION

LOUWVILLE HOUSING
ERF 7752 AND PORTION OF ERF 1003
VREDENBURG

iX ENGINEERS

Project no: 016-19

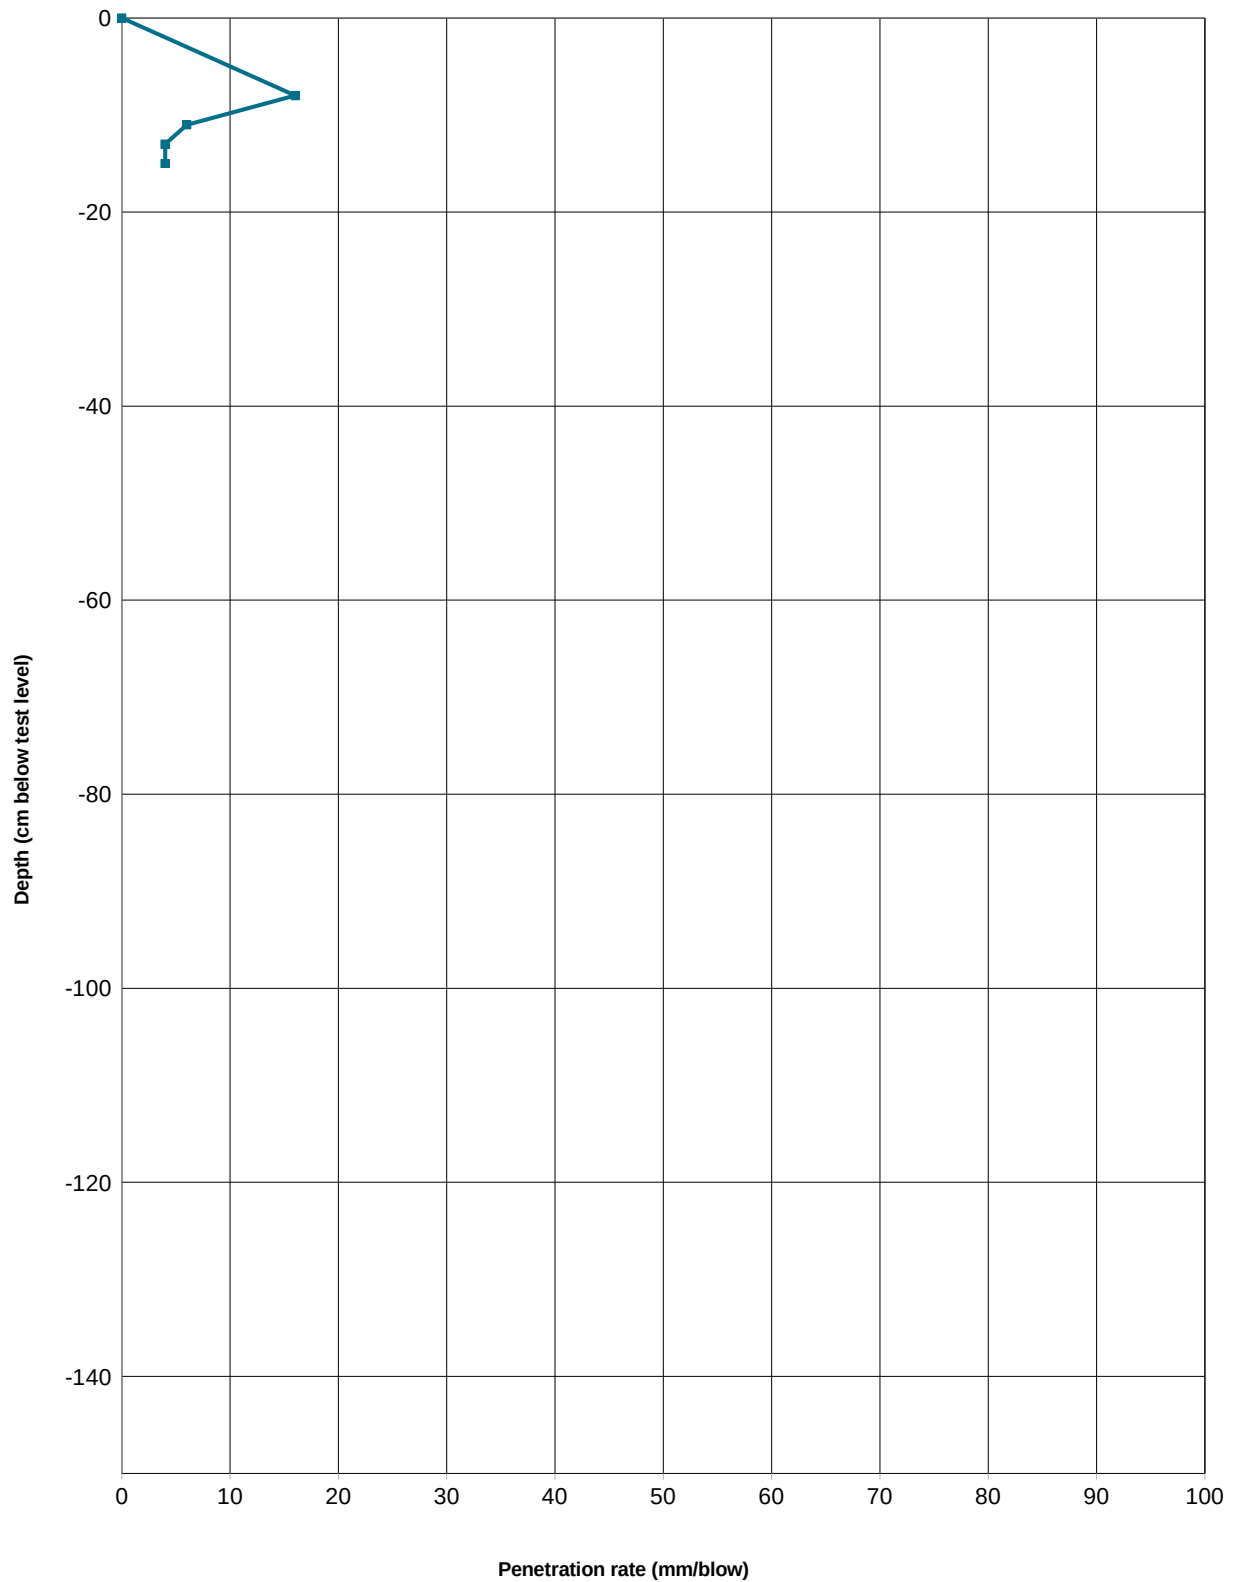
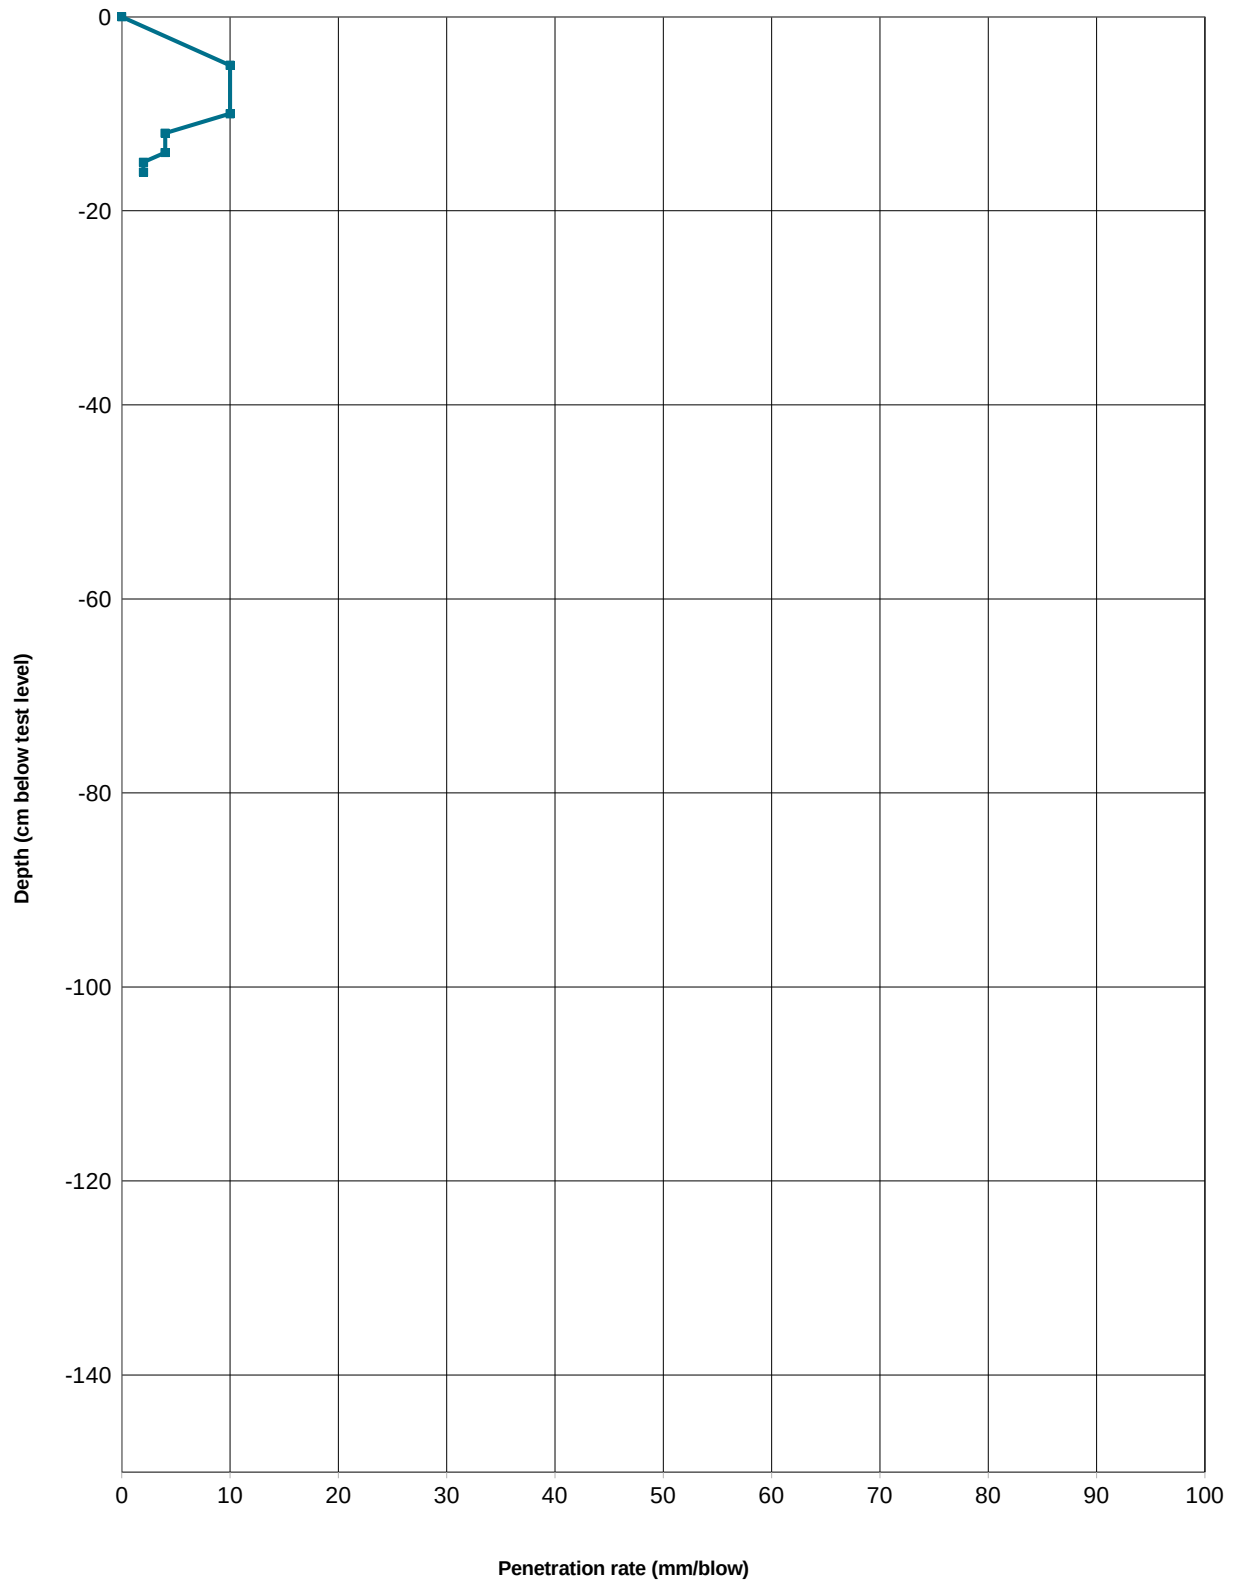
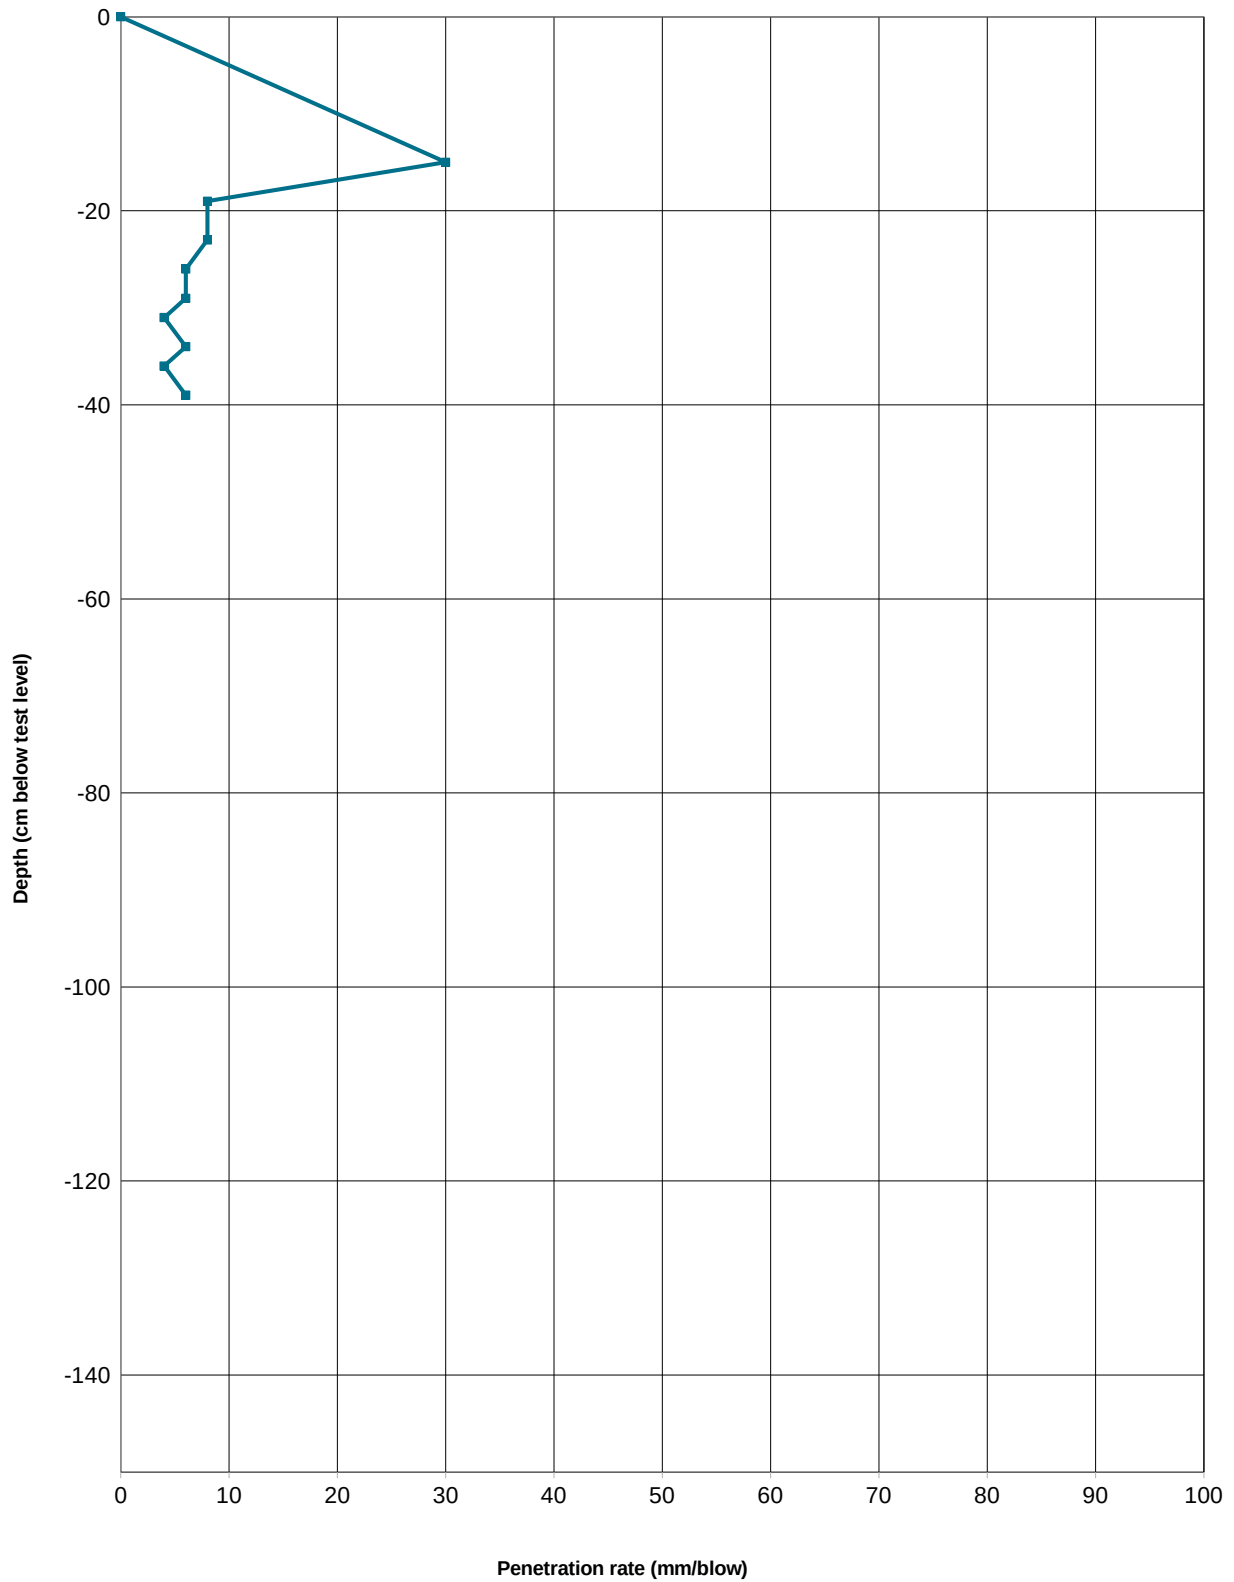
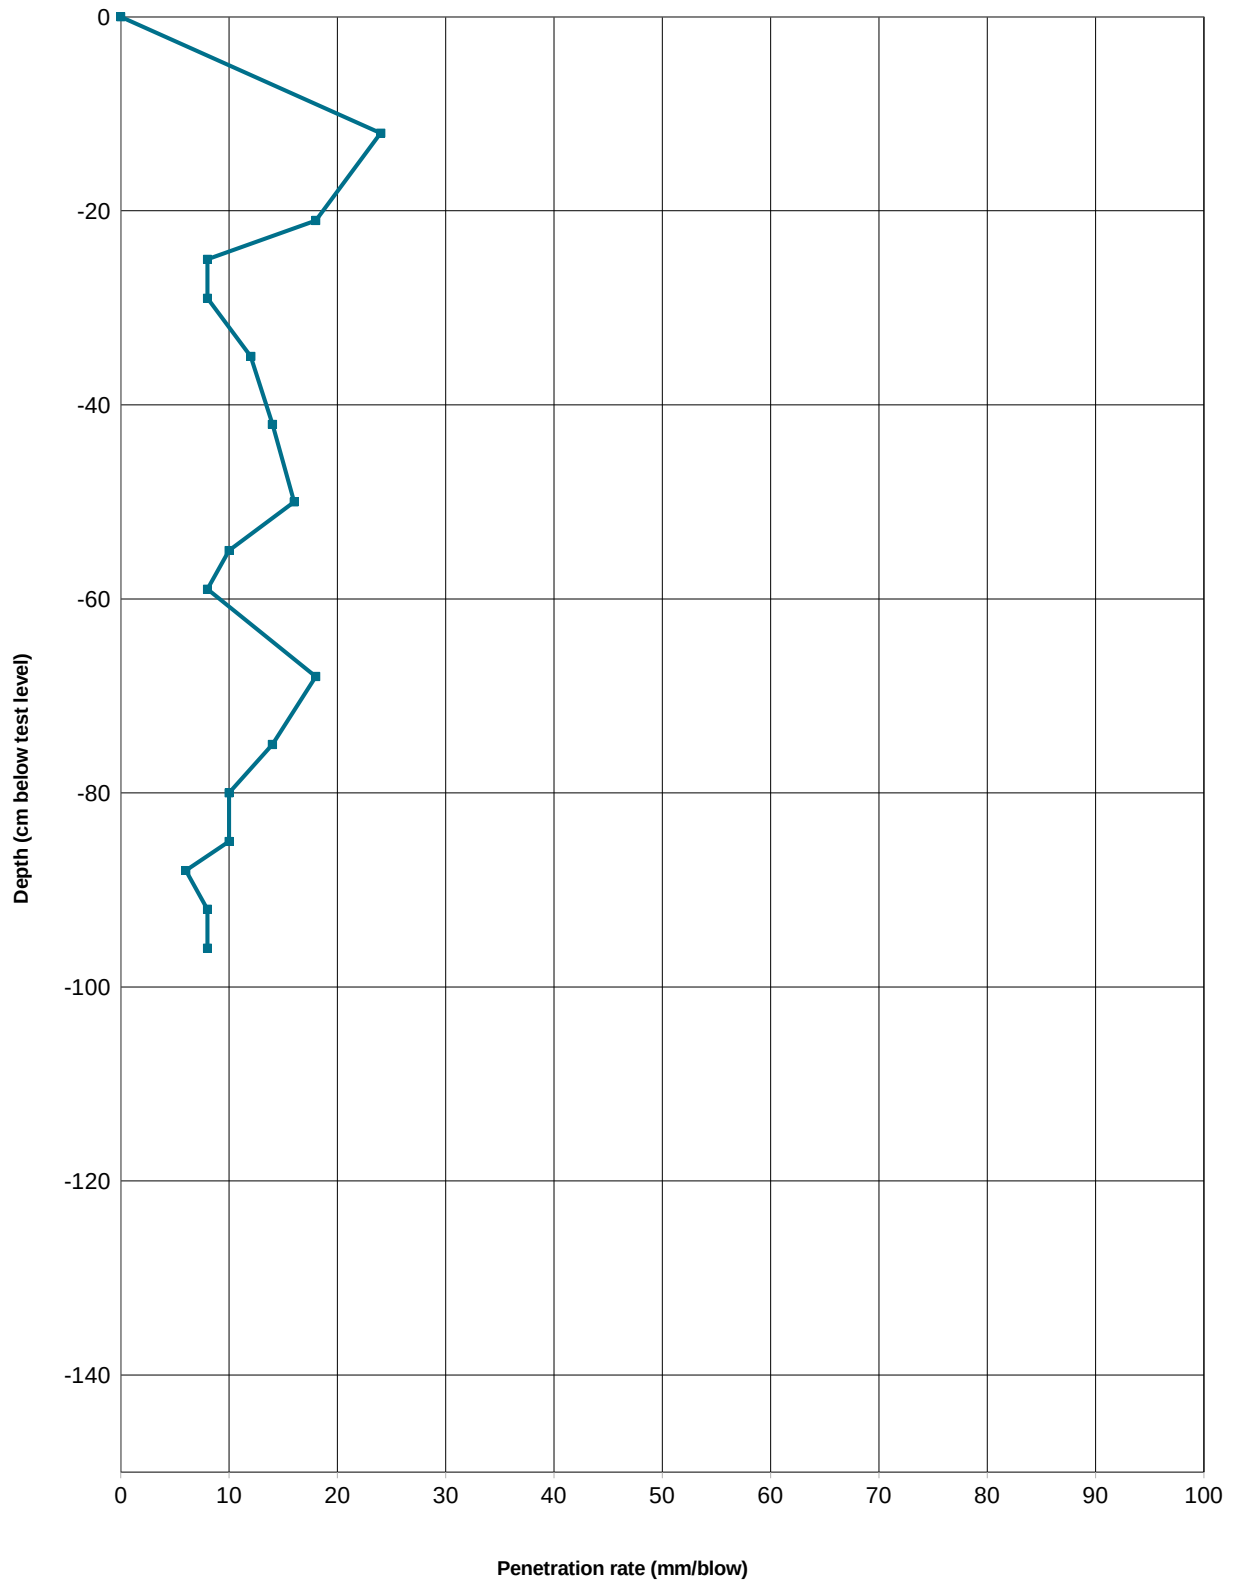
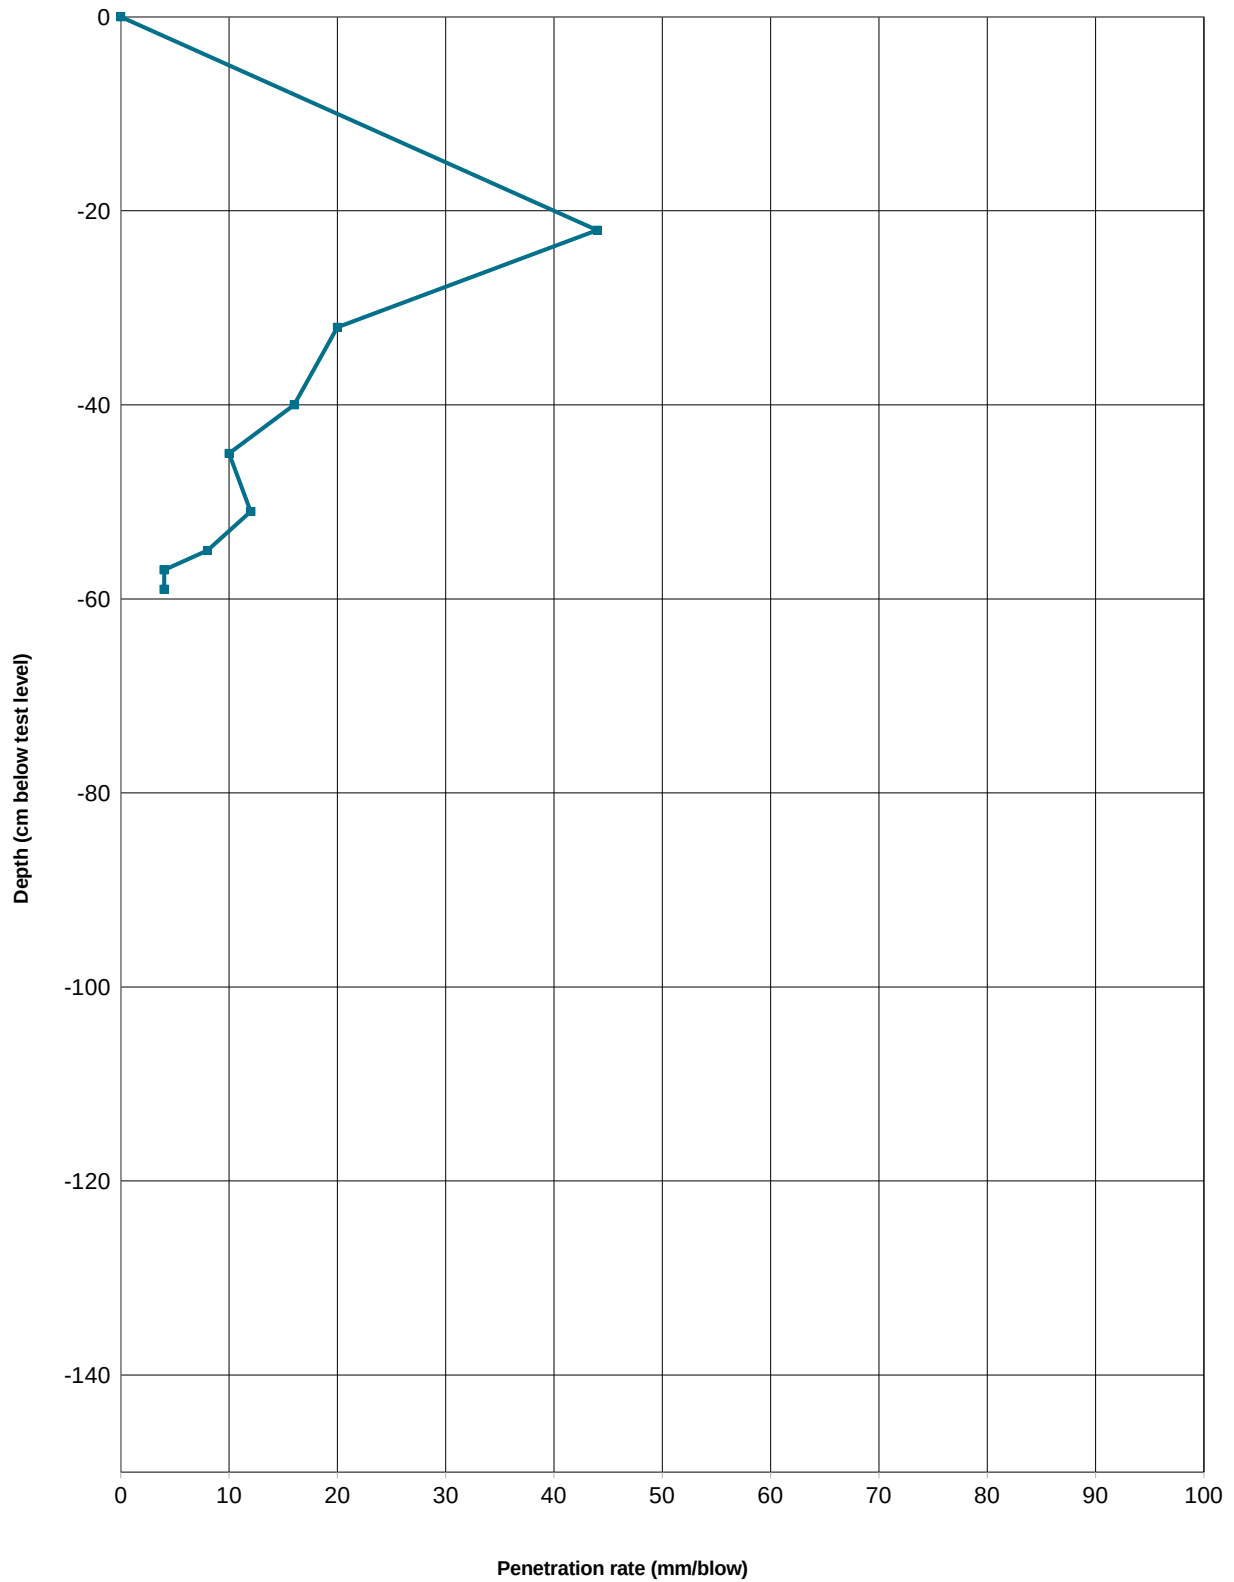
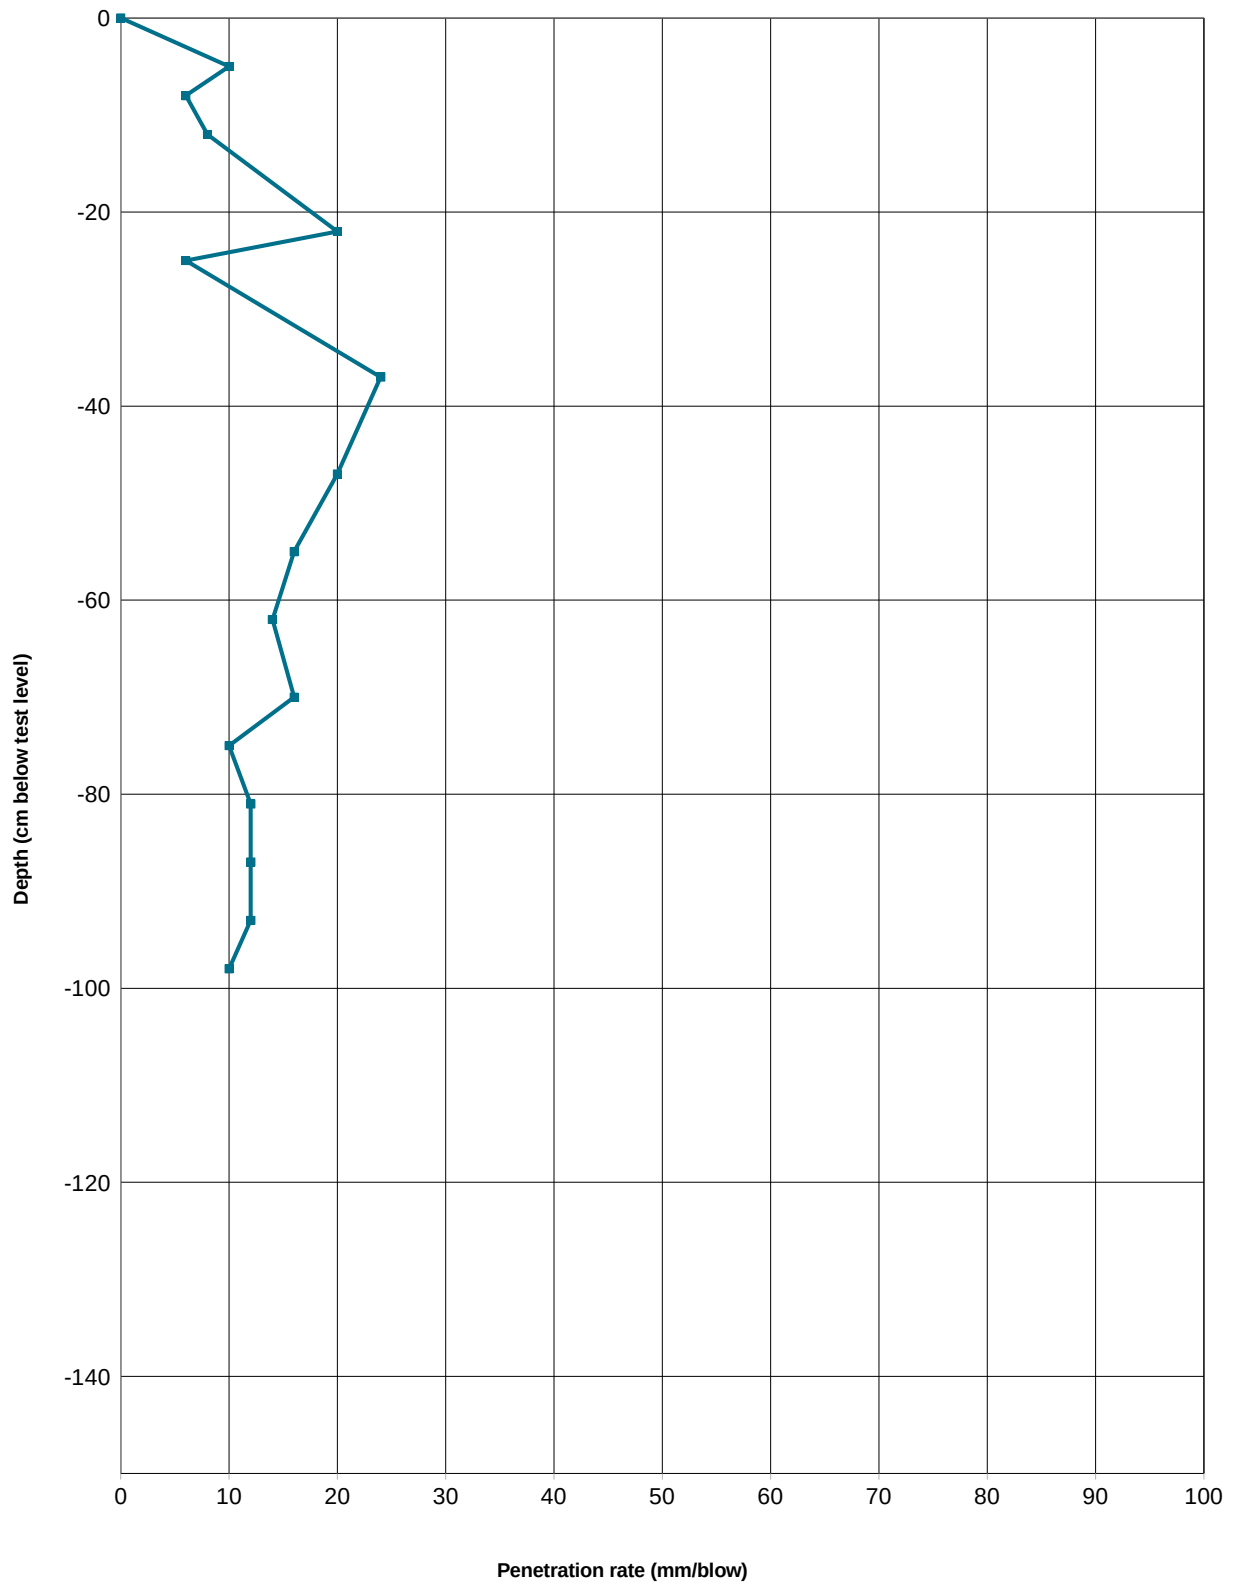
DPL NO: 1
LEVEL: GL

DYNAMIC PROBE LIGHT (DPL) TEST

- b) DPL test results indicate that the transported sandy soils as well as the clayey sands within approximately 1.0 m of present ground surface are generally dense to very dense with isolated areas of medium dense soils present throughout the site. The transported soils are moderately compressible and will form a competent load-bearing founding horizon if precautions are taken to accommodate potential softer spots.

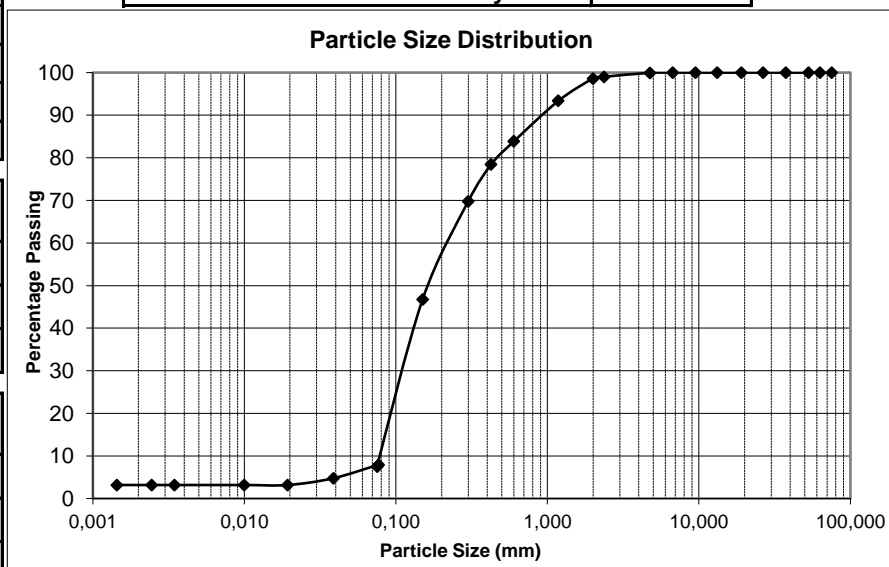
MOD AASHTO ; C.B.R. :	
MOD AASHTO (Kg/m ³)	1804
O.M.C. (%)	10,2
C.B.R. @ 100% Comp.	30
C.B.R. @ 98 % Comp.	20
C.B.R. @ 95 % Comp.	13
C.B.R. @ 93 % Comp.	9
C.B.R. @ 90 % Comp.	4
Swell (max) %	0,00

Tabulated Summary	Percentage
Gravel : Percentage - 4.75 mm	0
Sand : Percentage - 4.75mm and + 0.075mm	92
Silt : Percentage - 0.075mm and + 0.002mm	5
Clay : Percentage - 0.002mm	3

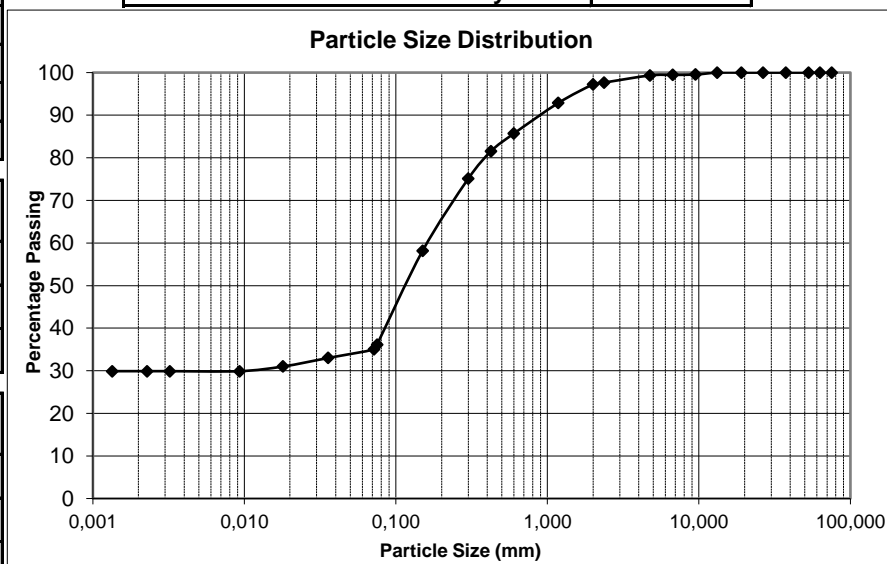
% SCS Dispersion:	
Initial Moisture Content (%) :	12,9
pH:	8,76
Conductivity mS/m:	320

Atterberg Limits :	
Liquid Limit	23
Plastic Index	12
Linear Shrinkage	6,0

Tabulated Summary	Percentage
Gravel : Percentage - 4.75 mm	1
Sand : Percentage - 4.75mm and + 0.075mm	63
Silt : Percentage - 0.075mm and + 0.002mm	6
Clay : Percentage - 0.002mm	30

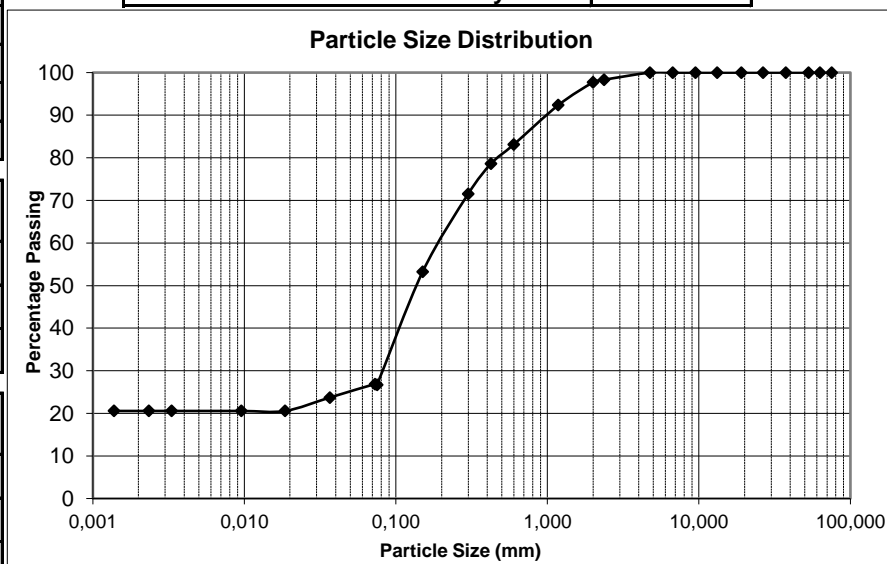
% SCS Dispersion:	
Initial Moisture Content (%) :	12,7
pH:	8,54
Conductivity mS/m:	200

Atterberg Limits :	
Liquid Limit	18
Plastic Index	8
Linear Shrinkage	4,0

Tabulated Summary	Percentage
Gravel : Percentage - 4.75 mm	0
Sand : Percentage - 4.75mm and + 0.075mm	73
Silt : Percentage - 0.075mm and + 0.002mm	7
Clay : Percentage - 0.002mm	20

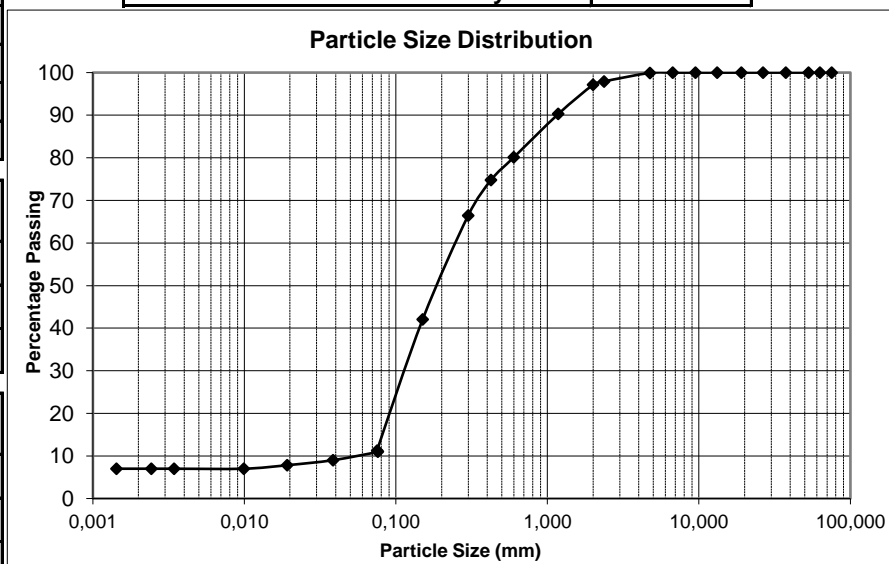
% SCS Dispersion:	
Initial Moisture Content (%) :	3,6
pH:	
Conductivity mS/m:

Tabulated Summary	Percentage
Gravel : Percentage - 4.75 mm	0
Sand : Percentage - 4.75mm and + 0.075mm	89
Silt : Percentage - 0.075mm and + 0.002mm	3
Clay : Percentage - 0.002mm	8
