TERRESTRIAL BIODIVERSITY IMPACT ASSESSMENT

PROPOSED LOUWVILLE HOUSING ON ERVEN 7752 AND 1003 VREDENBURG

Date: July 2019

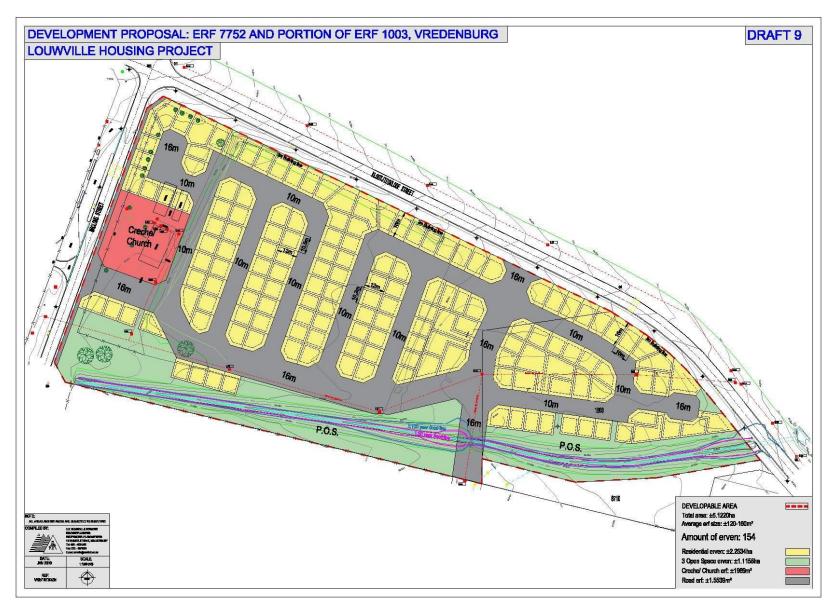
Figure 2: Proposed Louwville Housing Development Layout Map

Saldanha Bay Municipality proposes a housing development and associated infrastructure on erven 7752 and 1003 with a total development area of ± 5.122 ha. The development proposes the following:

- ±154 residential erven (±120-160m²);
- 3 open space erven (±1.1158ha) mainly along the southern border of the site which includes the concrete stormwater channel and its 1:100 year floodline area;

- Creche/church erf (±1989m²);
- Road erf (±1.5539m²); access roads to the development will be from Kootjieskloof street (250m from Maclon street) and Maclon street (127m from Kootjieskloof street); Proposed new roads situated in the 16m road reserves will be 5,0m wide, and new roads situated in the 10m road reserves will be 4,5m wide. The 5,0m wide roads will have kerbs installed on both sides, namely CK5 and MK10, while the 4,5m wide roads will have CK5 and edging (90mm).

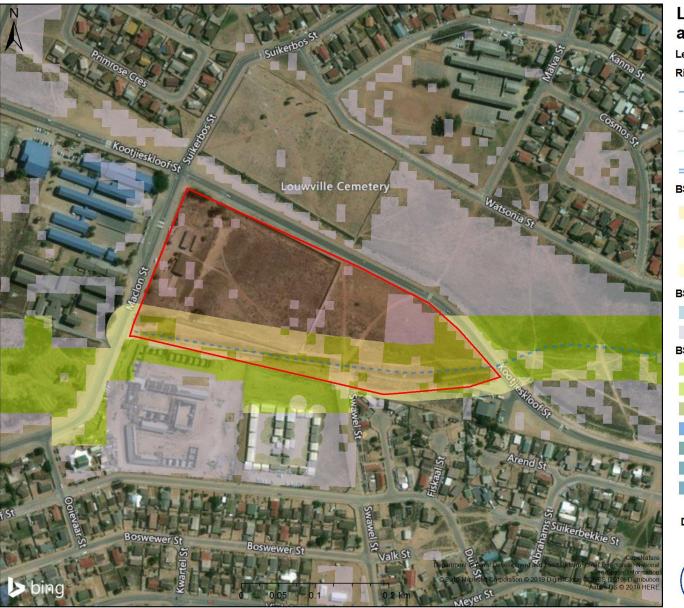
Figure 2: Extract of the Western Cape Biodiversity Spatial Planning map (2017), indicating proposed development area assessed and mapped CBAs and ESAs.

Louwville Housing CBA and ESA Map

As can be seen from Figure 2 in the report approximately 2ha of the south and southeastern sections of the site is mapped as terrestrial Critical Biodiversity Area, Ecological Support Areas and Ecological Support Area 2 (Restore).

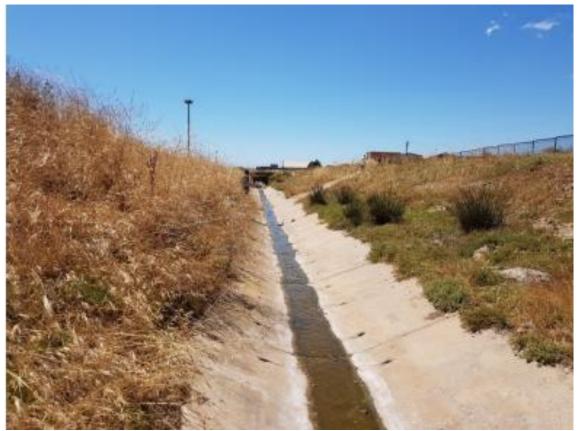
Photo 5: Concrete stormwater channel along southern border.

Observations and Findings on Site – There are no natural habitat nor flora or fauna species of conservation concern remaining on site, only a concrete storm water channel along the southern border of the site. The stormwater channel and its associated 1:100-year floodline area has been excluded from the proposed development area therefore hydrological functioning of the channel will continue as is.

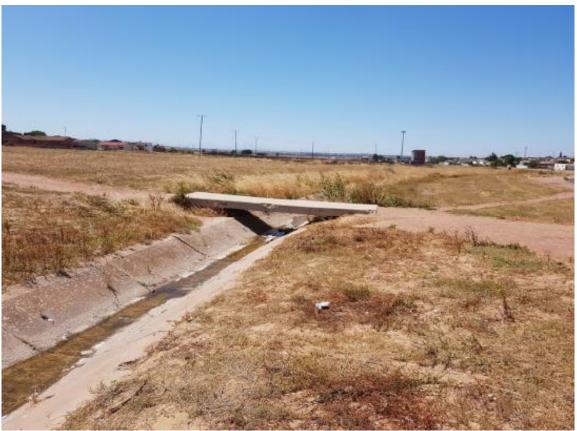
Photo 6: Concrete stormwater channel along southern border.

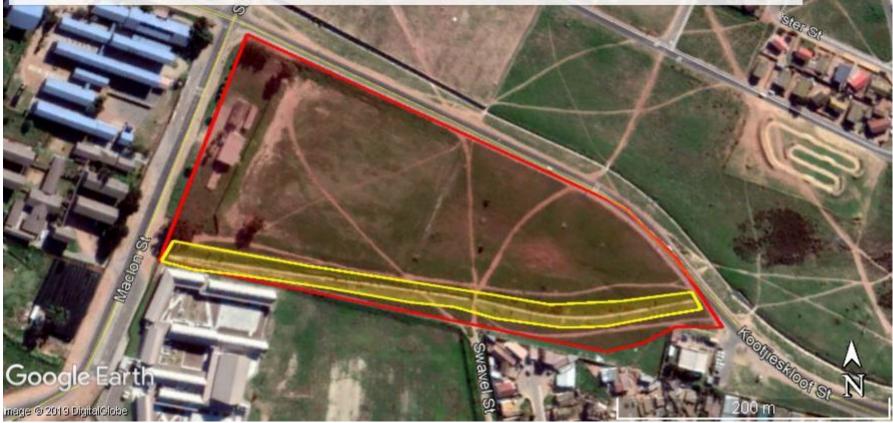
Figure 3: Terrestrial biodiversity sensitivity map of the proposed Louwville housing development site.

The site is considered to be of low terrestrial botanical/biodiversity sensitivity and conservation value (see Figure 3 below) due to the following reasons:

- Significantly low indigenous plant species diversity remaining on site.
- No plant, fauna or avifauna species of conservation concern recorded on site.
- Previous site clearance and developments leading to habitat transformation and fragmentation.
- Ongoing human impacts due to the urban surroundings and developments i.e. school grounds, residential areas, cemetery, informal sport fields, church and creche erven.
- Low terrestrial ecological connectivity opportunities due to isolation of site inside urban developed area.
- Low conservation and/or rehabilitation potential due to transformed state, the location within the urban area, low ecological connectivity value and small size of the site.

It is however important to note that the hydrological functioning of the stormwater channel along the southern border is to be maintained due to the supporting role which it plays in replenishing water resources which in turn maintains ecological functioning of remaining undeveloped areas surrounding Louwville, therefore this area has been mapped as important to maintain current hydrological functioning. The concrete stormwater channel and its associated 1:100 year floodline area which includes most of the mapped CBA, ESA and ESA2 areas on site have been excluded from the proposed development area (accept for required services infrastructure i.e. the access road which will be along existing access road over the channel) to be maintained as Public Open Space and therefore hydrological functioning of the stormwater channel will be maintained.

- Low Terrestrial Biodiversity/Botanical Sensitivity Area
- 🥏 Southern Concrete Stormwater Channel Hydrological Functioning and 1:100 year Floodline Area to be Maintained
