**FRESHWATER OPINION REPORT FOR THE CONSTRUCTION OF A ROAD AND ASSOCIATED
INFRASTRUCTURE ON PORTION 1 OF FARM BLOUBANK NO. 52, TULBAGH**

MARCH 2017

EXECUTIVE SUMMARY

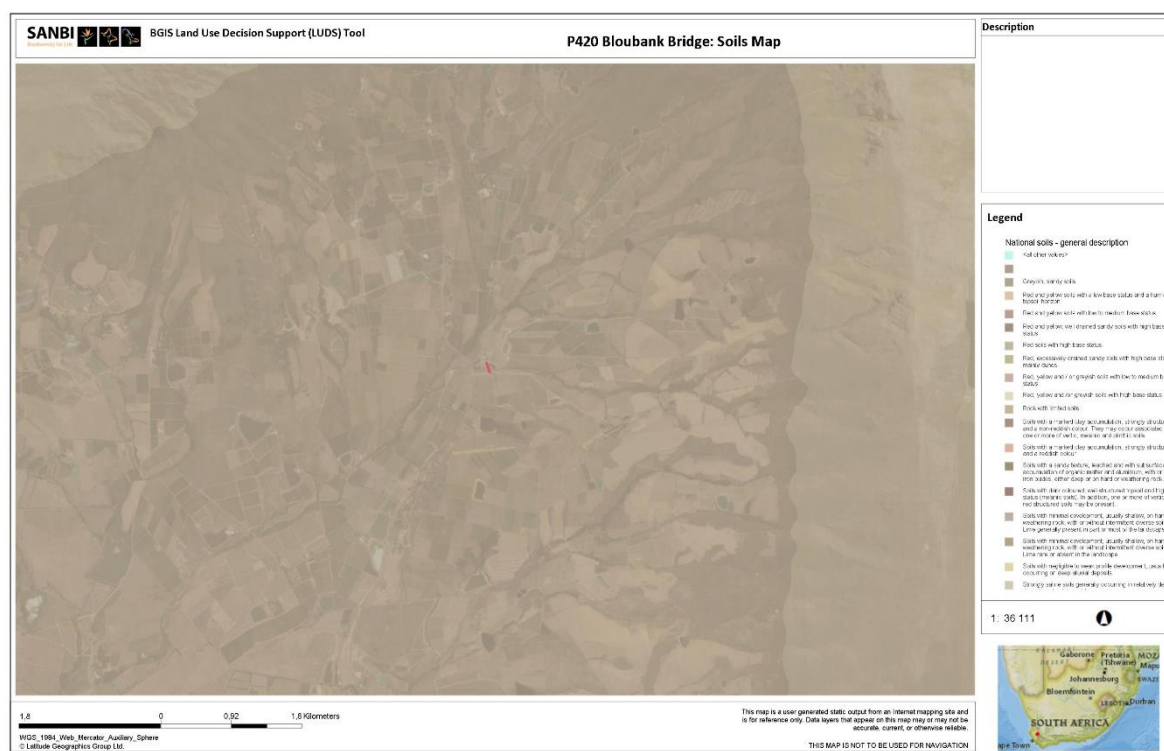
Figure 8. The Soils Map for the site of the newly constructed road (Red line) (SANBI BiodiversityGIS, 2017)

The soils show minimal development and are usually shallow on hard or weathering rock (brown area in Figure 8). Typically Glenrosa and Mispah forms are dominant. The soils are highly erodible.

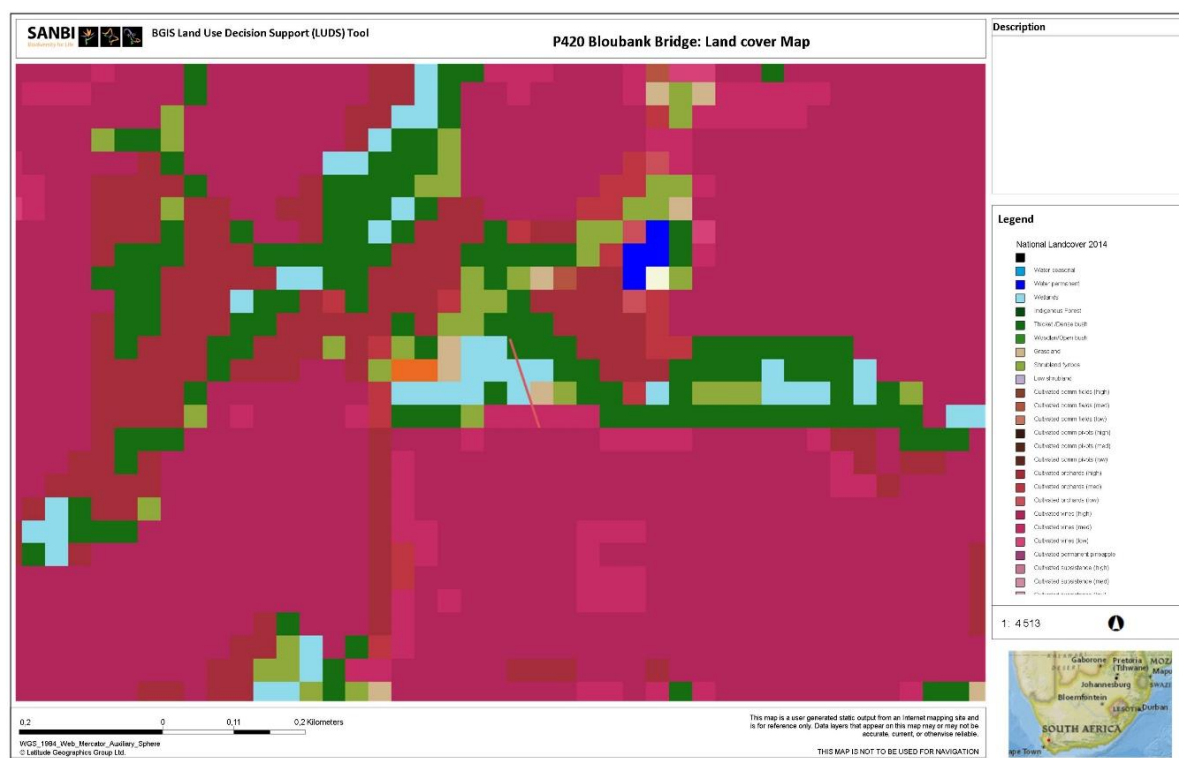
Fine scale land cover mapping in 2014 identified that most of the area has been cultivated (pink areas in Figure 12). The stream corridor has been mapped as a combination of dense shrub (dark green in Figure 12) and wetlands (light blue in Figure 12). The upper reaches of the stream lie within the Winterhoek Mountain Catchment Area and Groot-Winterhoek Wilderness Area protected areas.

Figure 12. National Landcover (2014) for the study area (SANBI BiodiversityGIS, 2017)

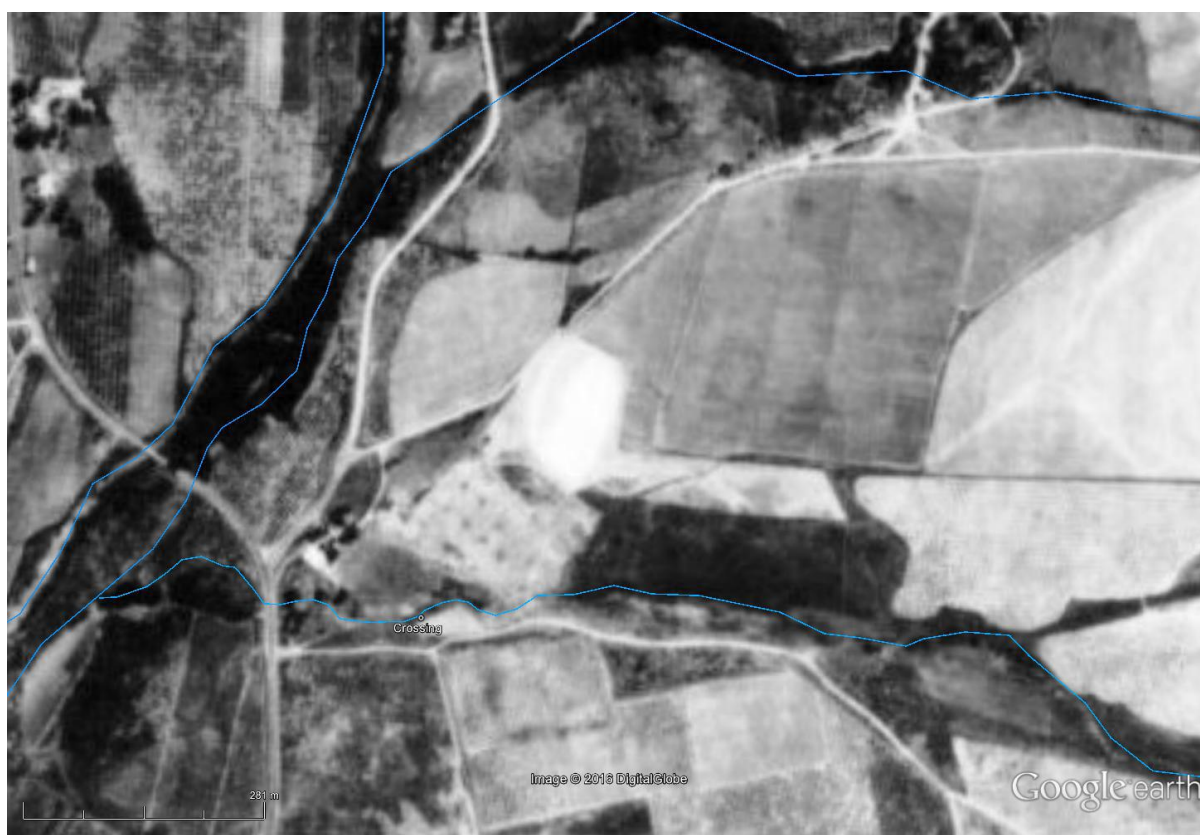
The following aerial images were examined to assess the modification to the stream that has taken place in the past 50 years: December 1966 (Figure 15); March 1980 (Figure 16); December 2002 (Figure 17) and February 2016 (Figure 18). All of these images show that there has been very little alteration to the channel course or the surrounding land cover for this period. The small farm dam on the northern bank of the stream was constructed after 1966 but before 1980. An informal crossing has been used from time to time through the stream at the site that is visible in some of the Google Earth images.

Figure 15. Aerial image taken in 1966/7 of the area

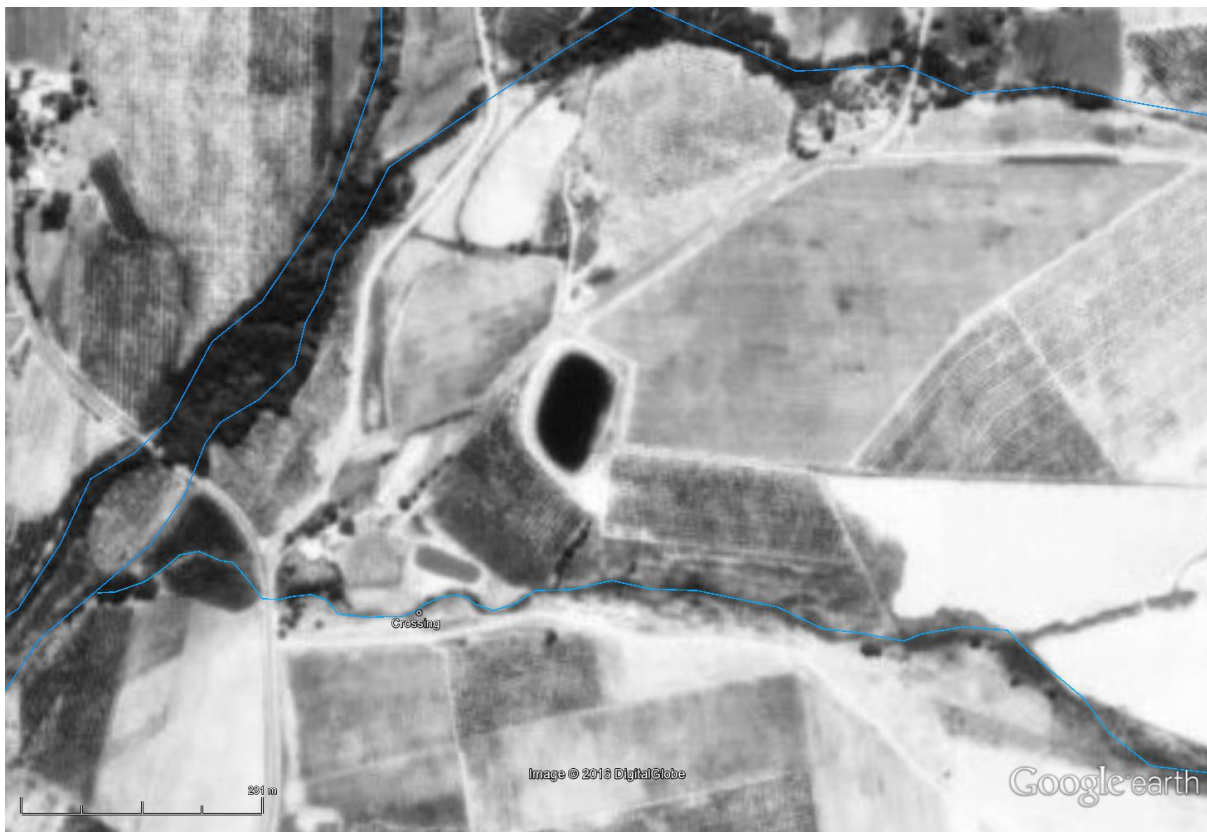
Figure 16. Aerial image taken in 1980 of the area

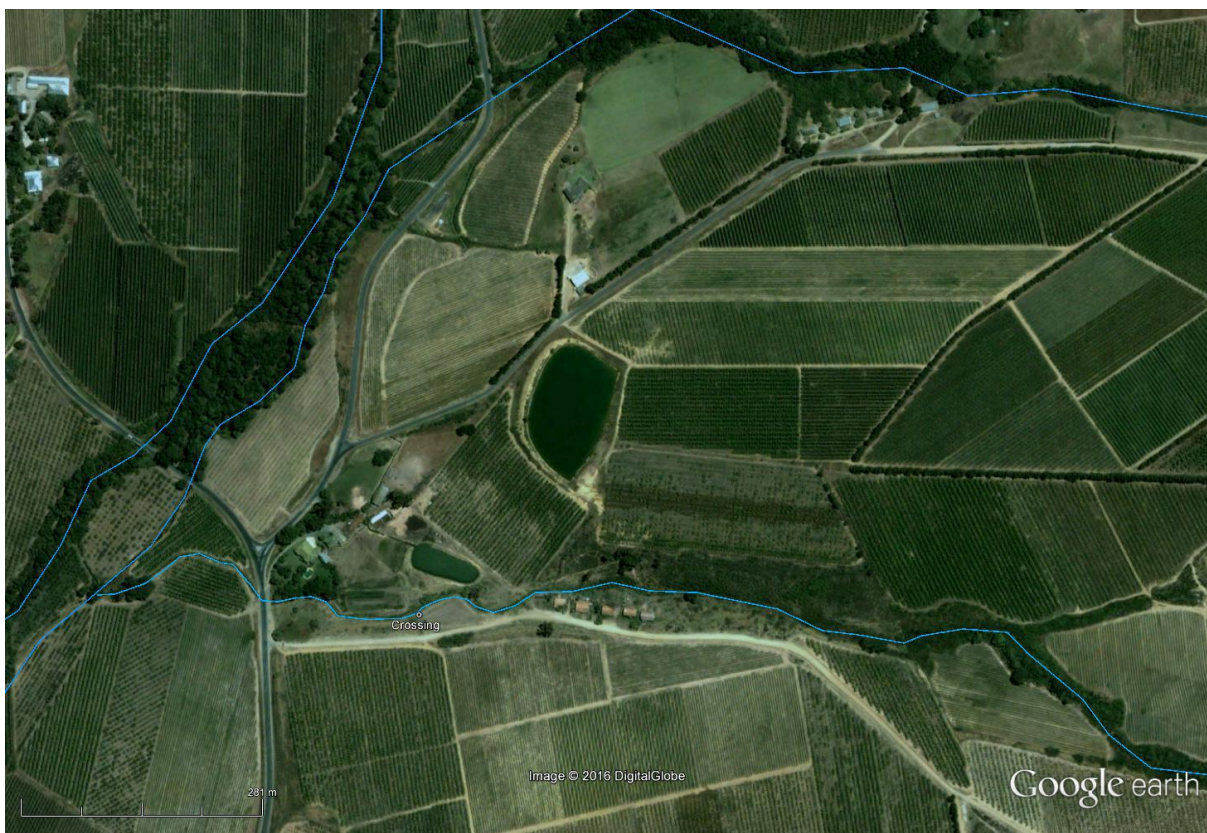
Figure 17. Google Earth image taken in 2002 of the area

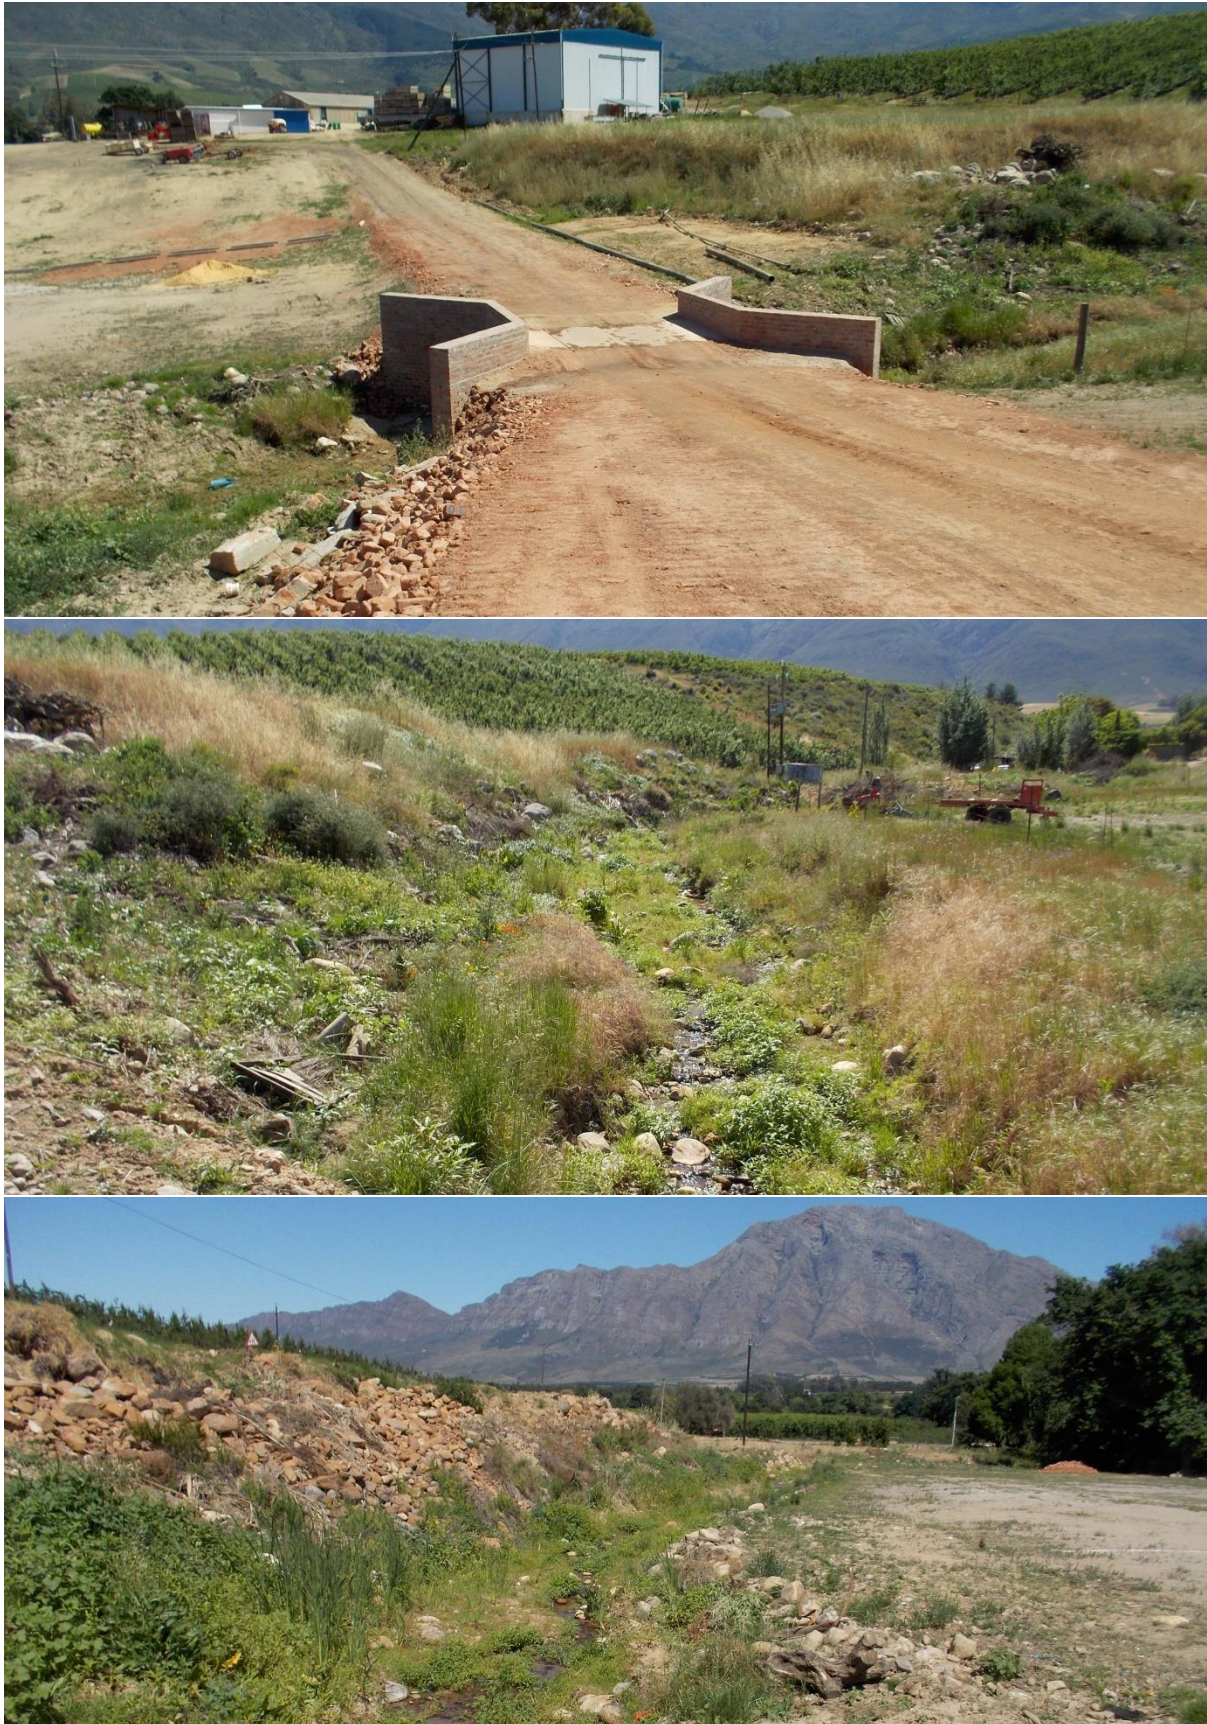
The stream at the site flows within a relatively deep channel upstream of the crossing that becomes shallower downstream of the structure. The stream is a lower foothill cobble bed stream that flows naturally throughout the year. The active channel is approximately 2.5m with an 8 to 10m wide macro channel. The southern bank upstream of the crossing is relatively low but downstream of the crossing is steep and approximately 4m high (Figure 19). The bank has been stabilised with boulders. The northern bank on the other hand, is steep upstream of the structure but downstream of the crossing is about 1m in height. All the indigenous riparian vegetation has been removed and the disturbed area now consists of exotic and invasive alien plants. The only remaining riparian vegetation occurs just upstream of the Witzenberg Road crossing over the stream. The banks at the culvert structure have been stabilised with bricks and the brick wing walls.

Figure 19. View of the culvert structure (top), stream upstream of the structure (middle) and downstream of the structure (bottom)

The following recommendations are provided for the rehabilitation of the site:

- Rubble and debris from construction activities that have been undertaken at the crossing should be removed.
- The stream banks should be cleared of exotic and in particular invasive alien plants. The invasive alien kikuyu grass in particular should be kept out of the riparian zone as it destabilises the river banks. It should be replaced by indigenous grasses such as kweek (*Cynodon dactylon*). This should be undertaken during the dry season but following rainfall events when the soil is moist. Weedy shrubs and small invasive alien saplings occurring along the stream banks within the disturbed area at the crossing should be hand pulled. Should this not be possible for some of the large plants, the plants should be sprayed with a
