## FRESHWATER ECOLOGICAL IMPACT ASSESSMENT

# PROPOSED VREDEBES STORMWATER WEIR CONSTRUCTION, CERES

Witzenberg Municipality

**DATE:** 06 August 2018

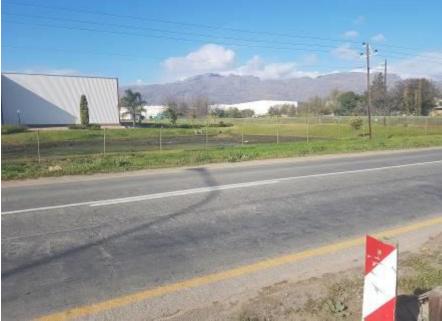
Figure 4: Start of the non-perennial river

The non-perennial river starts south of the R 46 road at a pack store.

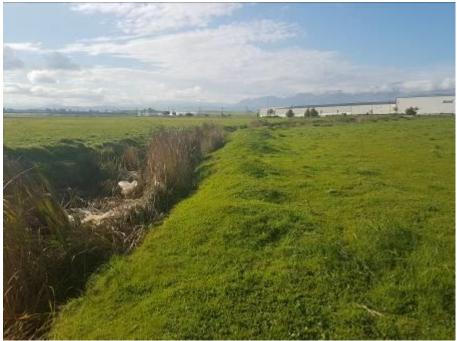
Figure 5: Non-perennial river upstream from weir crossing.

The non-perennial river at this point is channelled into constructed ponds at the pack store. From the ponds, the water flows in a north westerly direction underneath the R 46 in an earth channel for 250m until it reached the point where the weir will cross the non-perennial river.

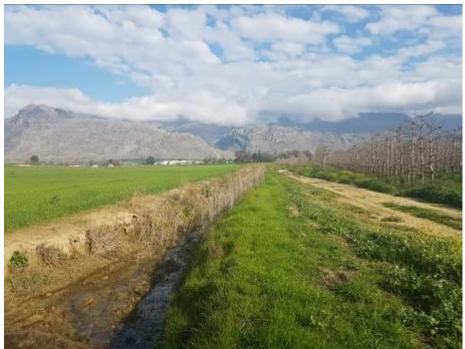
Figure 6: Non-perennial river downstream from weir crossing.

The non-perennial river continue flowing in a earth channel for another 400m between orchids and agricultural lands until it meets up with a non-perennial river that flows in a south western direction back towards the centre of the town of Ceres.

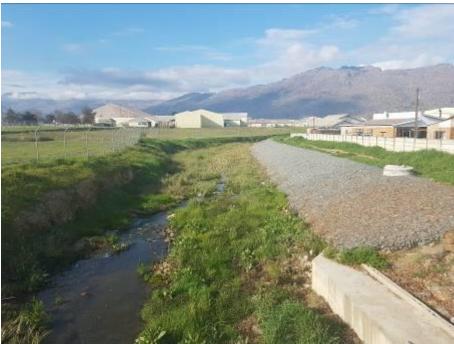
Figure 8: Tributary of the non-perennial river that flow into the Dwars River.

The tributary non-perennial river flows underneath the R 46 road west of the site in between the Ceres industrial area and residential area where it flows into the Dwars River which is a tributary of the Bree River.
