Johann Lanz

Soil Scientist (Pri.Sci.Nat)

Assessment of the impact of sand mining on agricultural potential on the farm Sandvlei number 1020, near Riebeek West

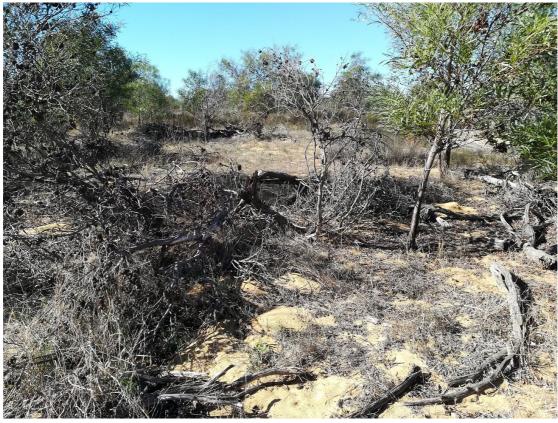
Figure 3. View of typical site conditions, showing the extent of wattle invasion.

The geology of the area is mainly greywacke and phyllite of the Moorreesburg Formation, Malmesbury Group, mostly covered by Quaternary quartz sand of the Springfontein Formation. The soils are generally deep sands overlying clay. Soils generally have upper horizons of light yellow coloured sand, underlain by lighter coloured sand, overlying clay. The sands are up to about 2.2 metres deep. Soils are classified, according to the South African soil classification system, predominantly as Fernwood 1210 where soils are deeper, and Kroonstad 2000 where the clay is shallower. Photographs of soils and site conditions are shown in Figures 3 and 4.

The investigated area is on land that, probably because of the dune topography and sandy soils, has never been under cultivation. The site is heavily infested by alien wattles. The surrounding lands are planted to small grains.

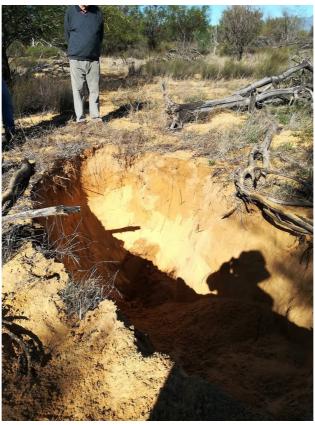
Figure 4. Typical deep sand soil profile of the investigated area (Fernwood soil form).
