**PHASE I**  
**GEOTECHNICAL SITE INVESTIGATION**

**ERVEN 513 & 1719**  
**NAPIER**

**ASLA DEVCO (PTY) LTD**

Project no: 178-17

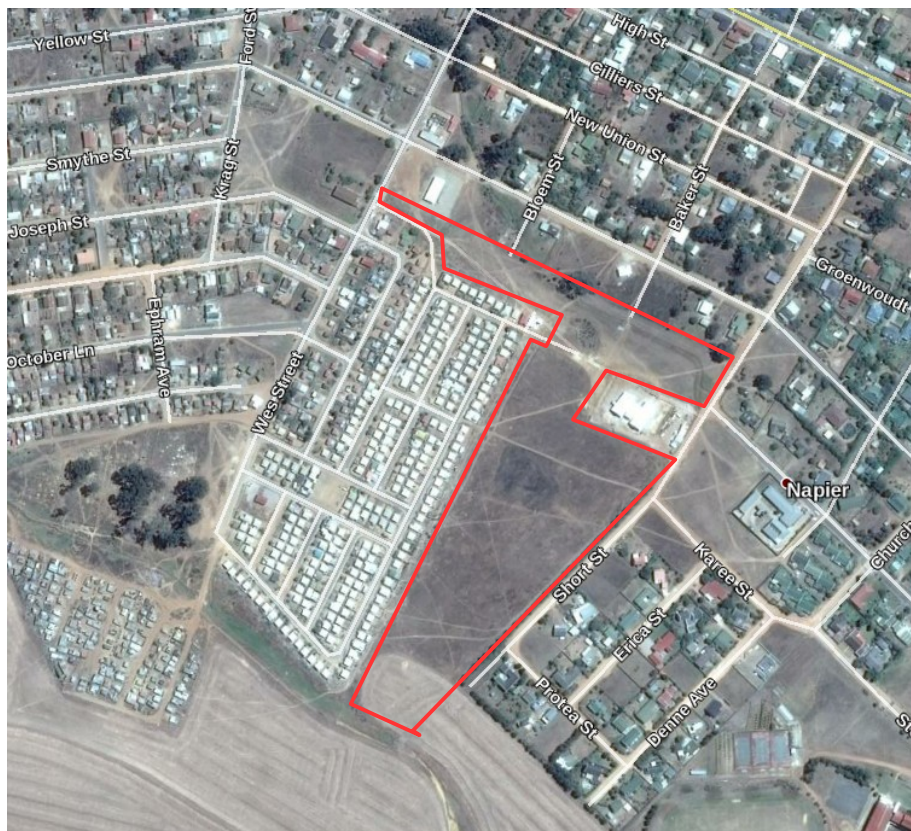
**Figure 3.2: Physiological features of the site**

Topographically, the broader area is fairly flat-lying, with a slight to moderate fall towards the south, north and north-west. Vegetation comprises grass, shrubs and scattered small trees. Site features are illustrated in the remote image in Figure 3.2.

Site features are illustrated in the remote image in Figure 3.2.

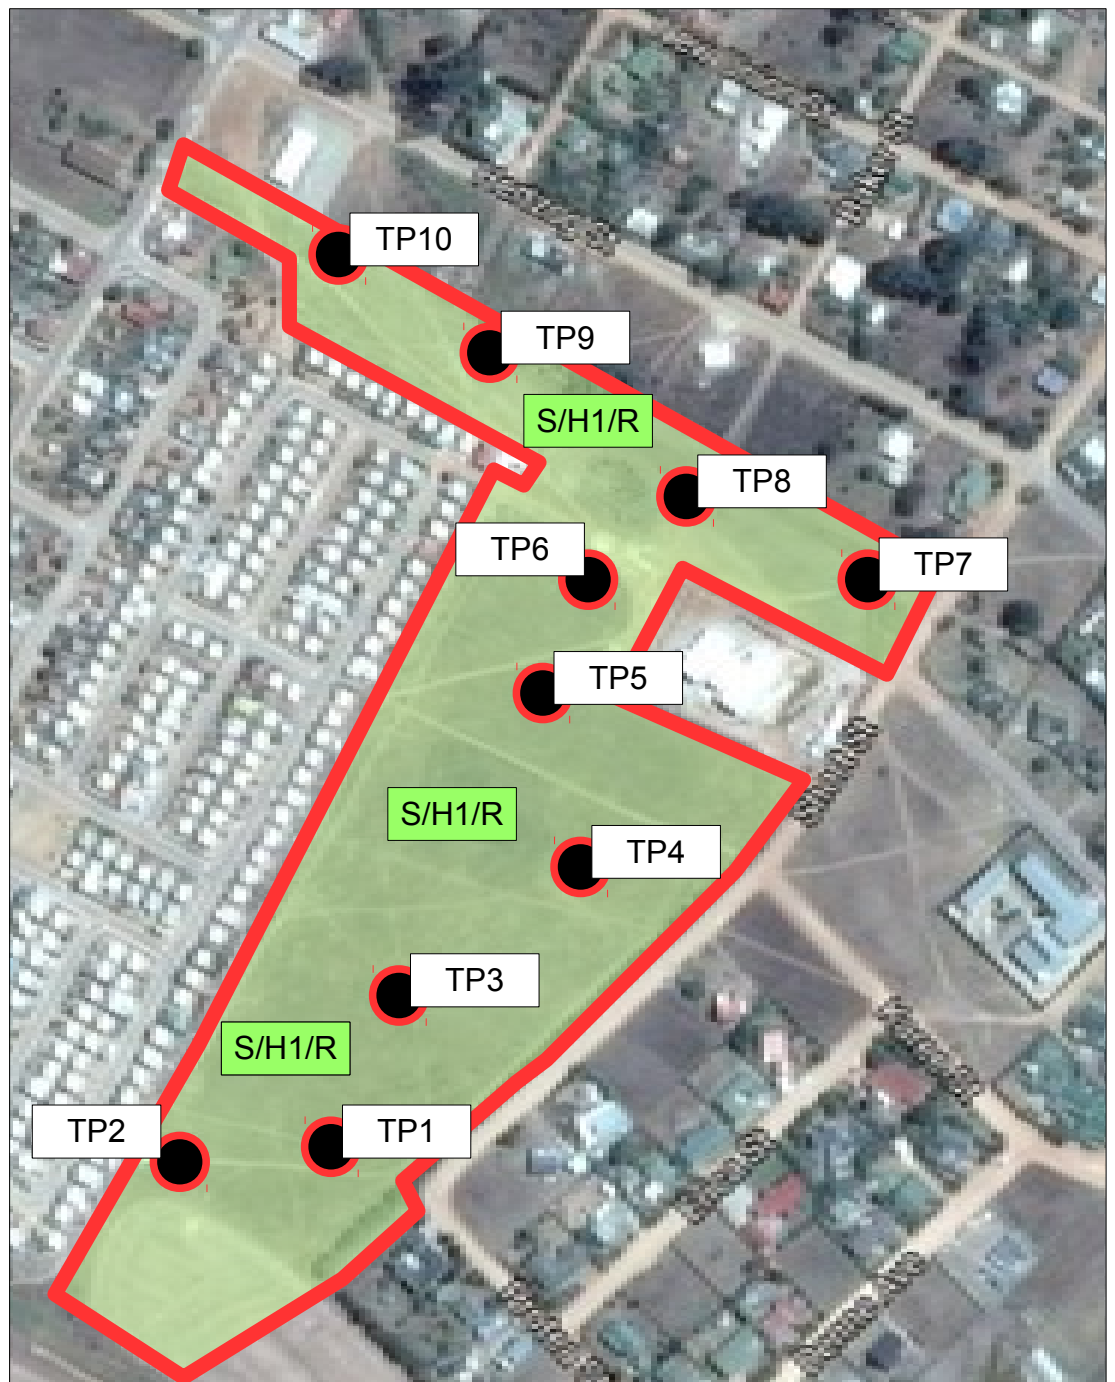
**TITLE:** SITE PLAN SHOWING TEST PIT POSITIONS

Test pit positions are shown in the site plan (see Appendix A). Copies of the recorded soil profiles are included in Appendix B.

The Residential Site Class Designation (after Watermeyer & Tromp and the Joint Structural Division) is set out in Table 7.1. The areal extent of classified areas is shown in the site plan in Appendix A.

As a result of the compressible transported soils (S), overlying low to moderately compressible and potentially expansive clayey soils (H1) and deeper residual weathered shale and siltstone rock (R), a site classification of **S/H1/R** is assigned to the entire site.

S/H1/R

Slightly  
compressible  
transported  
soils overlying  
potentially  
expansive  
clayey soils  
overlying rock

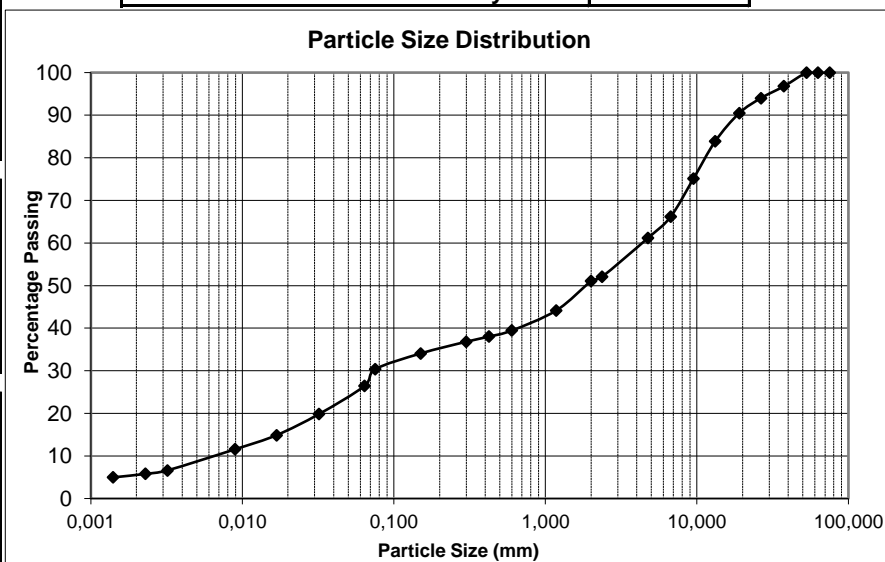
<b>% SCS Dispersion:</b>	
<b>Initial Moisture Content (%) :</b>	4,4
<b>pH:</b>	5,70
<b>Conductivity mS/m:</b>	163

Atterberg Limits :	
Liquid Limit	24
Plastic Index	9
Linear Shrinkage	4,0

Tabulated Summary	Percentage
<b>Gravel</b> : Percentage - 4.75 mm	39
<b>Sand</b> : Percentage - 4.75mm and + 0.075mm	31
<b>Silt</b> : Percentage - 0.075mm and + 0.002mm	24
<b>Clay</b> : Percentage - 0.002mm	6

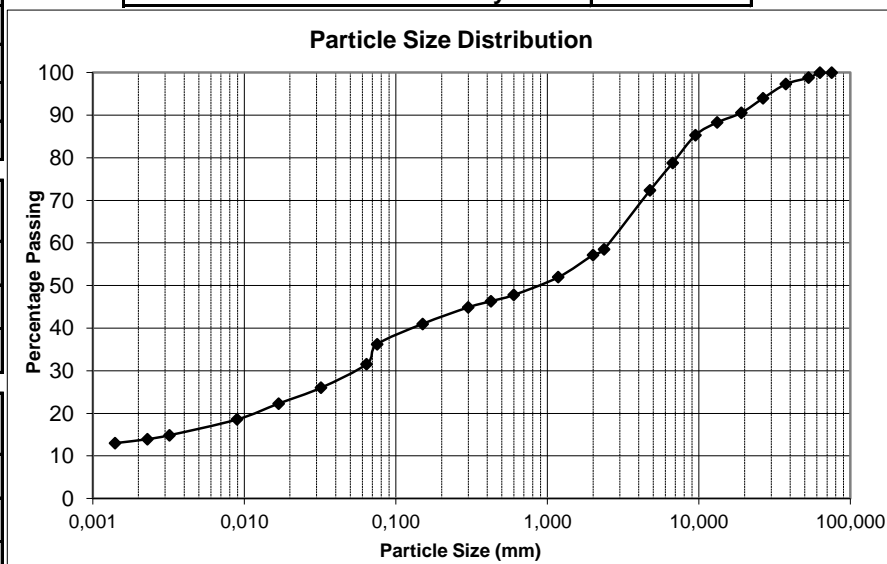
Atterberg Limits :	
Liquid Limit	30
Plastic Index	15
Linear Shrinkage	7,0

MOD AASHTO ; C.B.R. :	
MOD AASHTO (Kg/m <sup>3</sup> )	2092
O.M.C. (%)	10,4
C.B.R. @ 100% Comp.	60
C.B.R. @ 98 % Comp.	40
C.B.R. @ 95 % Comp.	22
C.B.R. @ 93 % Comp.	16
C.B.R. @ 90 % Comp.	8
Swell ( max ) %	0,20

Tabulated Summary	Percentage
<b>Gravel</b> : Percentage - 4.75 mm	28
<b>Sand</b> : Percentage - 4.75mm and + 0.075mm	36
<b>Silt</b> : Percentage - 0.075mm and + 0.002mm	22
<b>Clay</b> : Percentage - 0.002mm	14

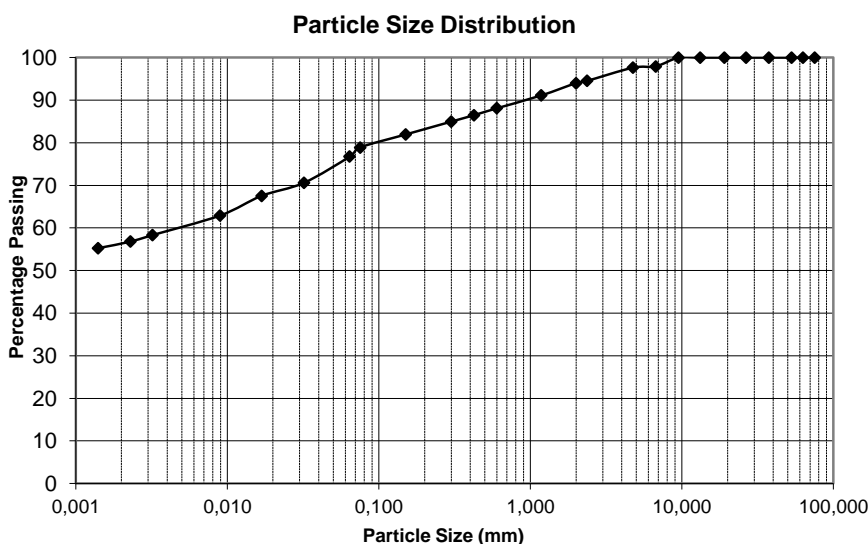
Atterberg Limits :	
Liquid Limit	42
Plastic Index	20
Linear Shrinkage	11,0

Tabulated Summary	Percentage
<b>Gravel</b> : Percentage - 4.75 mm	2
<b>Sand</b> : Percentage - 4.75mm and + 0.075mm	19
<b>Silt</b> : Percentage - 0.075mm and + 0.002mm	21
<b>Clay</b> : Percentage - 0.002mm	58

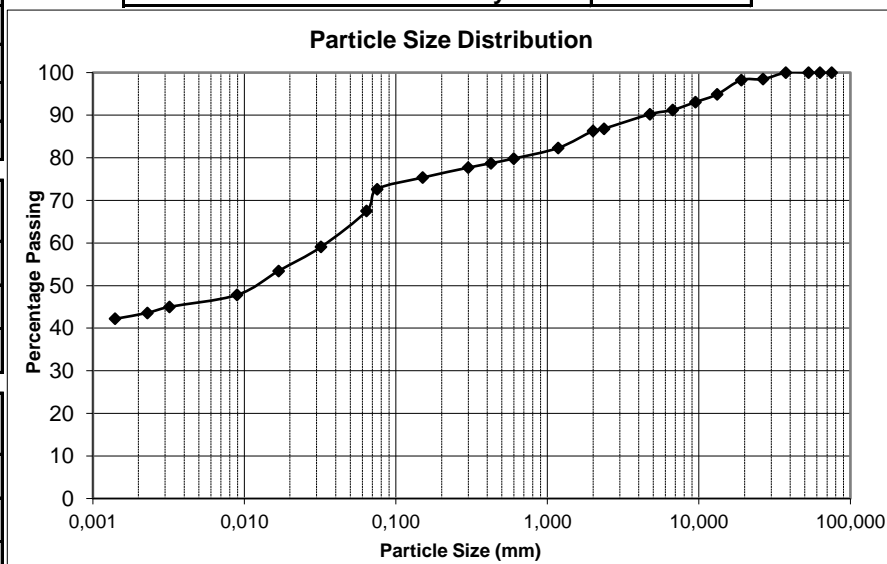
<b>% SCS Dispersion:</b>	
<b>Initial Moisture Content (%) :</b>	17,2
<b>pH:</b>	6,60
<b>Conductivity mS/m:</b>	35

Atterberg Limits :	
Liquid Limit	37
Plastic Index	18
Linear Shrinkage	9,0

Tabulated Summary	Percentage
<b>Gravel</b> : Percentage - 4.75 mm	10
<b>Sand</b> : Percentage - 4.75mm and + 0.075mm	18
<b>Silt</b> : Percentage - 0.075mm and + 0.002mm	29
<b>Clay</b> : Percentage - 0.002mm	44

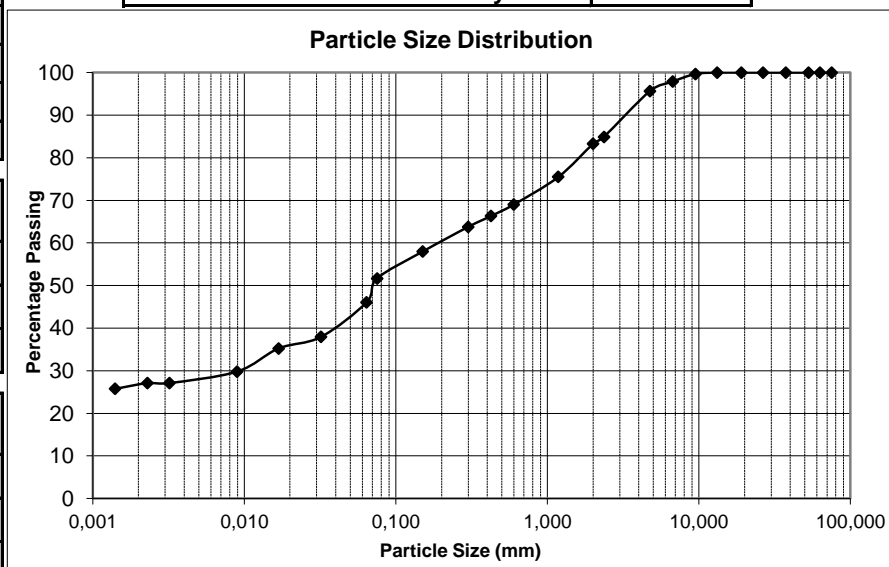
Atterberg Limits :	
Liquid Limit	33
Plastic Index	18
Linear Shrinkage	9,0

MOD AASHTO ; C.B.R. :	
MOD AASHTO (Kg/m <sup>3</sup> )	1960
O.M.C. (%)	13,7
C.B.R. @ 100% Comp.	29
C.B.R. @ 98 % Comp.	23
C.B.R. @ 95 % Comp.	15
C.B.R. @ 93 % Comp.	10
C.B.R. @ 90 % Comp.	7
Swell ( max ) %	0,70

Tabulated Summary	Percentage
<b>Gravel</b> : Percentage - 4.75 mm	4
<b>Sand</b> : Percentage - 4.75mm and + 0.075mm	44
<b>Silt</b> : Percentage - 0.075mm and + 0.002mm	25
<b>Clay</b> : Percentage - 0.002mm	27
