**REPORT ON GEOTECHNICAL INVESTIGATION FOR THE
PROPOSED NEW ERICA ROAD BRIDGE OVER NATIONAL
ROUTE R300, KUILS RIVER**

JULY 2018

K&T PROJECT REFERENCE: 15642GG

**BOREHOLE LOCATION PLAN
ERICA ROAD - R300**

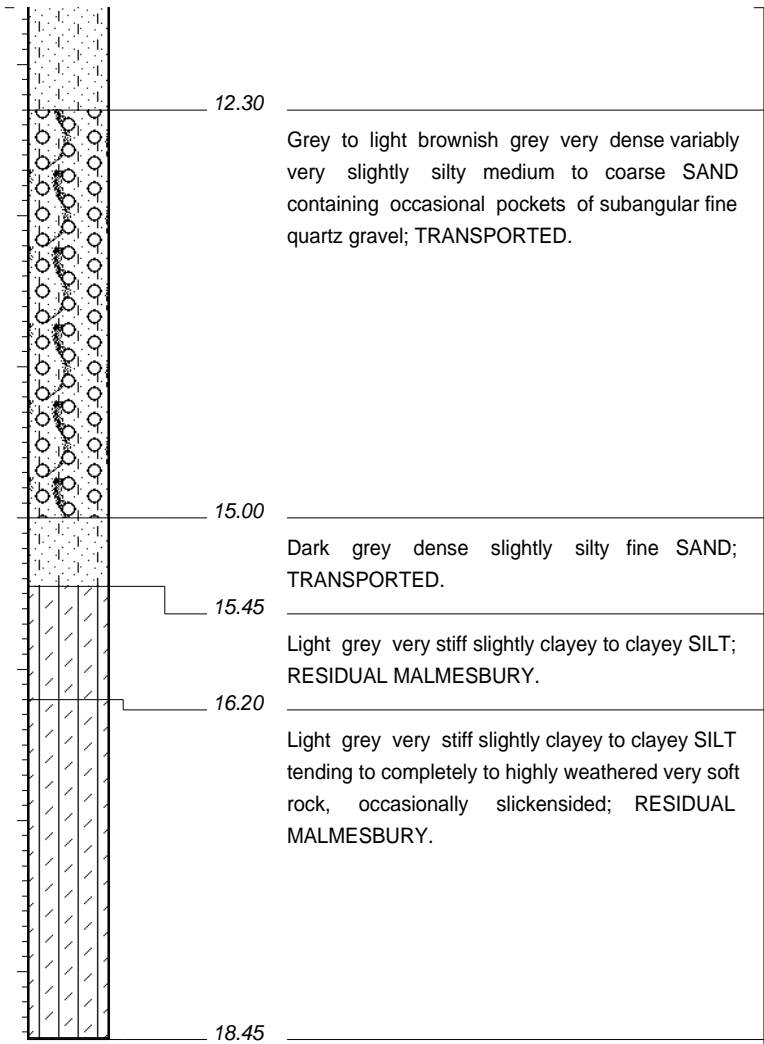
NOTES
 1) Groundwater table measured at 2.45m depth on 03/08/2018.
