**Assessment of the impact of sand mining on agricultural potential on
Portion 2 of Farm number 1242 near Kraaifontein**

1 Introduction and brief

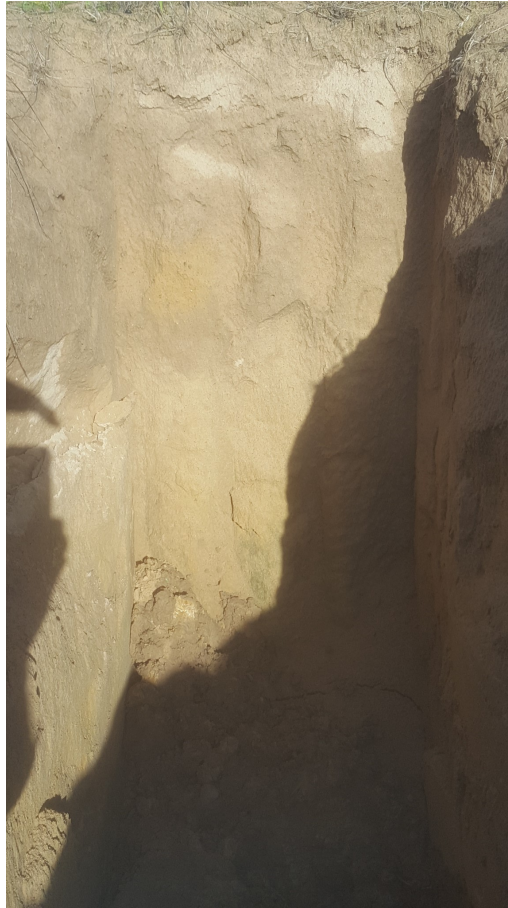
The soils are generally fairly deep, medium grade sands overlying clay or gravel. They are bleached, grey coloured sands, and are mostly of the Kroonstad soil form and Kd1000 soil family, as classified by the South African soil classification system. The depth below surface to the clay varies between 50 cm and 160 cm. A typical soil profile is illustrated in Figure 3.

Figure 3. Typical soil profile from site. *Kroonstad 1000 soil family (test pit 1).*
