REVISED FRESHWATER ECOLOGICAL IMPACT ASSESSMENT

PROPOSED SWELLENDAM HOUSING AND BULK SEWER PIPELINE CONSTRUCTION

Prepared for: Swelldam Municipality

DATE: 11 December 2018

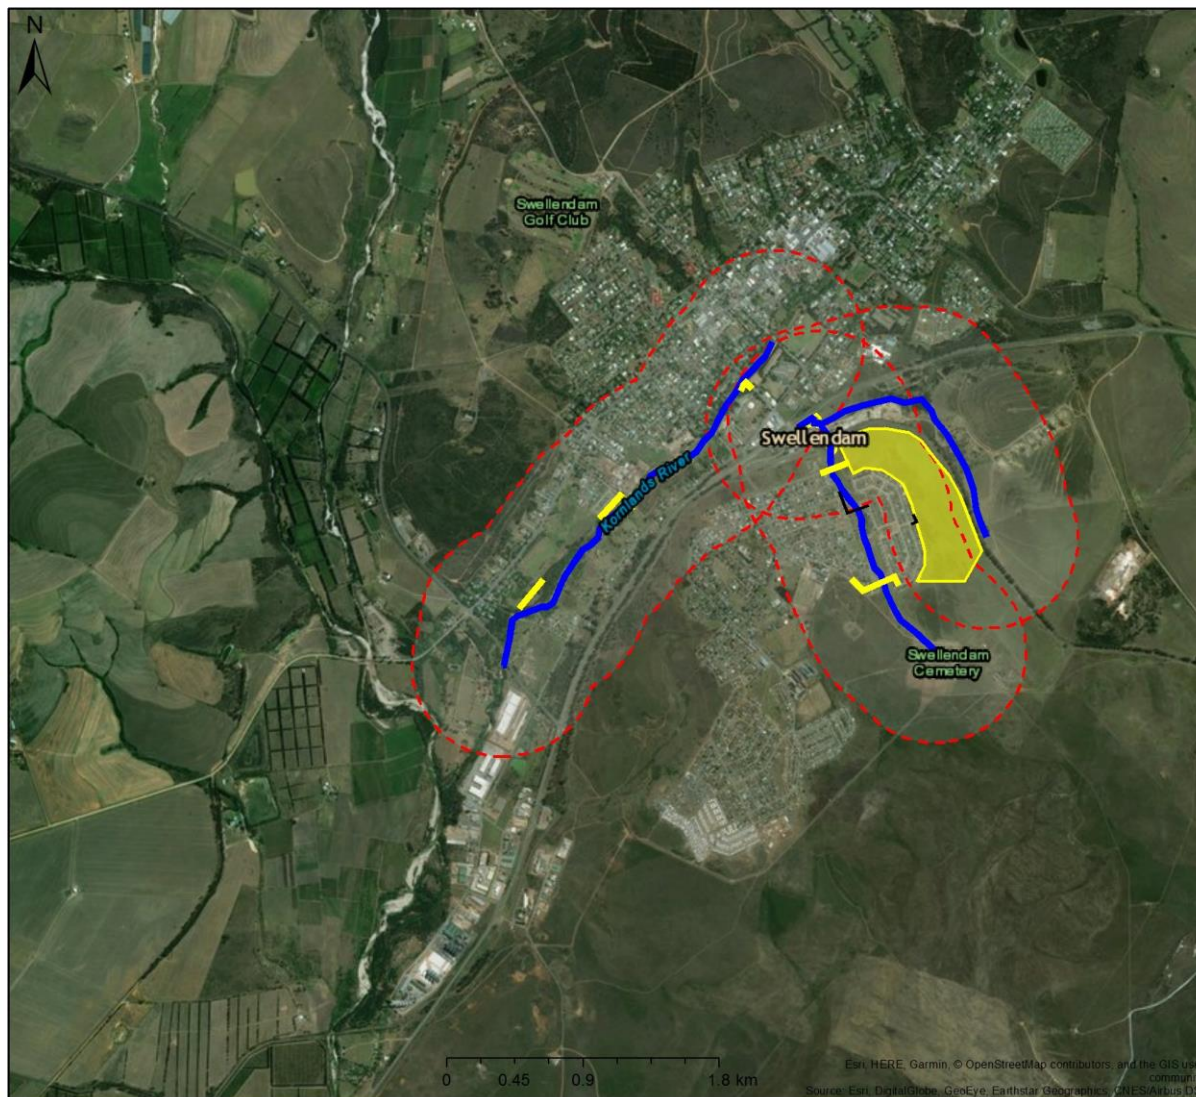
**Swellendam Housing.
FIA. DWS regulated**

Sewer reticulation will need to be upgraded to accommodate the proposed development. The following is currently proposed:

- SSS1.2: 250 mm Ø New flow diversion
- SSS1.3: 84 m x 250 mm Ø New outfall sewer
- SSS1.6: 315 mm Ø New flow diversion
- SSS1.7: 100 m x 315 mm Ø New outfall sewer
- SSS1.8: 229 m x 315 mm Ø Re-align existing bulk sewer
- SSS1.9: 304 m x 315 mm Ø Re-align existing bulk sewer

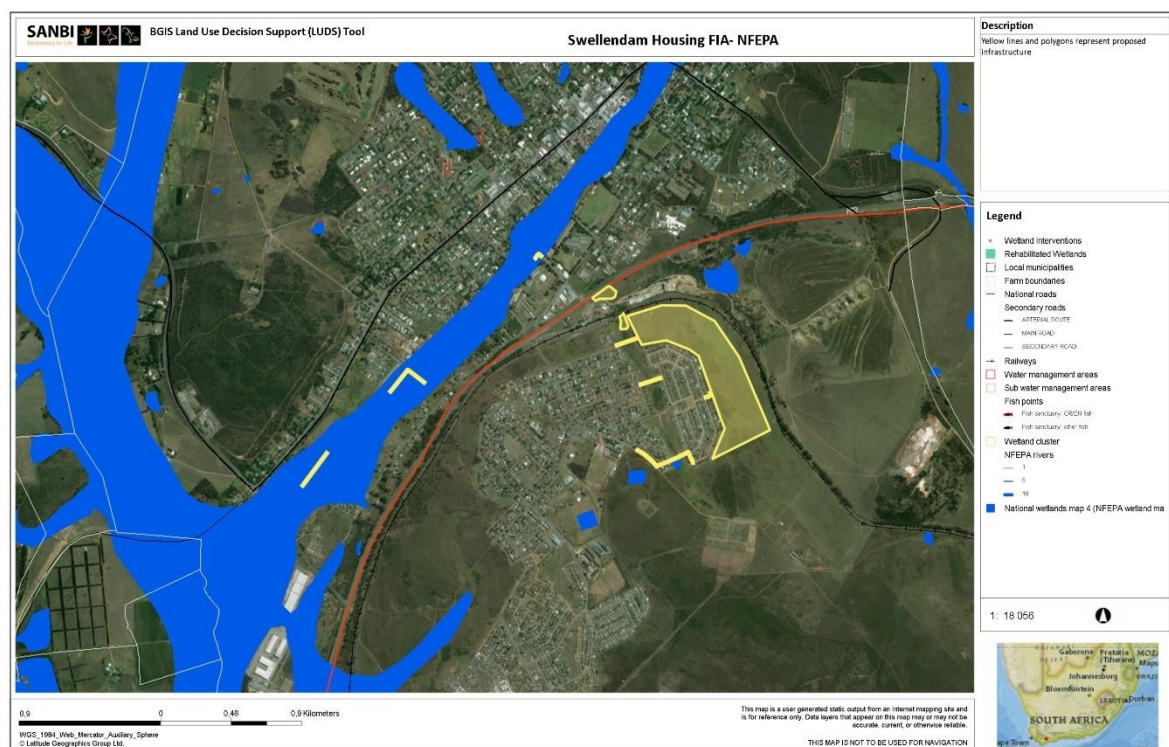
Two biodiversity conservation mapping initiatives are of relevance to the freshwater ecosystems within the study area; the Western Cape Biodiversity Spatial Plan mapping initiatives that were undertaken on a regional basis and the National Freshwater Ecosystem Priority Areas (NFEPA) mapping initiative. The Koorlands River was identified as a NFEPA wetland area (Natural valley floor floodplain wetland and an artificial NFEPA wetland was identified in the western non-perennial stream where the sewer pipeline will cross the river.

Figure 2: The National Freshwater Ecosystem Priority Areas (NFEPA) mapping initiative.

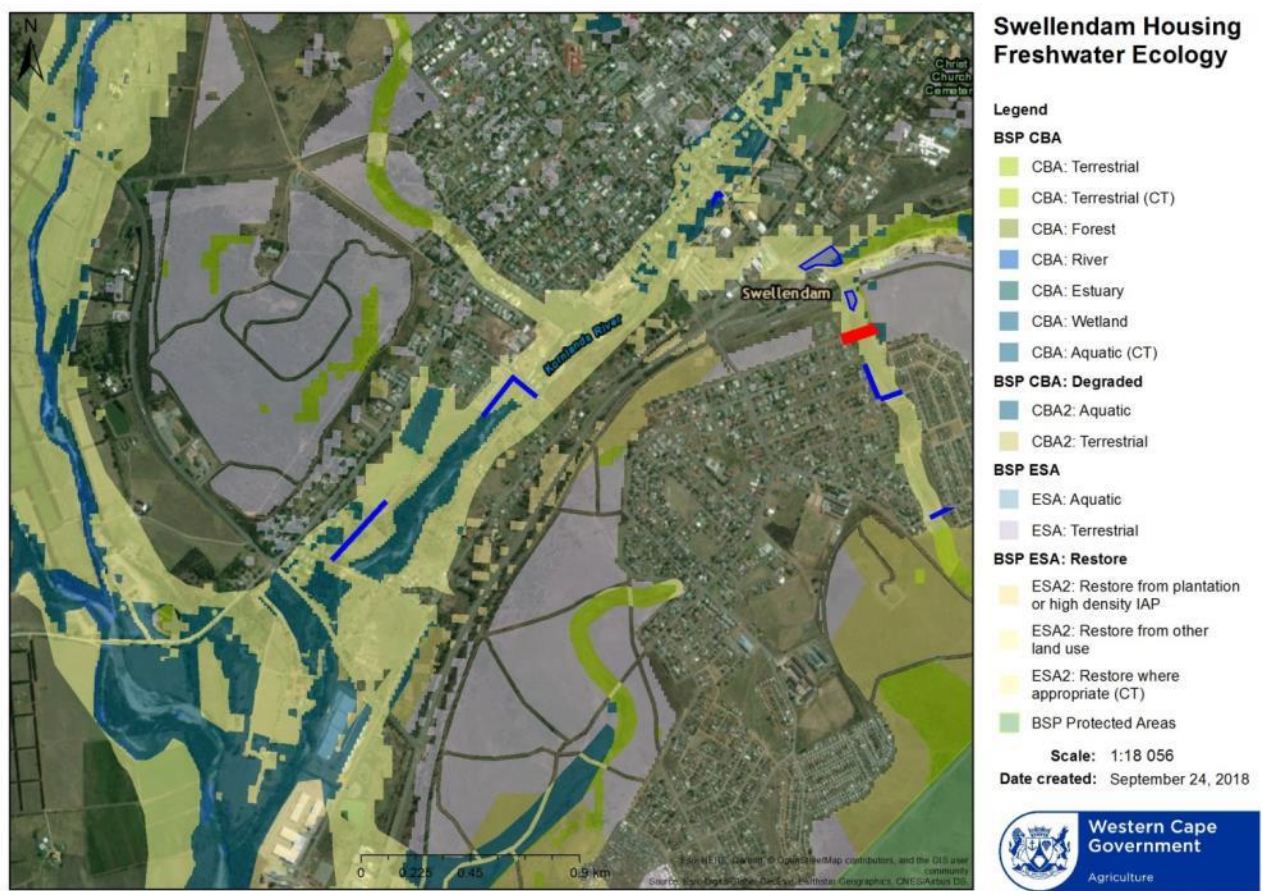
The Koorlands perennial river and non-perennial river that will be impacted was identified as Ecological Support Areas (ESAs) in the latest Western Cape Biodiversity Spatial Plan (2017). ESA's are supporting zones required to prevent the degradation of Critical Biodiversity Areas and Protected Areas.

Figure 3: Western Cape Biodiversity Spatial Plan mapping initiative.

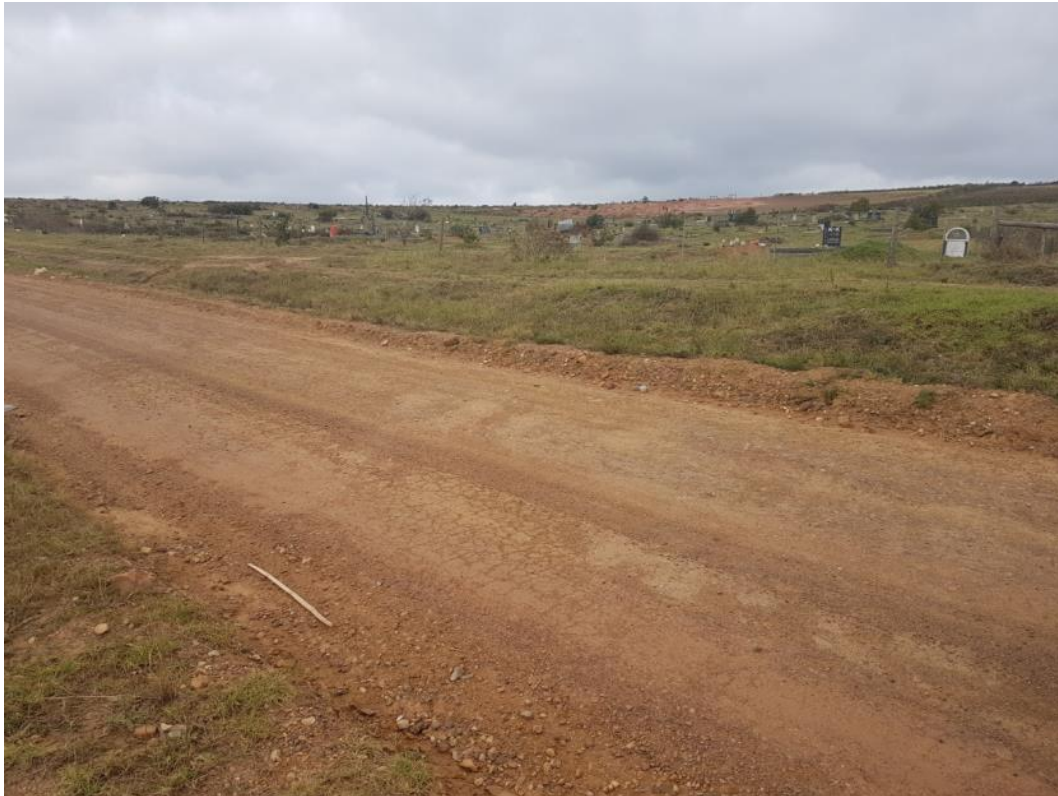
The non-perennial river on the western side of the proposed housing development in which two sewer pipeline crossings, a road and the upgrade of two attenuation dams is planned and proposed starts south of the site on a cemetery and flows in a northern direction.

Photo 1: Start of the Non-perennial River and gravel access tod to cemetery.

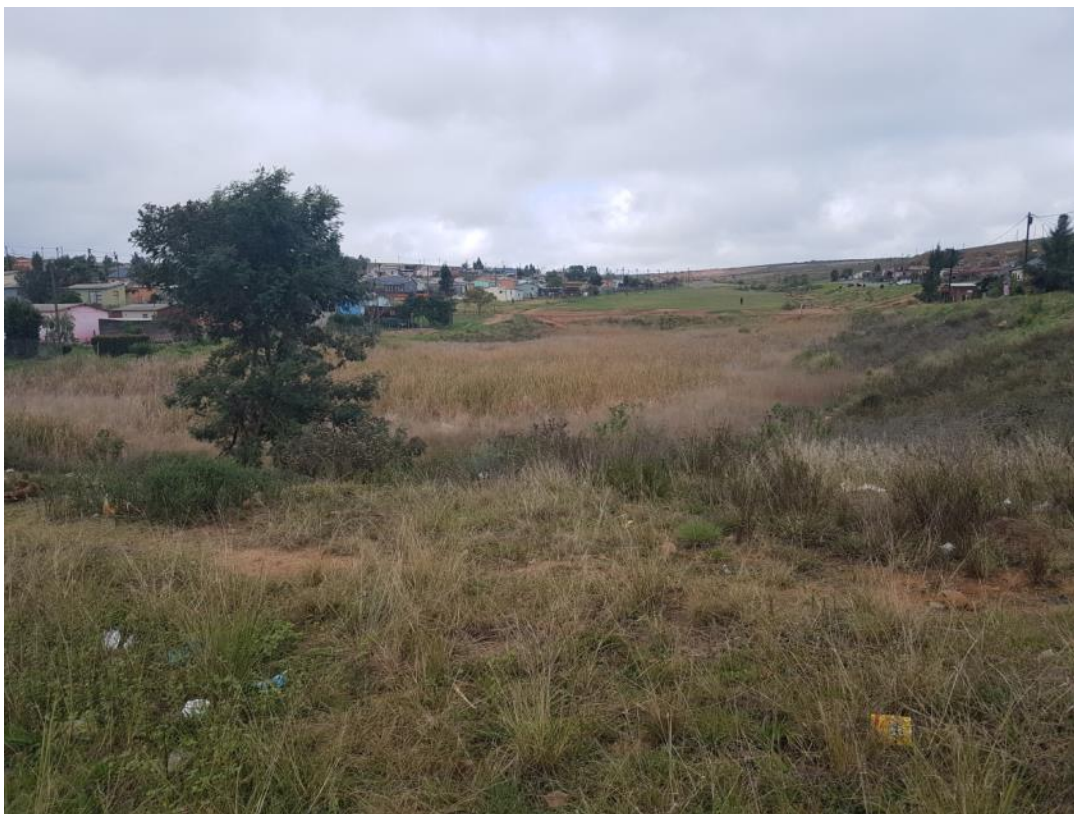
It crosses the access gravel road to the cemetery before it flows in between two residential areas with two road crossings and a railway line before it meets up with a non-perennial river that runs east of the development also in a south west direction.

Photo 2: Non-perennial river on western side of housing development

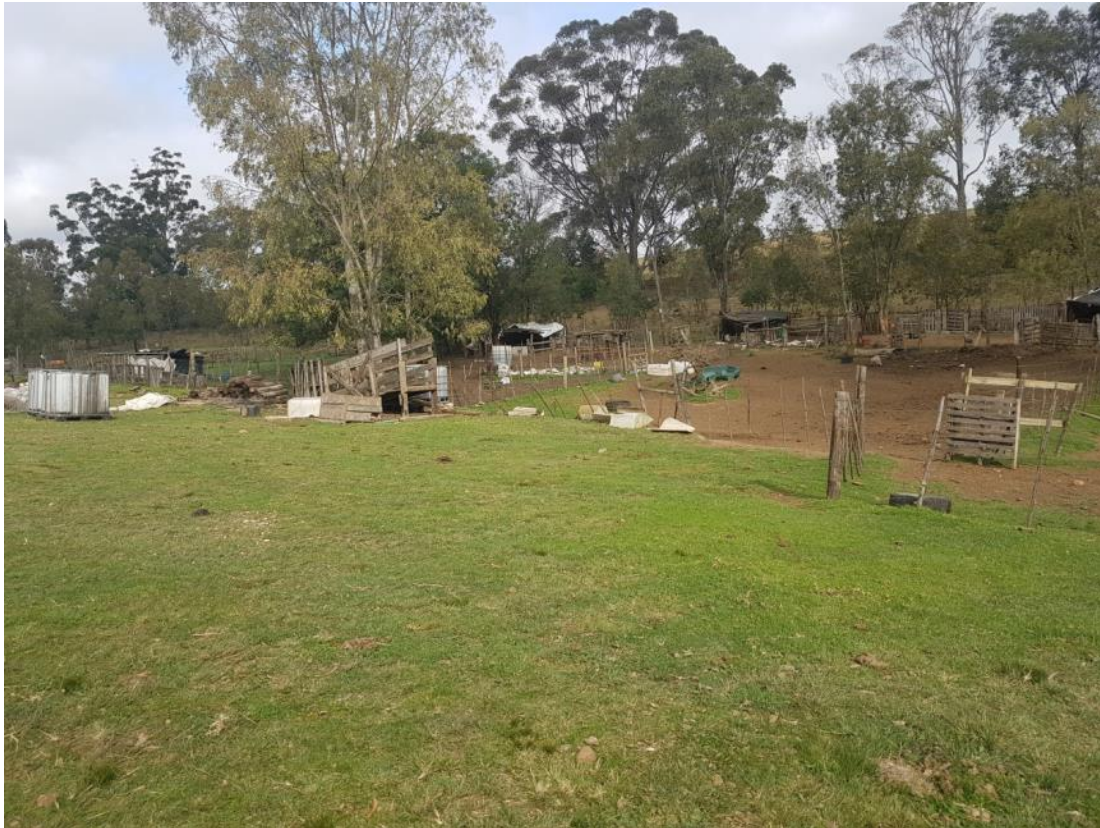
The non-perennial river on the eastern edge of the housing development flows in a northern direction and then parallel with the N2 in a western direction until it meets up with the proposed upgrade area of the western stream attenuation dam. This non-perennial river starts at an area where small scale livestock is kept.

Photo 3: Upper catchment and start of the eastern Non-perennial River

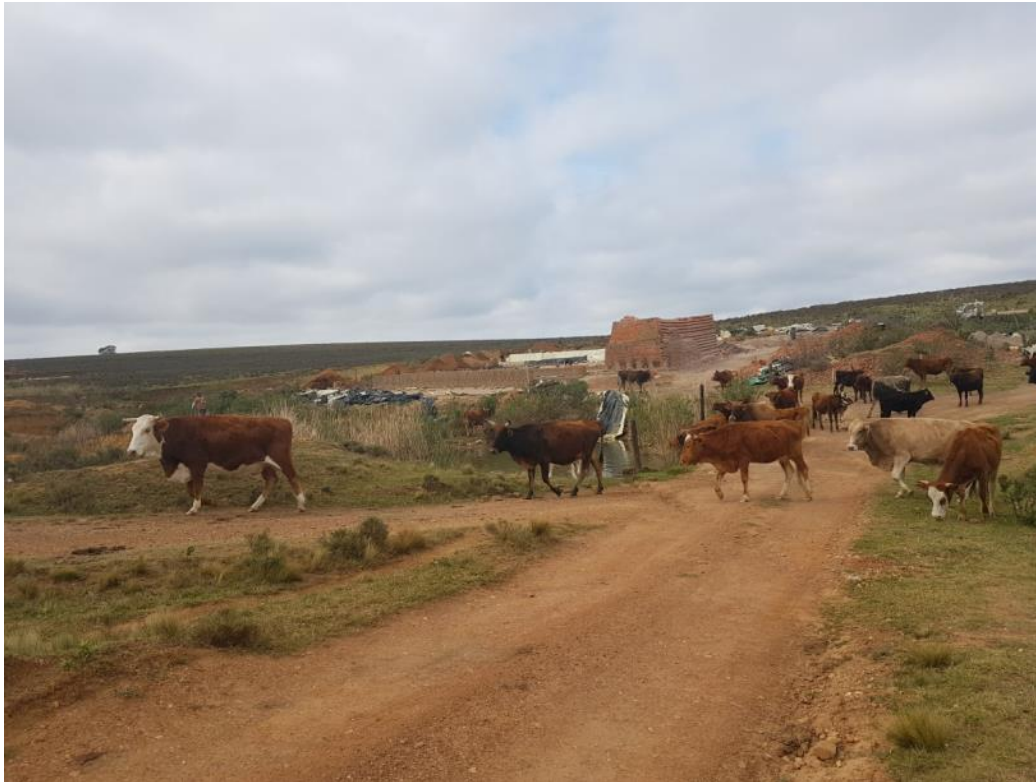
A non-perennial river which flow from east to west meet up with this non-perennial river before it is crossed by the gravel road. A clay brick quarry is situated on the edge of the stream that flows from east to west.

Photo 4: Stream that meets up with the eastern non-perennial river.

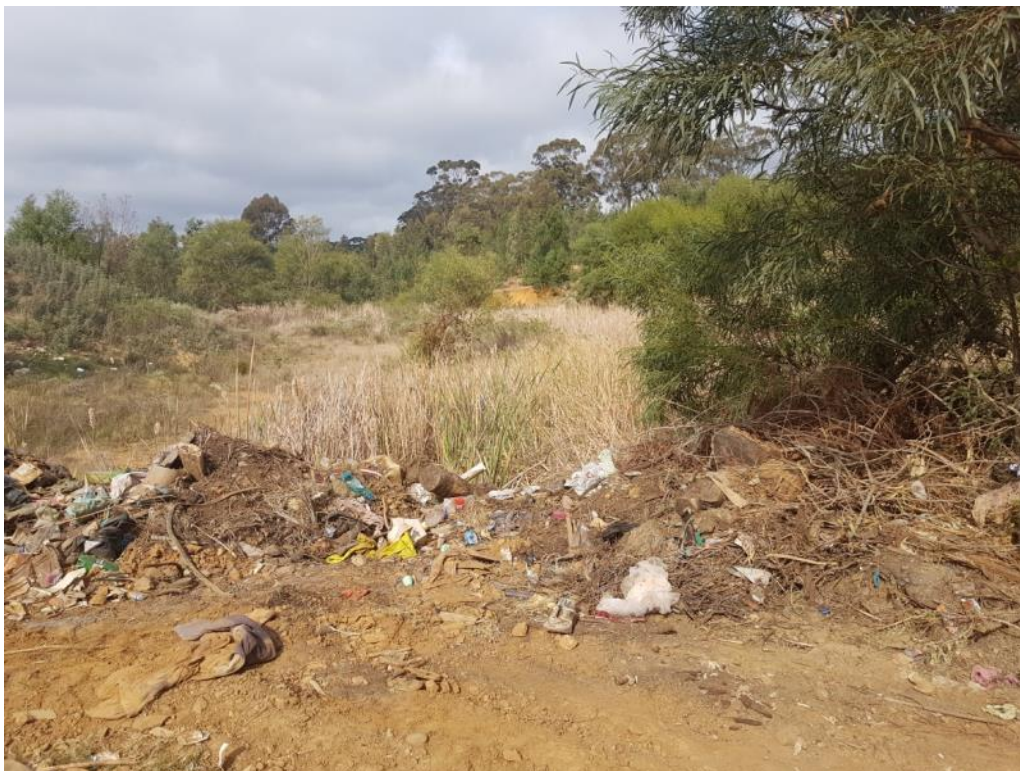
A gravel road that give access to the small scale farming activities and clay brick quarry area crosses the eastern non-perennial river where after the non-perennial river flows into an instream dam.

Photo 5: Upstream view from the gravel access road crosses the eastern non-perennial river.

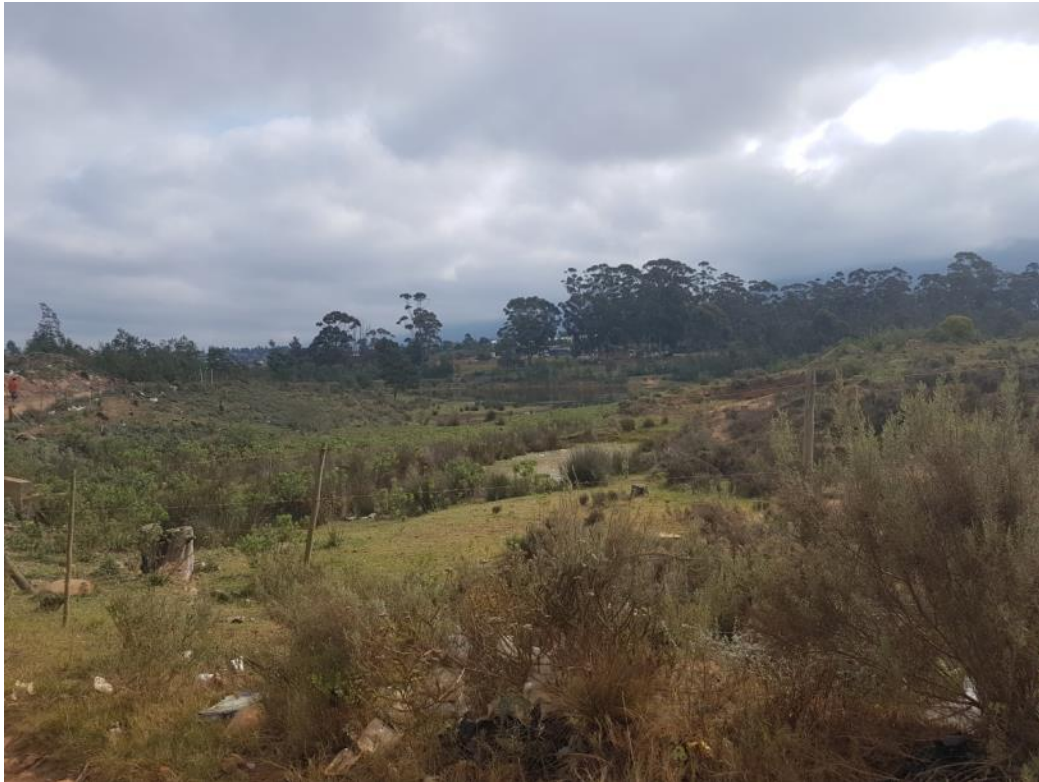
Photo 6: Downstream view from the gravel access road crosses the eastern non-perennial river.

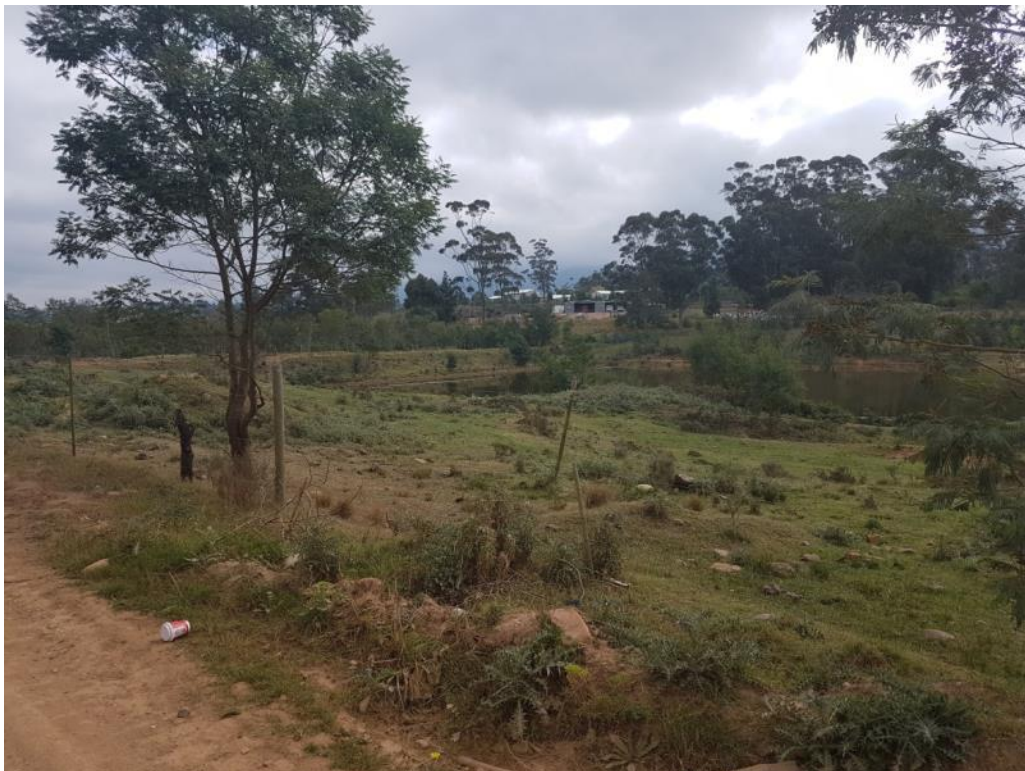
Photo 7: Instream dam the eastern non-perennial river.

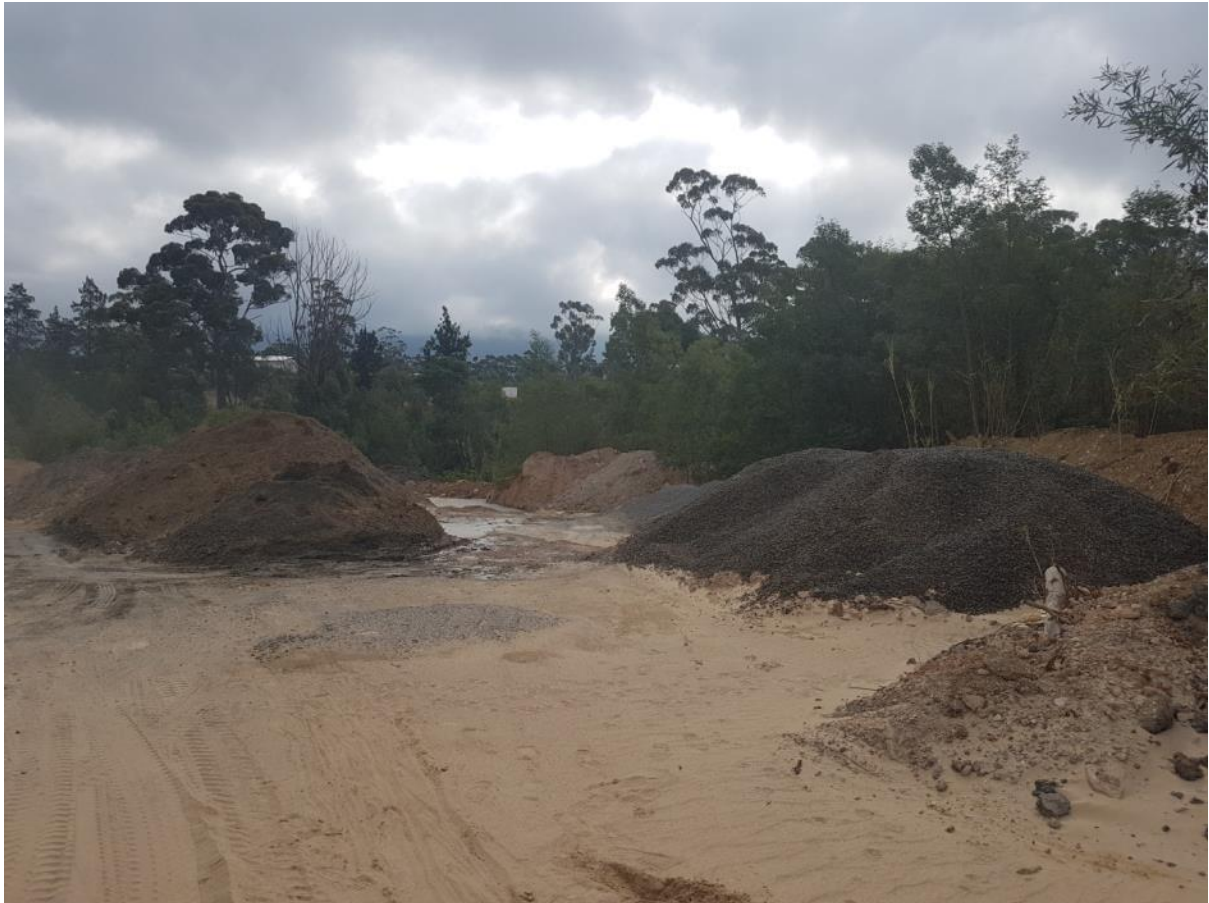
The non-perennial river flow in between industrial activities, stockpiling of mining aggregate and the N2 downstream of the instream dam.

Photo 8: Stockpile of mining aggregate on edge of non-perennial river with storm water runoff from these areas into the river.

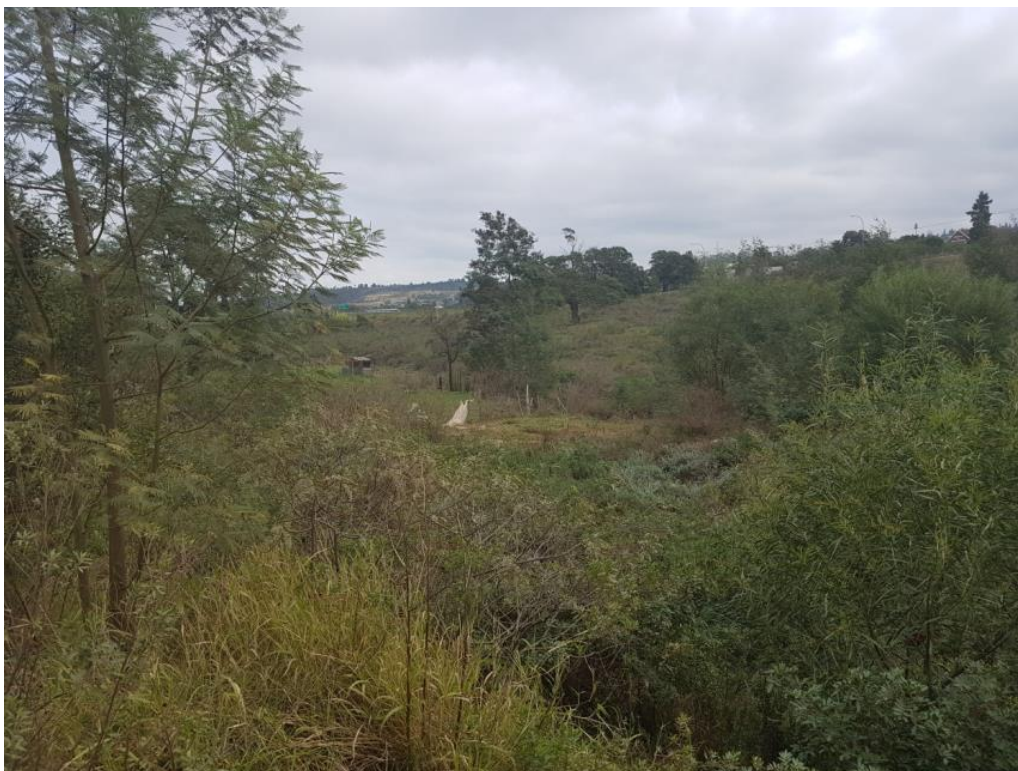
Photo 9 a: Remnants of freshwater ecological features in sections of the non-perennial river downstream of the industrial activities. These areas are however limited.

All of these activities have a significant impact on the freshwater ecology of the non-perennial river.

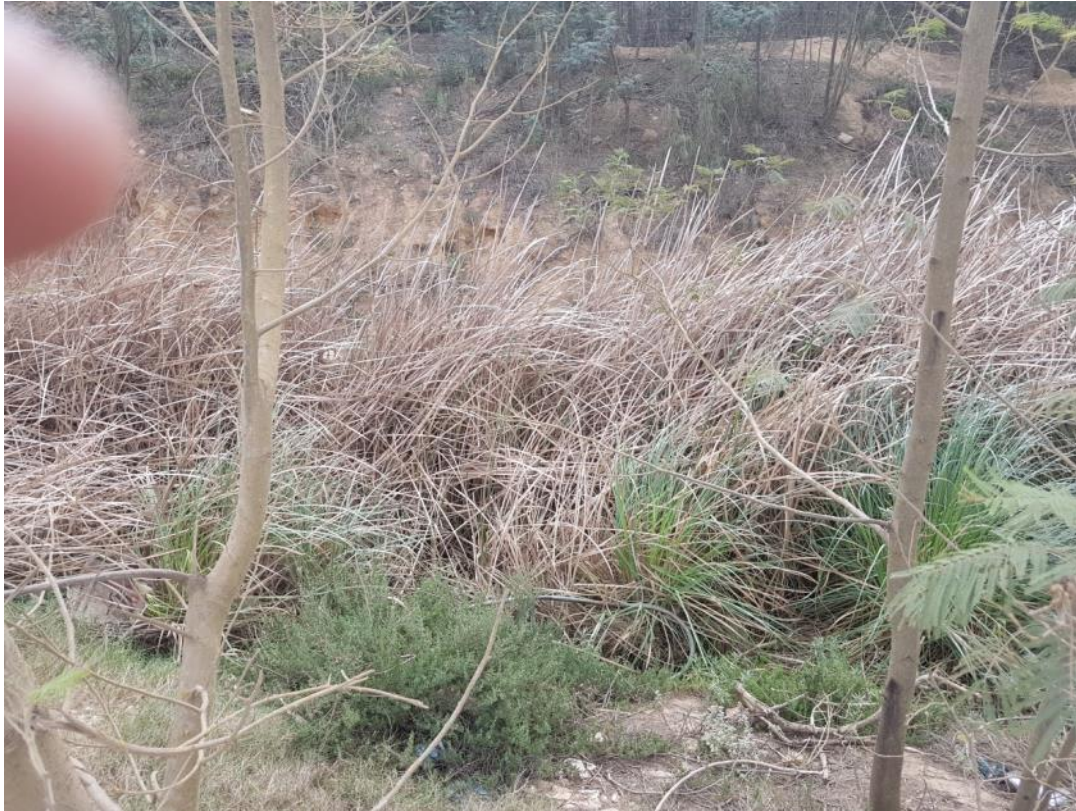
Photo 9 b: Remnants of freshwater ecological features in sections of the non-perennial river downstream of the industrial activities. These areas are however limited.

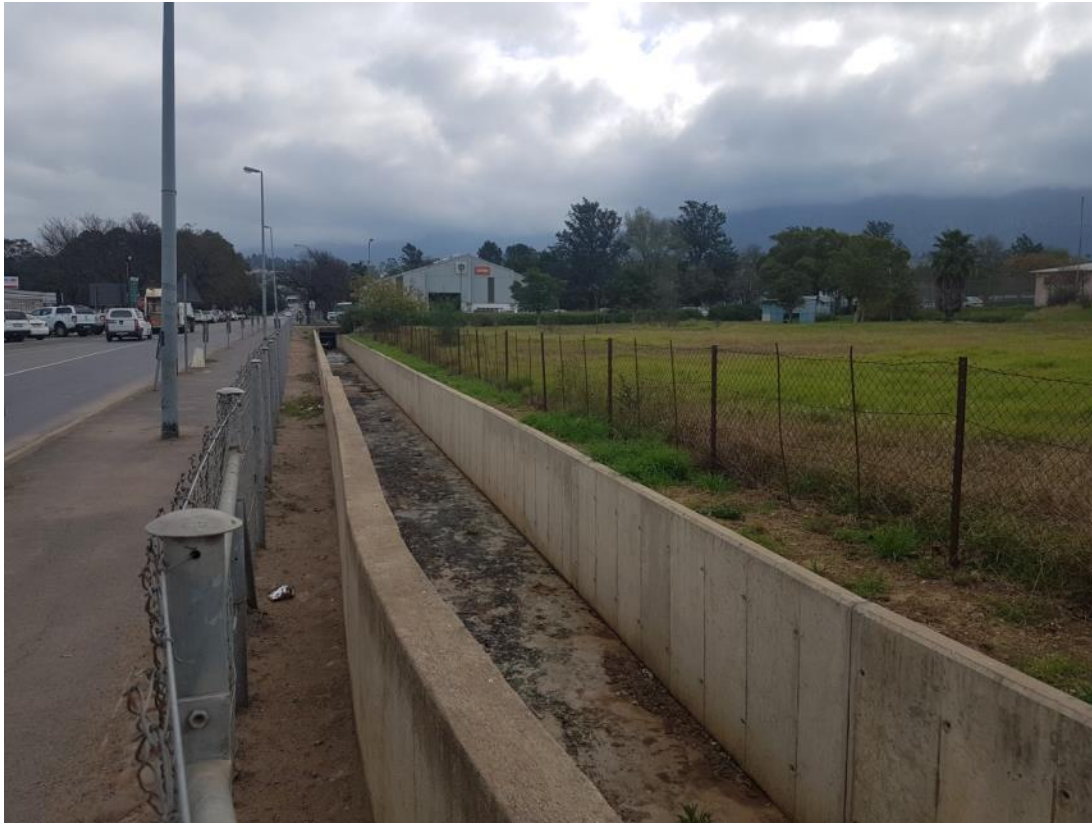
From the proposed attenuation dam where the western and eastern non-perennial rivers meet up the non-perennial river is channelled in a concrete channel underneath the N2 and through the town until it meets up with the Koornlands perennial river.

Photo 10: Concrete channel section of the non-perennial river

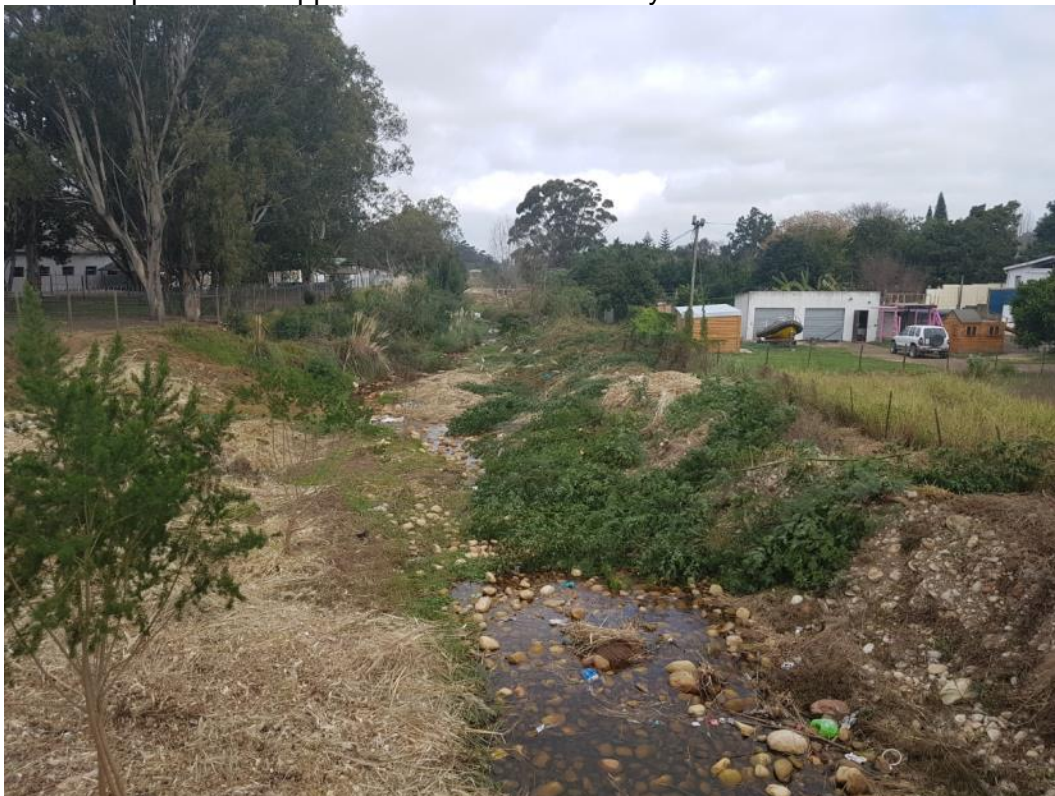
The Koorndals river follows in an western direction through the town of Swellendam before it meets up with the Klippe river which is a tributary of the Bree River.

Photo 11: Downstream view of the Koorndals River where the sewer pipe will be upgrade on the eastern bank of the river.

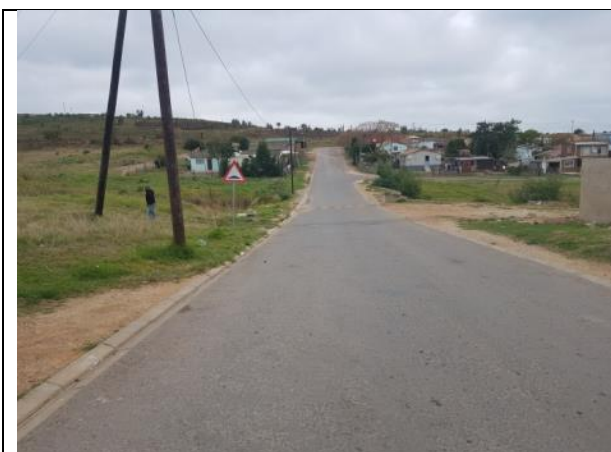
Photo 12: Propose upgrade of existing water pipeline inside road crossing.

Flow conditions	No water was flowing during time of site visit. Constructed road surface	No water was flowing during time of site visit.	No water was flowing during time of site visit.
Water clarity	No water was flowing during time of site visit. Constructed road surface	No water was flowing during time of site visit.	No water was flowing during time of site visit.
Stones habitat characteristics	Constructed road surface	Consisted of a silted river bed with no stones or diverse habitat	Consisted of a silted river bed with no stones or diverse habitat
Vegetation habitat characteristics	None. Road surface	Limited and dominated by <i>Pennisetum clandestinum</i> .	Limited and dominated by <i>Pennisetum clandestinum</i> .
Other habitat characteristics	None as result of infrastructure.	None as result of constructed attenuation dam. The surrounding land uses, cemetery in the catchment, road crossings and attenuation dam all contributed to the poor ecological state that the non-perennial river is in.	None as result of upstream constructed attenuation dam and road crossing. The surrounding land uses, cemetery in the catchment, road crossings and attenuation dam all contributed to the poor ecological state that the non-perennial river is in.

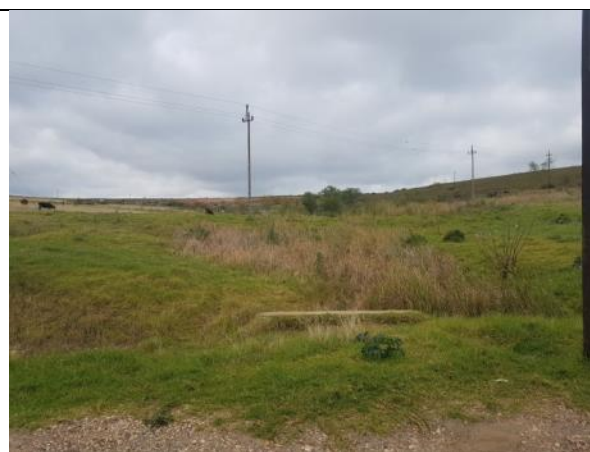
Photo 13: Artificial wetland upstream of water pipeline crossing.

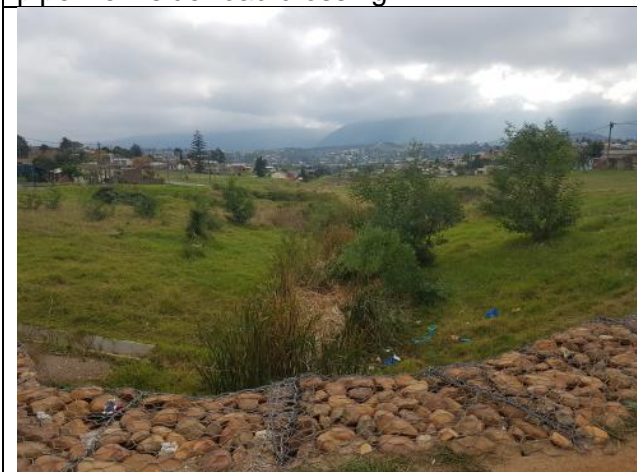
Photo 14: Artificial wetland downstream of water pipeline crossing.

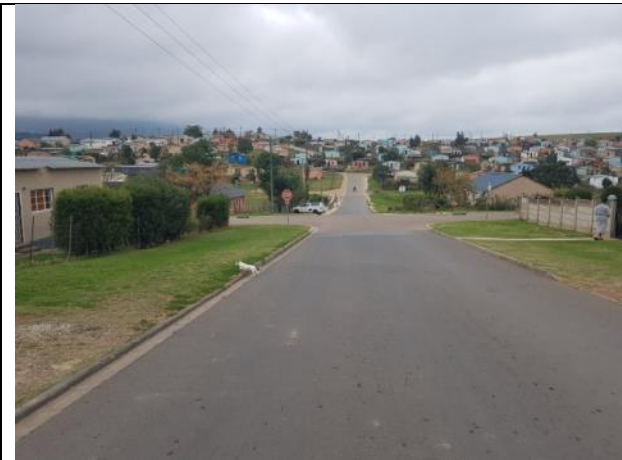
Photo 15: Water pipeline crossing upgrade.

Depth characteristics	Constructed road surface and flat area on bank of river outside flood plain.	No water was flowing during time of site visit. The river at this point is characterised by a constructed attenuation dam.	No water was flowing during time of site visit. The river however has a deep natural channel.
Flow conditions	Constructed road surface	No water was flowing during time of site visit.	No water was flowing during time of site visit.
Water clarity	No water was flowing during time of site visit. Constructed road surface	No water was flowing during time of site visit.	No water was flowing during time of site visit.
Stones habitat characteristics	Constructed road surface	Consisted of a silted river bed with no stones or diverse habitat	Consisted of a silted river bed with no stones or diverse habitat
Vegetation habitat characteristics	None. Road surface and degraded areas	Limited and dominated by <i>Pennisetum clandestinum</i> .	Limited and dominated by <i>Pennisetum clandestinum</i> .

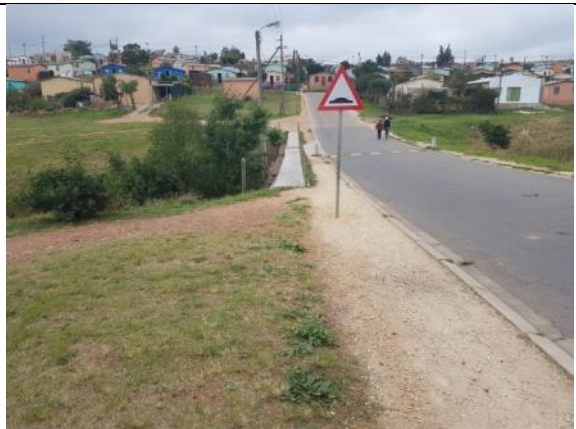
Photo 16: Water pipeline crossing upgrade.

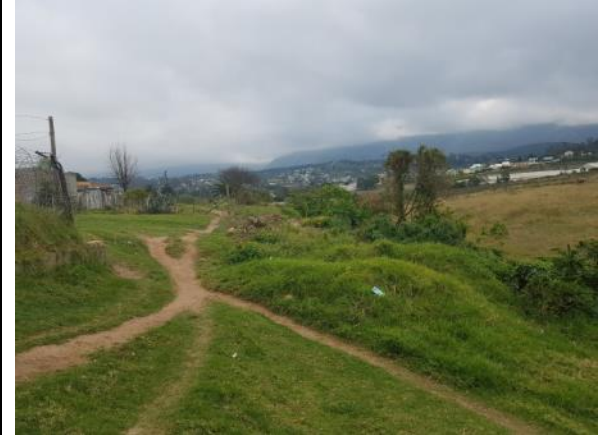
Photo 17: Water pipeline upgrade.

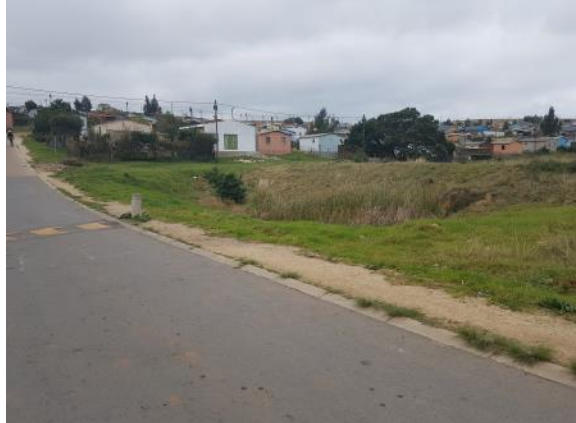
Photo 18: Water pipeline crossing upstream of upgrade.

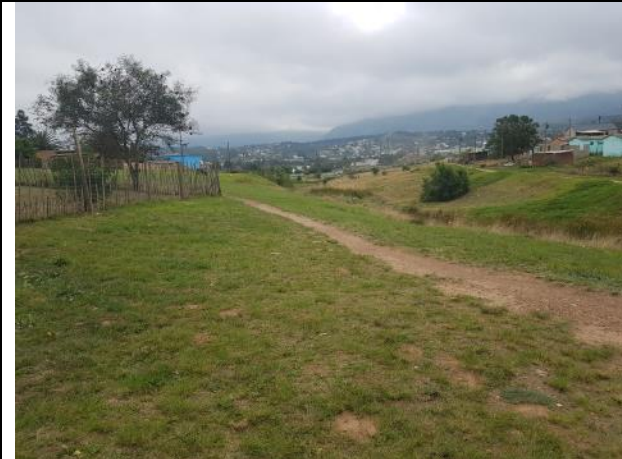
Photo 19: Water pipeline crossing downstream of upgrade.

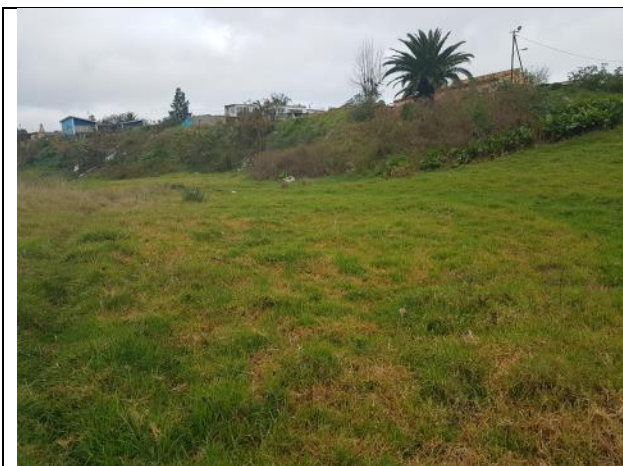
Photo 20: Proposed road crossing site in non-perennial river.

Depth characteristics	The river however has a deep natural channel.	The river however has a deep natural channel.	The river however has a deep natural channel.
Flow conditions	No water was flowing during time of site visit.	No water was flowing during time of site visit.	No water was flowing during time of site visit.
Water clarity	No water was flowing during time of site visit.	No water was flowing during time of site visit.	No water was flowing during time of site visit.
Stones habitat characteristics	Consisted of a silted river bed with no stones or diverse habitat	Consisted of a silted river bed with no stones or diverse habitat	Consisted of a silted river bed with no stones or diverse habitat
Vegetation habitat characteristics	The vegetation at this point is totally degraded and dominated by <i>Pennisetum clandestinum</i> .	The vegetation at this point is totally degraded and dominated by <i>Pennisetum clandestinum</i> .	The vegetation at this point is totally degraded and dominated by <i>Pennisetum clandestinum</i> .

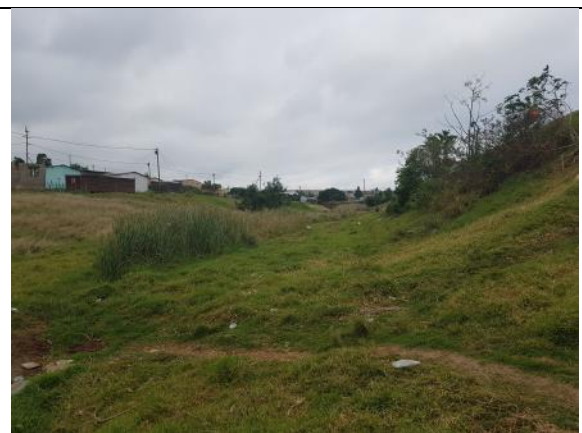
Photo 21: Upstream view of proposed road crossing. Wetland indicator species present.

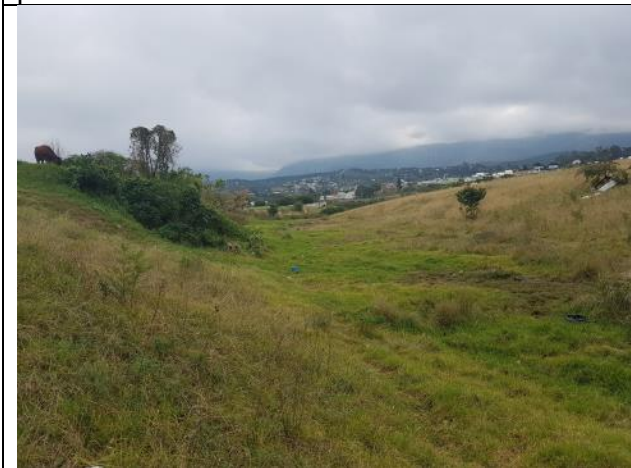
Photo 22: Downstream view of proposed road crossing.

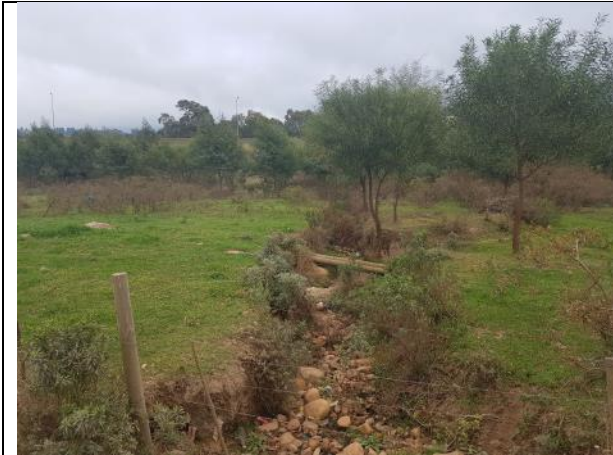
Photo 26 Proposed attenuation dam.

Depth characteristics	Flat area	Flat area	None. Water is channelled underneath the N2 and into a concrete channel.
Flow conditions	No water was flowing during time of site visit. The river channel at this point consists of a small eroded channel as a result of the concentrate stream release underneath the railway line.	No water was flowing during time of site visit. The river channel at this point consists of a small eroded channel as a result of the concentrate stream release underneath the railway line.	None. Water is channelled underneath the N2 and into a concrete channel.
Water clarity	No water was flowing during time of site visit.	No water was flowing during time of site visit.	No water was flowing during time of site visit.
Stones habitat characteristics	Consisted of eroded river channel with sand and stone river bed.	Consisted of eroded river channel with sand and stone river bed.	None. Water is channelled underneath the N2 and into a concrete channel.

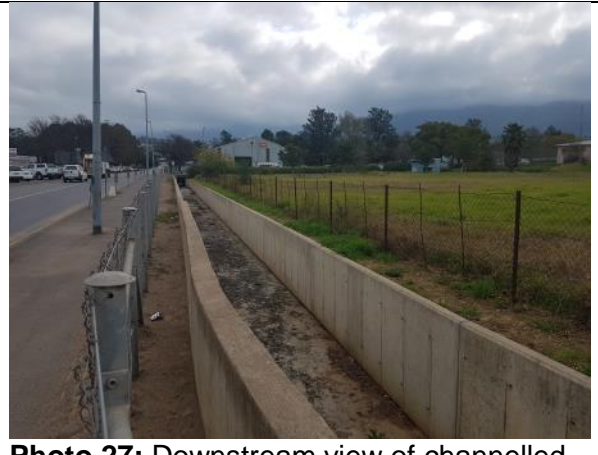
Photo 27: Downstream view of channelled non-perennial river.

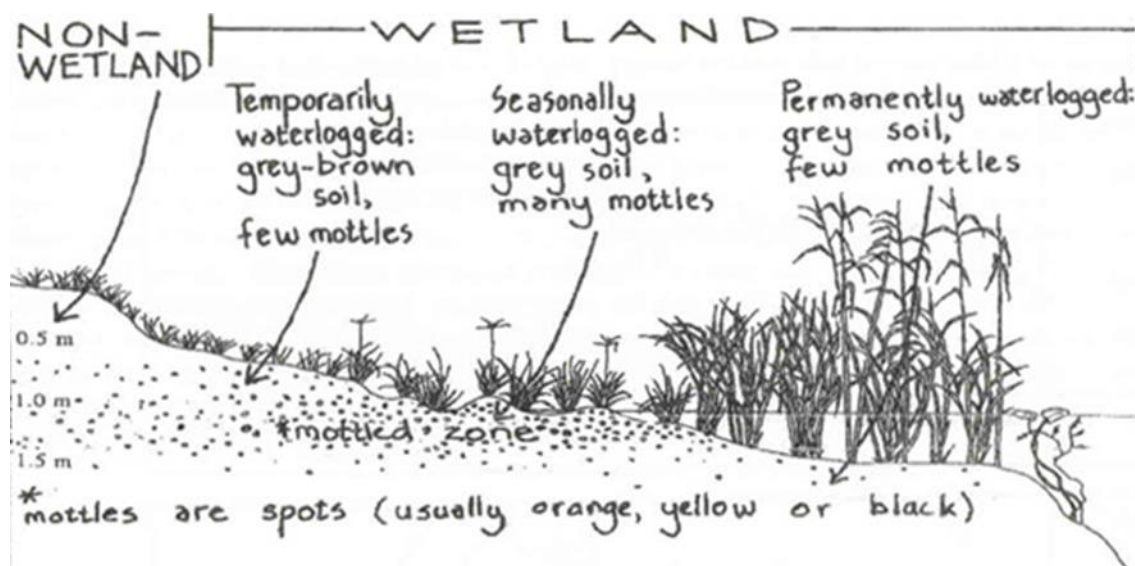
The wetland delineation process uses four wetland indicators to provide an estimate of the extent of a wetland. They are: landscape position (must be flat or depressed), vegetation (must be hydrophilic), soil form (must complement an existing wetland type) and soil wetness (water table must be within 50 cm of profile).

Figure 4: Wetland illustration

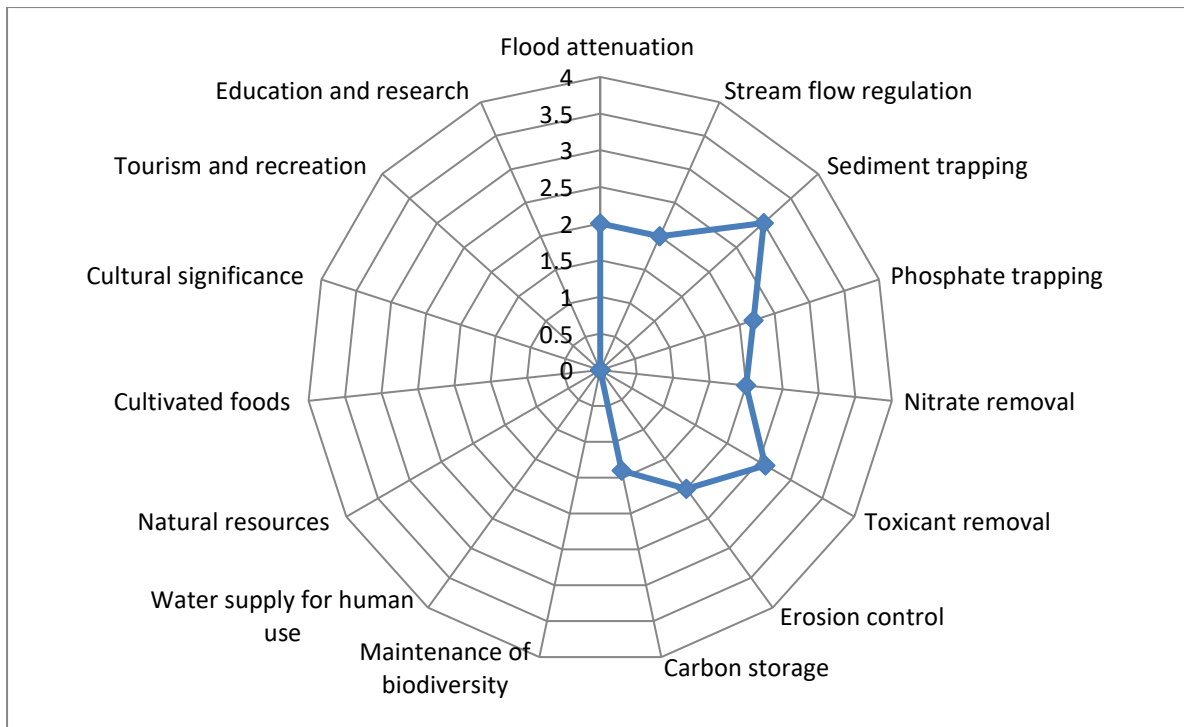
Figure 5: Ecosystem services provided by the wetland area

The wetlands Ecoservice has a value of 1.075 (Low/marginal). Wetlands that are not ecologically important and sensitive at any scale. The biodiversity of these wetlands is ubiquitous and not sensitive to flow and habitat modifications. From an ecological perspective, the wetland areas are of a low to marginal ecological sensitivity and importance. They provide a refuge for some indigenous species and water attenuation functions. Furthermore, as they are the interface between the terrestrial and aquatic environments, they have higher species diversity than the surrounding terrestrial, which has been extensively altered.

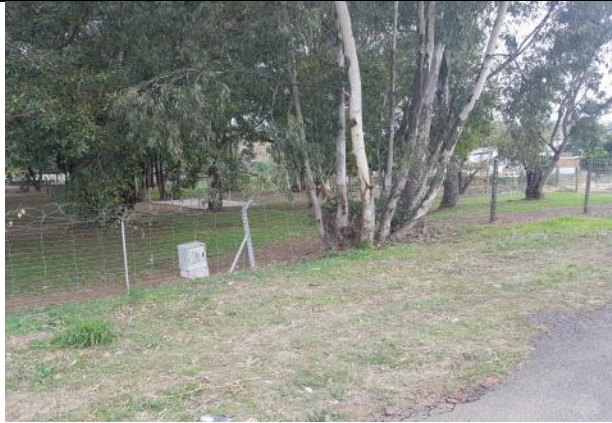
Photo 27: Propose upgrade of existing sewer pipeline.

Depth characteristics	Water was flowing during time of site visit in the Koorlands River next to the site.	Water was flowing during time of site visit. The river has a deep natural channel.	Water was flowing during time of site visit. The river has a deep natural channel.
Flow conditions	Water was flowing during time of site visit in the Koorlands River next to the site.	Water was flowing during time of site visit. The river has a deep natural channel.	Water was flowing during time of site visit. The river has a deep natural channel.
Water clarity	Site outside the river.	The water observed in the Koorlands River at the time of the survey was clear.	The water observed in the Koorlands River at the time of the survey was clear.
Stones habitat characteristics	Site outside the river.	The river channel is characterised by alluvial river rock channel.	The river channel is characterised by alluvial river rock channel.

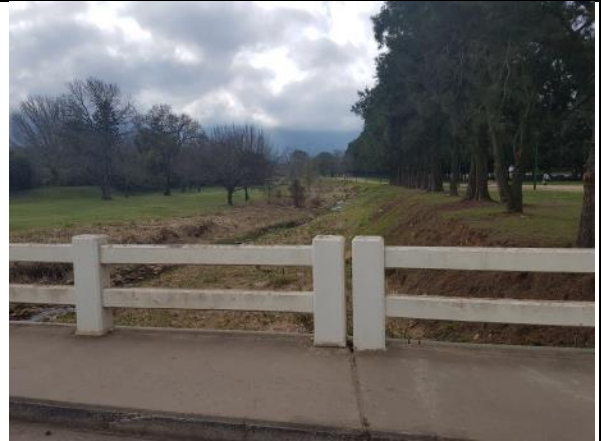
Photo 28: Upstream view of Koorlands river where the sewer pipeline upgrade is proposed.

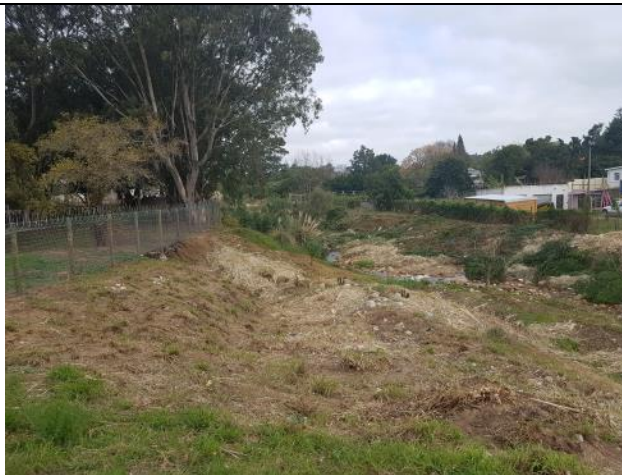
Photo 29: Upstream view of Koorlands river where the sewer pipeline upgrade is proposed.
