REVISED FRESHWATER ECOLOGICAL IMPACT ASSESSMENT

PROPOSED SWELLENDAM HOUSING AND BULK SEWER PIPELINE CONSTRUCTION

Prepared for: Swelldam Municipality

DATE: 11 December 2018

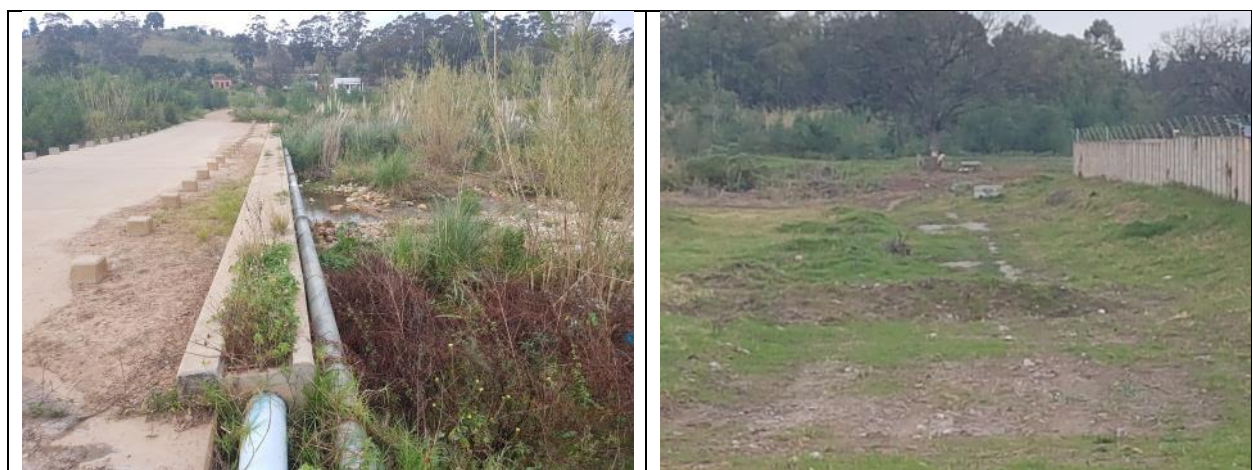
Photo 30: Upgrade of existing sewer pipeline hanged downstream on the bridge.

Photo 31: Upgrade of existing sewer pipeline outside the river and its banks.

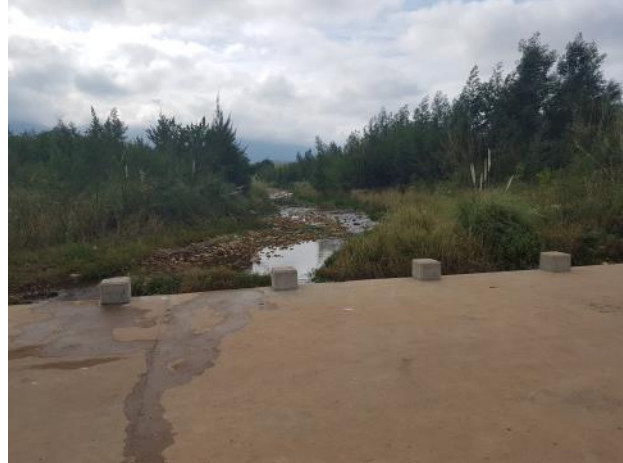
Photo 32: Upstream of Koorlands River of existing sewer pipeline crossing.

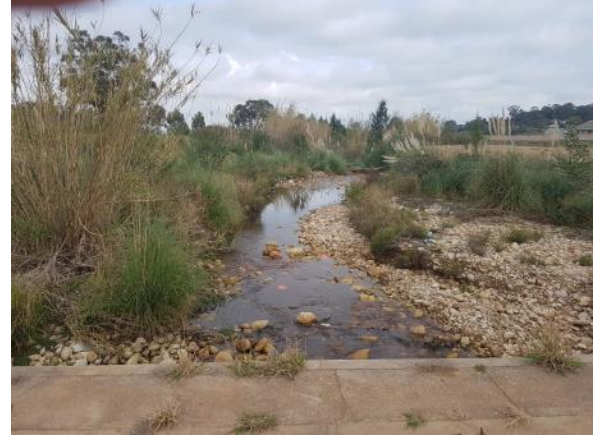
Photo 33: Upstream of Koorlands River of existing sewer pipeline crossing.

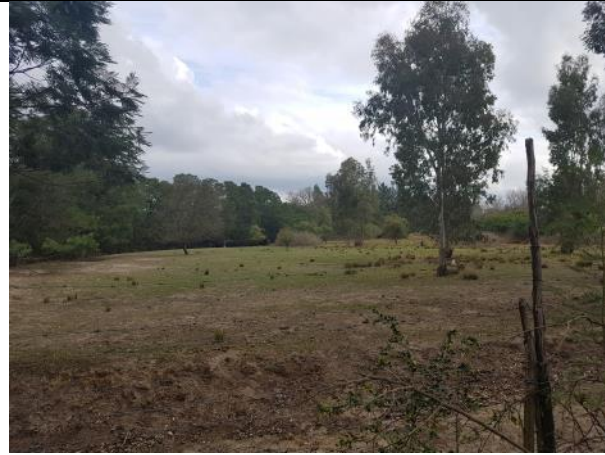
Photo 34: Proposed sewer pipeline upgrade next to river.

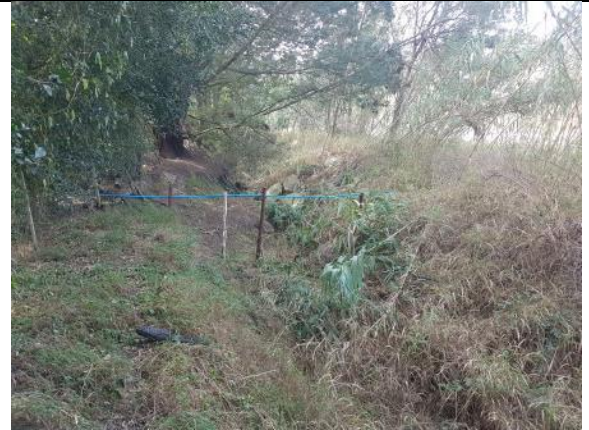
Photo 35: Condition of the riparian vegetation of the Koorndlands River next to the proposed sewer pipeline upgrade.

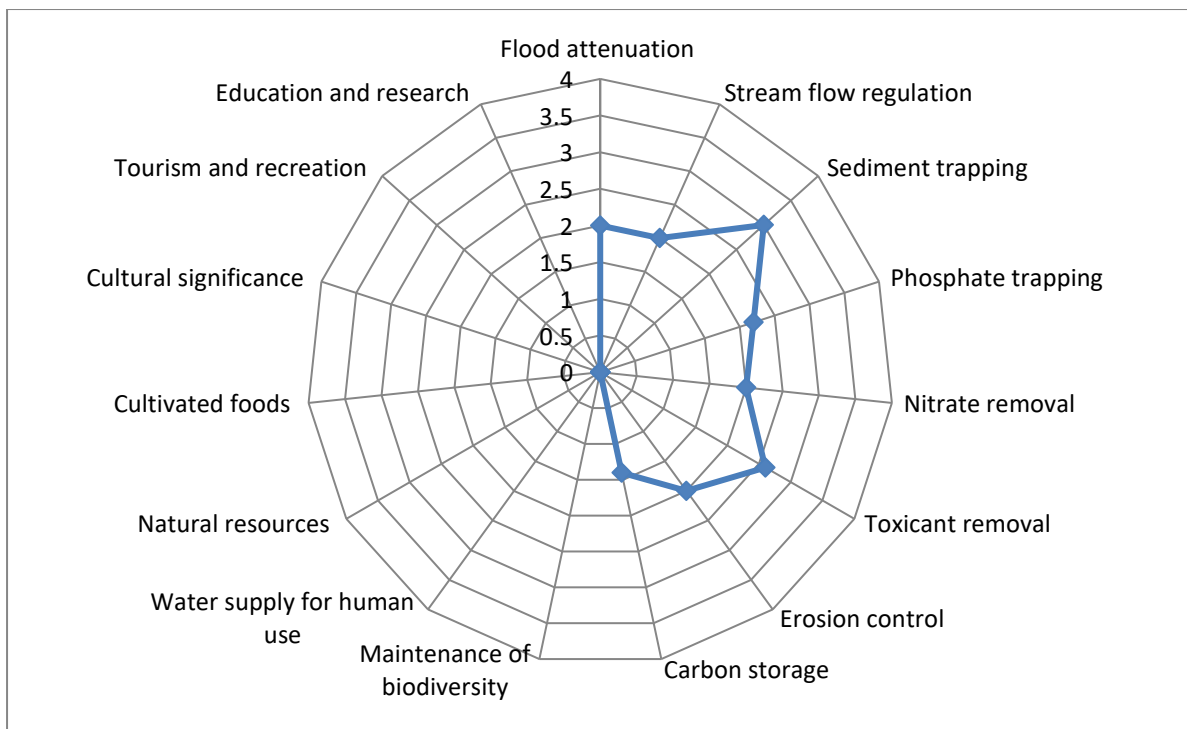
Figure 6: Ecosystem services provided by the wetland area

The wetlands Ecoservice has a value of 3 (Moderate). Wetlands that are not ecologically important and sensitive at any scale. The biodiversity of these wetlands is ubiquitous and not sensitive to flow and habitat modifications. From an ecological perspective, the wetland areas are of a moderate ecological sensitivity and importance. They provide a refuge for some indigenous species and water attenuation functions. Furthermore, as they are the interface between the terrestrial and aquatic environments, they have higher species diversity than the surrounding terrestrial, which has been extensively altered.
