FRESHWATER RESOURCE VERIFICATION FOR THE PROPOSED SWELLEN DAM HOUSING AND BULK SEWER AND WATER PIPELINES, WESTERN CAPE

January 2019

Prepared by:	Scientific Aquatic Services
Report authors:	K. Marais (Pri. Sci. Nat)
	C. du Preez
Report reviewer	S. van Staden (Pr. Sci. Nat)
Report Reference:	SAS 219009
Date:	January 2019

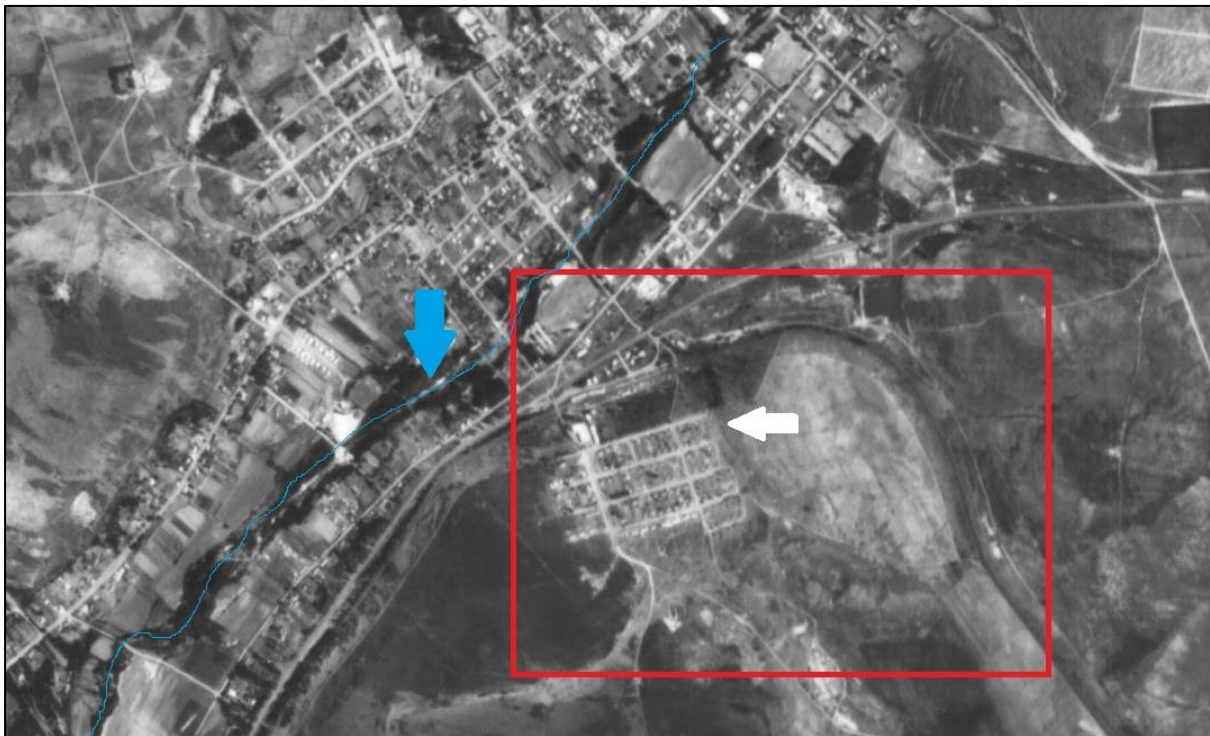
On review of the historical imagery dating back to 1960, the Kroonlands River, a tributary to the Klip River can be clearly identified, as indicated by the blue arrow in Figure 3 below as well as a watercourse to the west of the study area, as indicated by the white arrow in Figure 3 below.

Figure 3: Historical imagery (1960) of the study area (Estimated location of the study area indicated by red block (Flight Plan 02585 of Job 444))

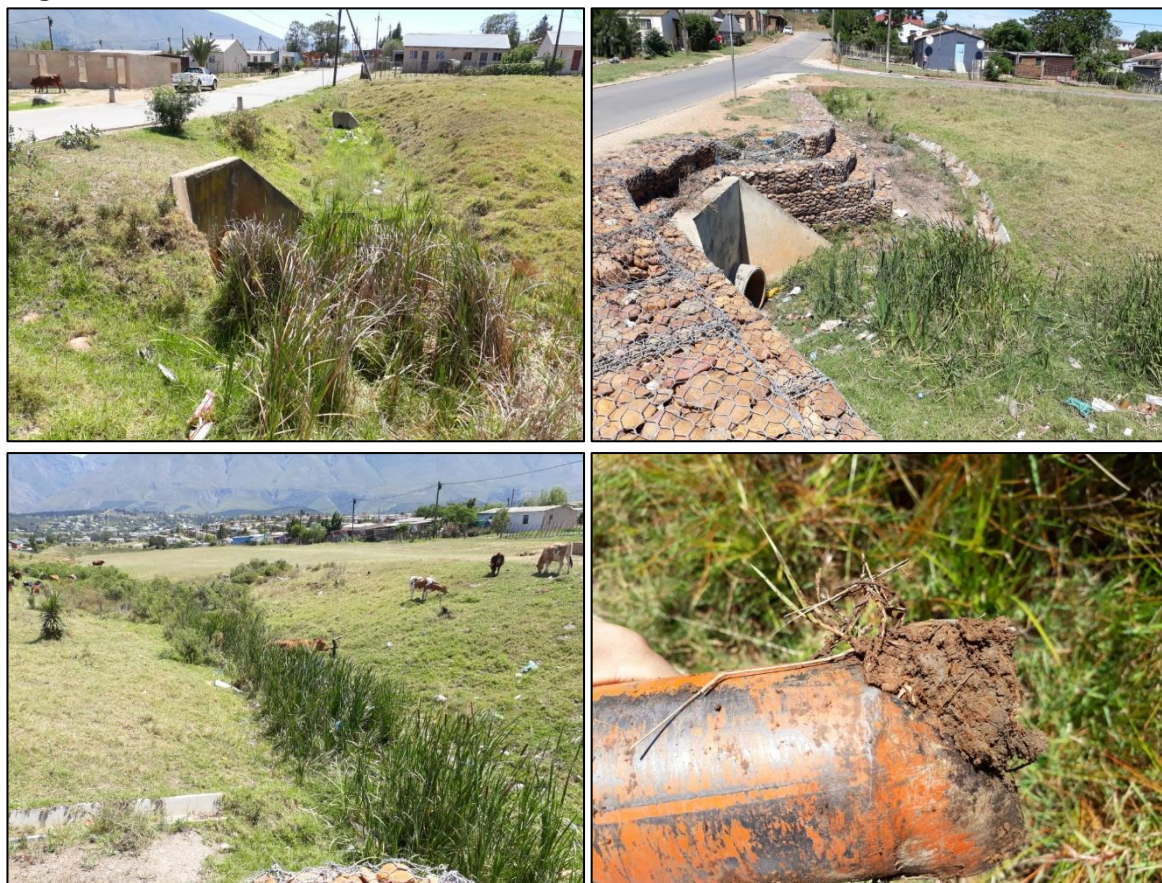
Segment 1

A Modified Channelled Valley Bottom Wetland (CVBW) was identified to traverse the existing residential area, approximately 300m to the west of the study area. An existing road crosses the CVBW and a pipe culvert has been installed. In communication with the local residents, the area upstream of Riesiebaan Street is affected by ponding during the rainy season and water is diverted downstream through the pipe culverts. Obligate species included *Cyperus marginatus*, *Juncus effusus*, *Paspalum distichum* and *Typha capensis*. Soil samples, although limited in depth due to the rocky nature of the area, indicated mottling indicative of a wetland feature. A new pump station is also proposed approximately 30m to the east of the delineated CVBW.

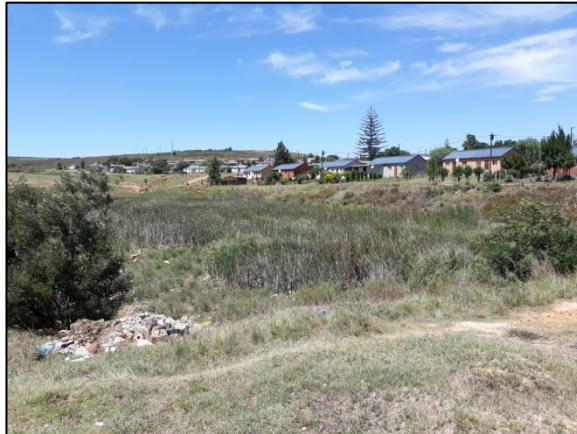
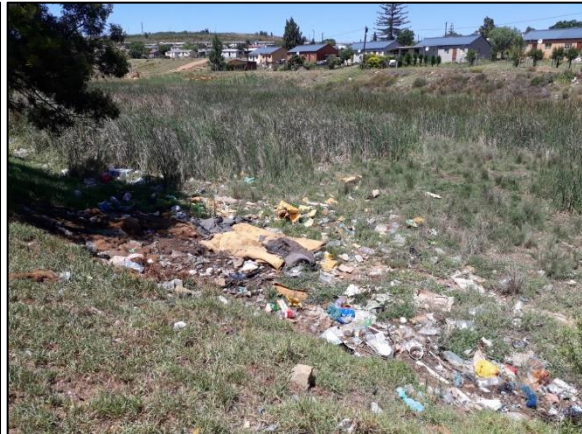
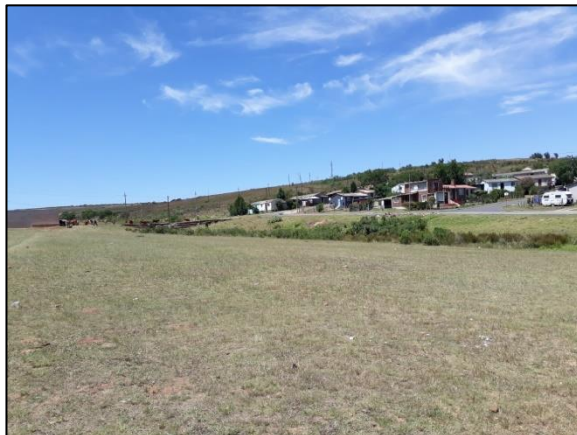
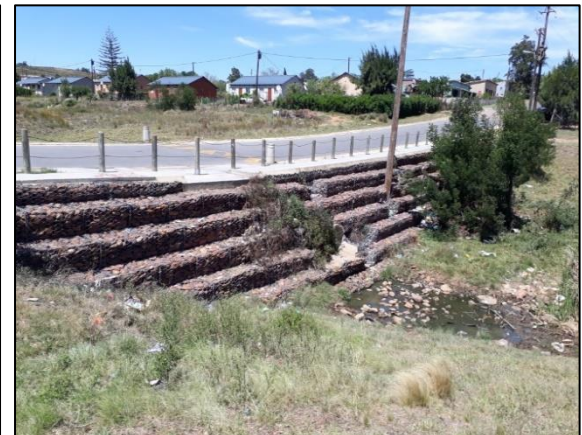
Segment 2

An existing attenuation pond was noted upstream of Sofietjie Street, within the CVBW. This was likely created as part of the stormwater management for the existing residential area. The proposed pipeline will cross the system within the existing road reserve and as such impacts on the CVBW can be considered minimal. Scouring was noted at the pipe culvert outlet on the downstream section due to the pipe not being installed at base level of the wetland feature. Obligate species within the attenuation pond as well as downstream included *Cyperus textilis*, *Juncus effusus*, *Typha capensis*, *Cyperus marginatus* and *Panicum repens*.

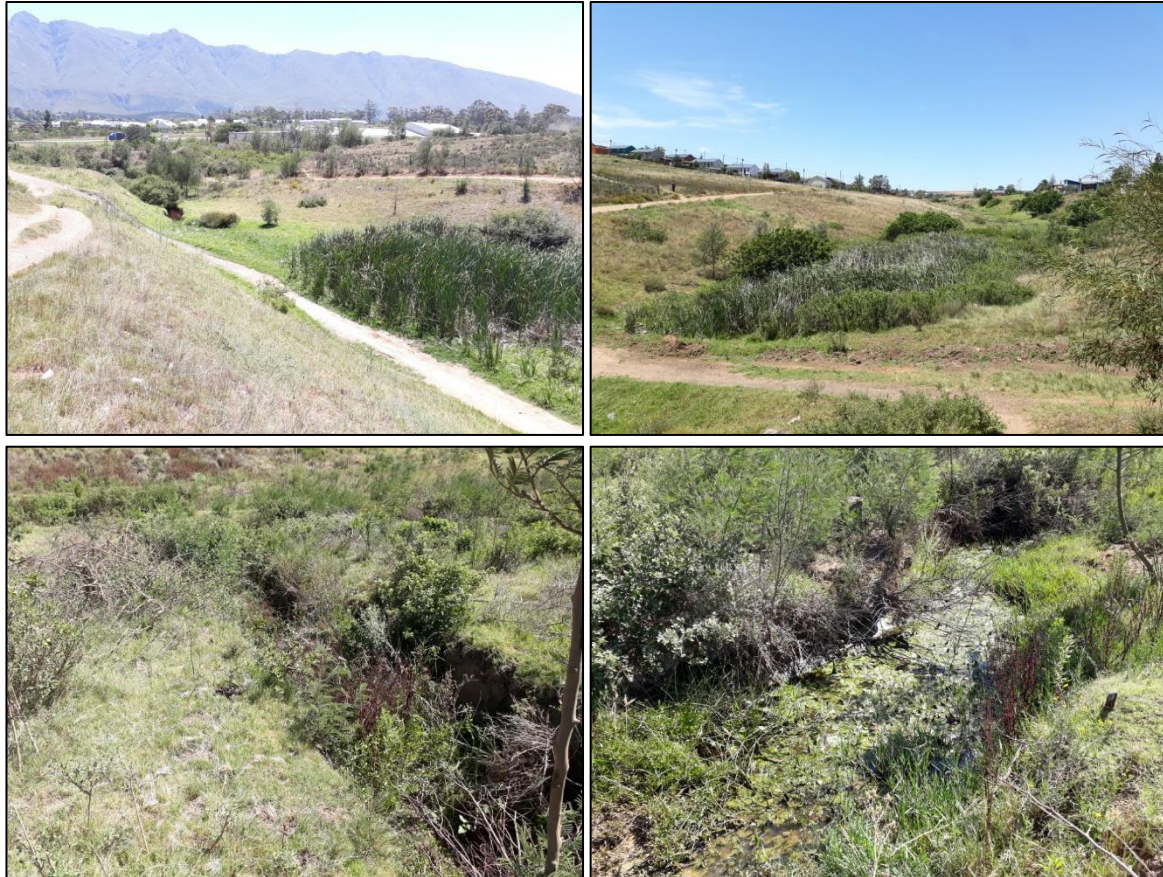
Two sites were identified to be utilised as additional attenuation areas for the new housing development. A smaller attenuation pond will be located within the modified CVBW, approximately 80m north of the proposed access road, directly south of the railway line (refer to top two photos). An additional, larger attenuation pond is proposed approximately 90m north of the railway line, south of the N2 highway (refer to bottom two photos). This attenuation pond will be created at the existing culvert below the N2 and will encompass the confluence of the modified CVBW and the severely modified CVBW that is located to the north of the study area. Obligate species identified included *Juncus effusus*, *Paspalum distichum*, and *Typha capensis* and ponding of water was noted within the severely modified CVBW, and included aquatic waterblommetjies (*Aponogeton distachyos*).

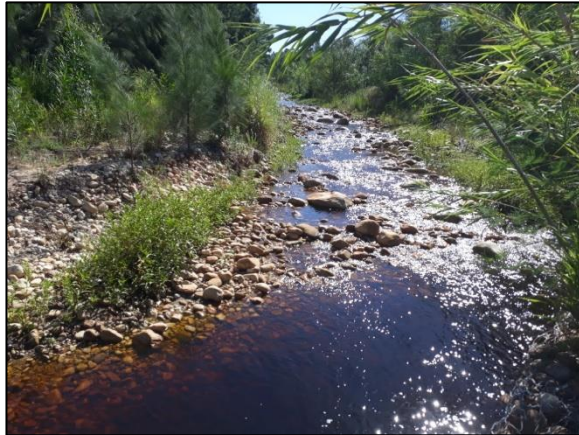
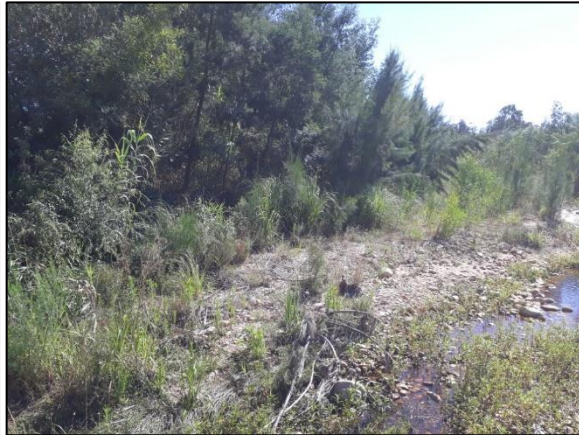
Segment 1 is approximately 300m in length and is situated within a servitude on a private property. The pipeline is approximately 30m north of the Kroonlands River and runs in a north eastern direction. Obligate species associated with this portion of the Kroonlands River included *Persicaria lapathifolia*, *Arundo donax* (Category 1b listed Alien and Invasive species) and *Cortaderia selloana*.

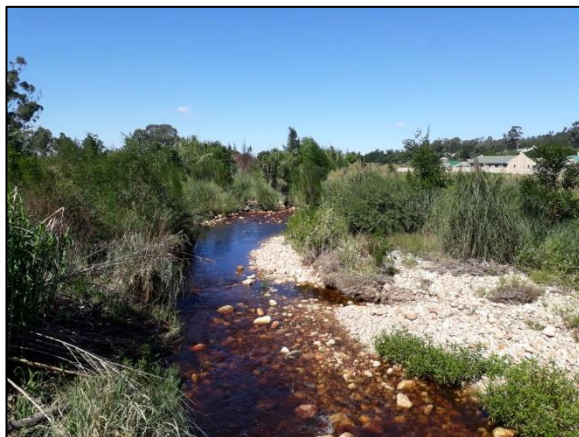
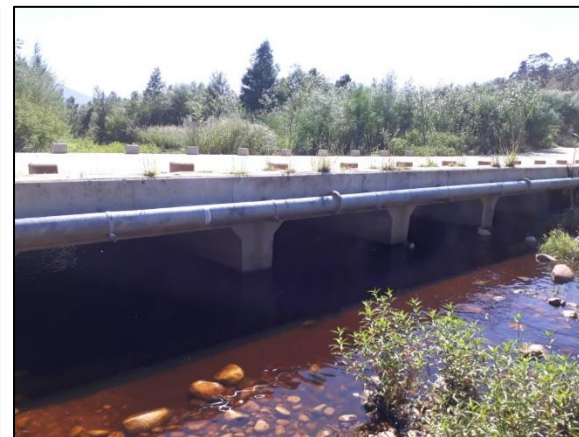
Segment 2 is approximately 328m in length, is situated parallel to the Kroonlands River, approximately 25m to the north west before turning southwards along Lombard Street, crossing the Kroonlands River over the existing culvert bridge. An existing pipeline is visibly attached to the concrete culverts (refer to figure above). Obligate species identified within this portion of the river included *Persicaria lapathifolia*, *Arundo donax* (Category 1b listed Alien and Invasive species), *Typha capensis* and *Cyperus marginatus*.

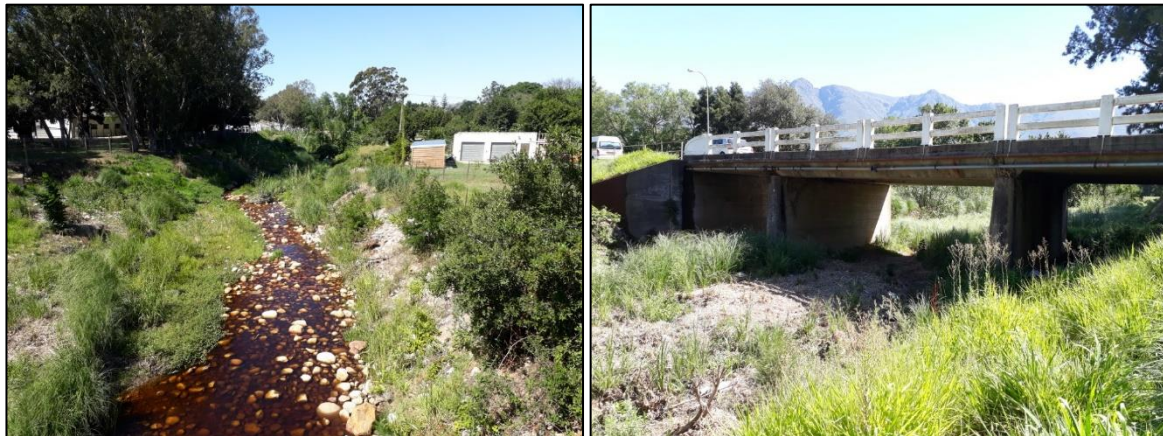
Segment 3 is approximately 85m in length and is located along the northern embankment of the Kroonlands River before turning southwards onto Station Road. An existing pipeline is visibly attached to the bridge crossing over the river (refer to figure above). Residential erven were not to encroach onto the buffer zone surrounding the Kroonlands river. Obligate species identified within this portion of the river included *Persicaria lapathifolia*, *Cyperus marginatus* and *Panicum repens*.
