FRESHWATER RESOURCE VERIFICATION FOR THE PROPOSED EXPANSION OF CATTLE HOUSING FOR THE MARYKA BOERDERY, NEAR MALMESBURY, WESTERN CAPE

January 2019

Prepared by: Scientific Aquatic Services
Report authors: C. du Preez
K. Marais (Pri. Sci. Nat)
Report reviewer S. van Staden (Pr. Sci. Nat)
Report Reference: SAS 219008
Date: January 2019

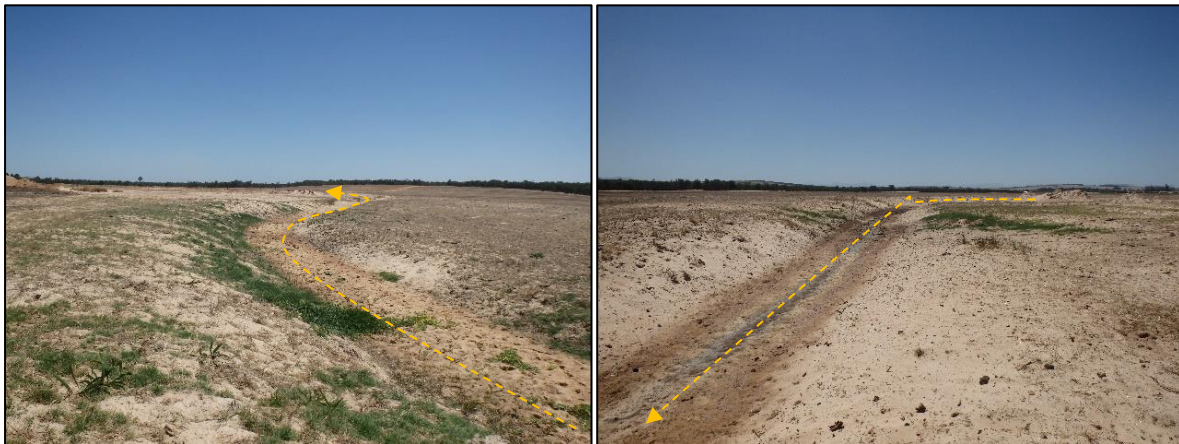
Figure 5: Photographs of the watercourse located within the study area. Only *Cynodon dactylon* grass species and saplings of the invasive *Acacia saligna* (Port Jackson) were present on the embankment thereof. (*The yellow arrow indicates the direction of drainage).

2. Hanekom (2018) determined that this watercourse is critically modified (Present Ecological State (PES) Category E) due to the significant loss of natural habitat and biota owing to the cultivation practices surrounding the watercourse. This was apparent during the site assessment undertaken by SAS in January 2019, as the embankments of some portions of the watercourse have been straightened, grazed and trampled, impacting on its geomorphology and hydrological regime (Figure 5). The PES Category E is thus supported by SAS.

3. Hanekom (2018) made use of the Riparian Vegetation Response Assessment Index (VEGRAI) to assess the vegetation component of this watercourse and ranked the VEGRAI to be D/E. From the photographs taken of the watercourse during the site assessment (Figure 5), the watercourse has limited vegetation cover with only a few patches of *Cynodon dactylon* grass established on the embankment, which conforms to the VEGRAI ranking and low ecological importance (Ecological Importance and Sensitivity (EIS)) of Hanekom (2018). This scoring is thus supported by SAS.

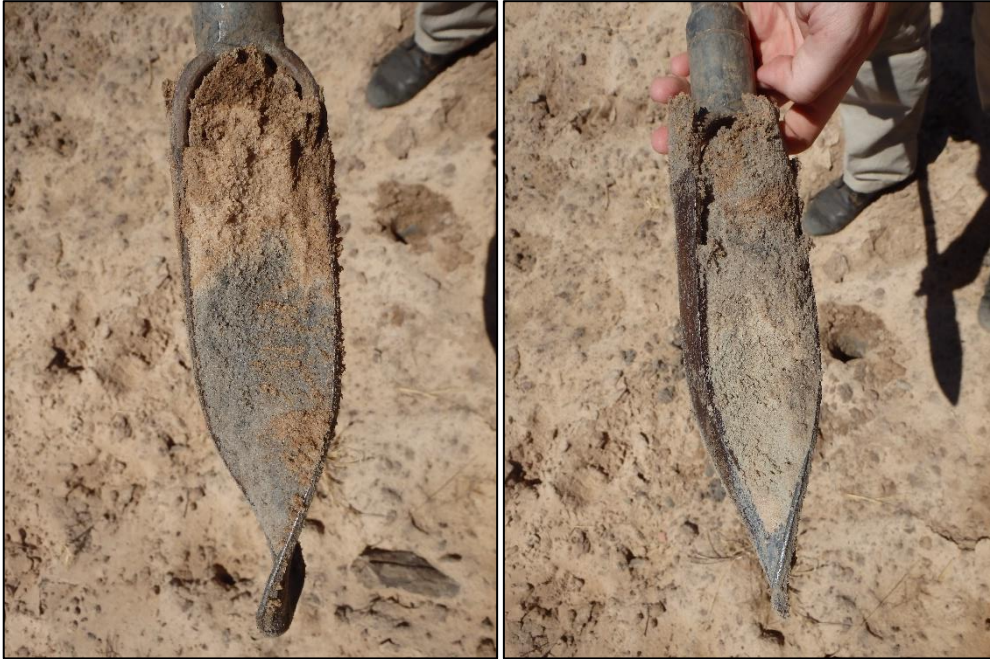
Figure 6: Soil auger samples were taken within the watercourse bed. A prominent gleyed soil layer was apparent within the first auger sample taken (left). All auger samples taken within the same pit after that (right) are gleyed throughout the entire sample.

4. The soil profile of the watercourse was investigated with the use of a hand auger to determine if redoximorphic features such as mottling and gleying were present. These features are caused by prolonged saturated conditions in the soil and the subsequent development of anaerobic conditions. The various soil auger test holes developed within the watercourse bed all showed a very shallow (within the first 20 cm from the soil surface) gleyed soil layer (Figure 6). This layer, with a low chroma grey matrix, indicate that certain soil components (such as iron and manganese) have been leached out of the soils as they are usually permanently inundated. In this case, water seepage into the auger pit was observed within 40cm of the soil surface. This is a significant observation given that the field assessment was taken in the middle of the dry season.

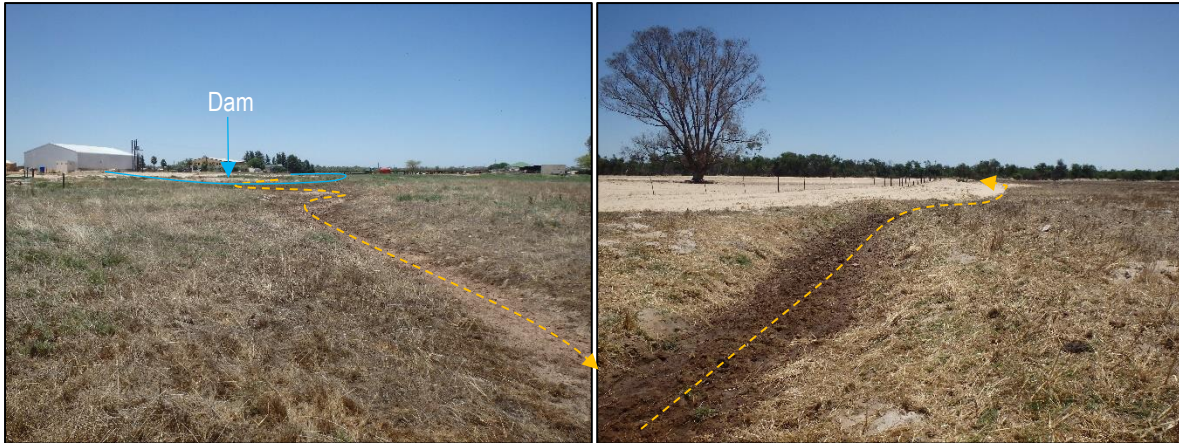
Figure 7: Wetland 2 located within the study area. (Left) The upstream reach of the system (west of the dam) is well vegetated, however, trampling of vegetation was noted. (Right) The vegetation within the downstream reach was noted to be less vegetated, as it is adjacent to a feeding lot. (*The yellow arrow indicates the direction of drainage).

6. A second watercourse was also identified by SAS during the site assessment (Figure 7 and Figure 8) and is also identifiable on the historical imagery (Figure 4). This system is located within the central portion of the study area and drains in a northerly direction, towards the Groen River. Based on comparisons of the current extent and condition of this watercourse from digital imagery to that of the historical imagery, it is clear that water from the surrounding feedlots and a dam (located west of the existing storage sheds) feeds into the system. Overall, this drainage line is considered severely degraded (to the same extent as the) and has limited ecological functioning.
