# **DWS (DW781) FRESHWATER ECOLOGICAL INFORMATION**

## **PROPOSED HOUSING PROJECT ON ERVEN 10866 and 11008 IDAS VALLEY, STELLENBOSCH**

**November 2014**

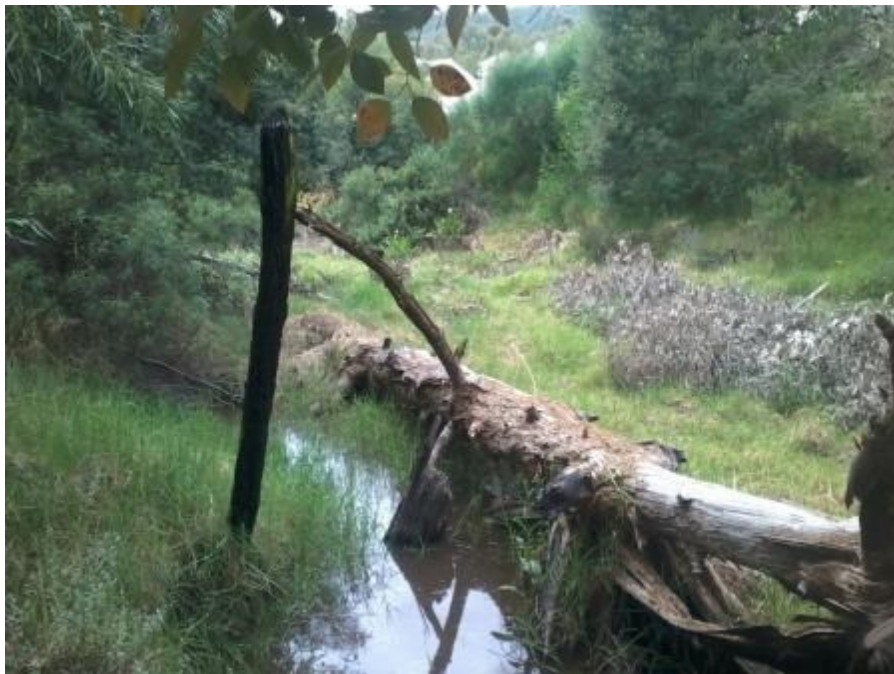
**Photo 1:** Ecological characteristics of the upper reaches of the impacted area of the river.

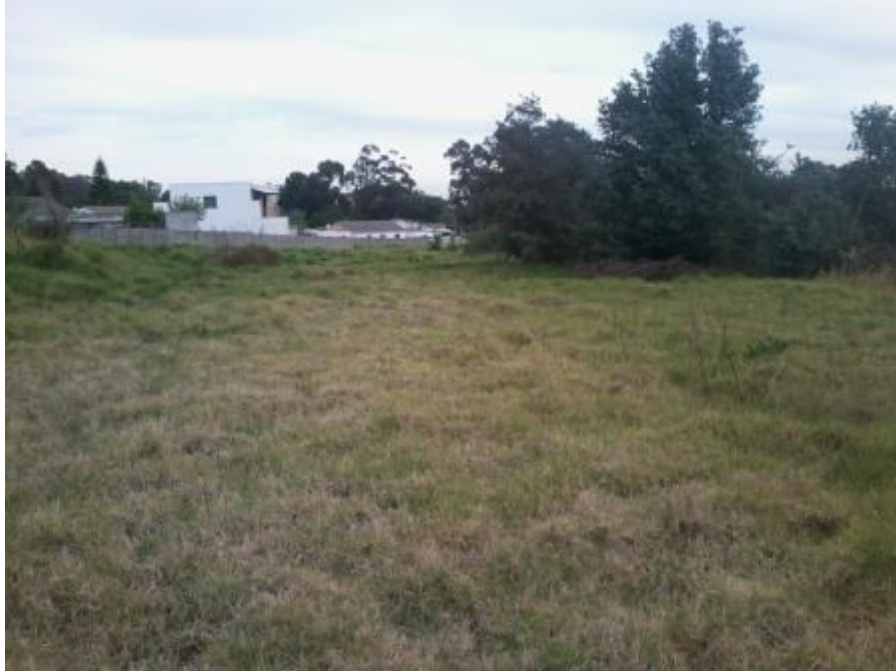
This non-perennial river is defined by a deep narrow channel which is blocked at the road crossing before it meets up with the tributary on the southern boundary. This non-perennial river has a defined channel on the northern and southern edge of the property. However, the middle section of the river is silted up and overgrown with kikuyu grass. This resulted in the river overflowing its banks and running through the proposed development area in winter. It is recommended that the silt be removed and the channel redefined and that the silt that is removed be used to construct a berm to restore the river flow inside the defined river channel.

The non-perennial river to be impacted upon on the eastern boundary is defined by a deep narrow channel which is blocked at the road crossing before it meets up with the tributary on the southern boundary. This non-perennial river has a defined channel on the northern and southern edge of the property. However, the middle section of the river is silted up and overgrown with kikuyu grass. This resulted in the river overflowing its banks and running through the proposed development area in winter.

**Photo 2:** Ecological characteristics of the middle section of the impacted area of the river (river channel that is silted up and overgrown with kikuyu grass).

The river banks not impacted upon and the non-development areas next to the river and the river itself must be cleared of aliens to allow for the natural riparian vegetation to establish. These management actions will improve the current ecological state and functioning of the river.

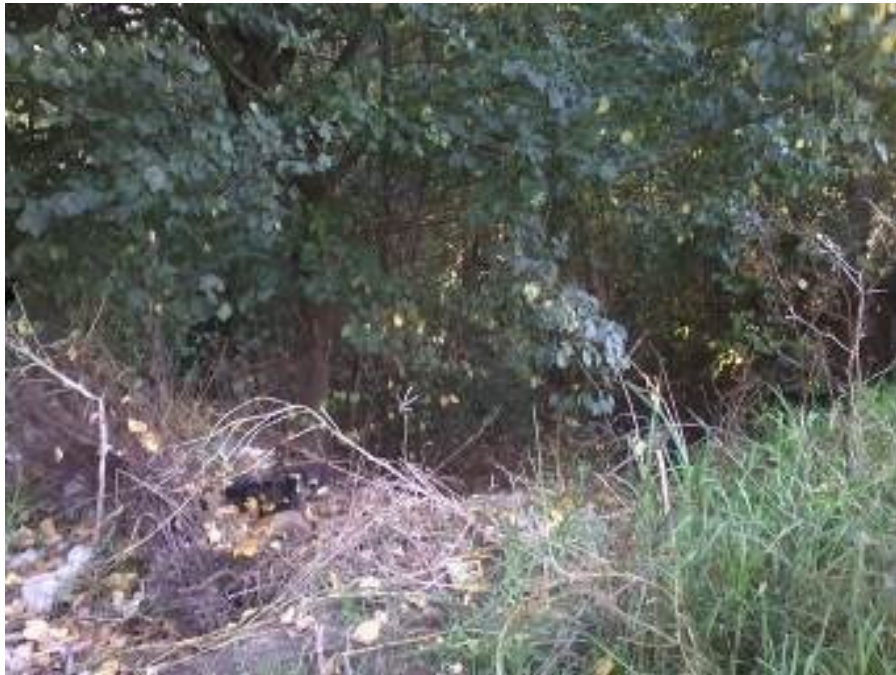
**Photo 3:** Ecological characteristics of the lower section of the impacted area of the river (deep river channel area).
