Idas Valley, Stellenbosch Erf 10866

Wetland Assessment

August 2015

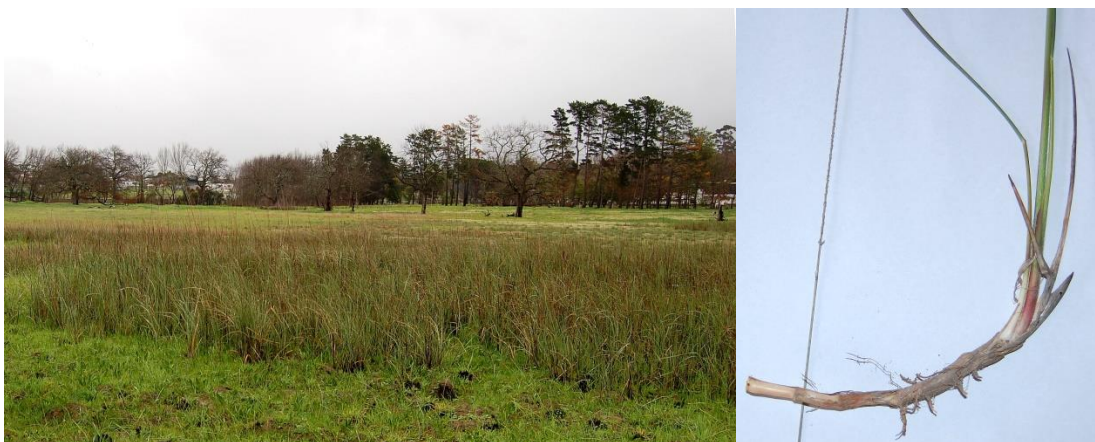
Figure 1. River Bed Grass

The river bed grass is listed as an “obligatory wetland” species (DWAF, 2005) and is probably the plant that was taken for “sedge” during the Cape Nature site visit. Nevertheless, the presence of this plant is indeed indicative of a wetland. The grass was present in concentrated patches over quite a substantial area.

The wetland at Erf 10866 was delineated according to the presence of river bed grass *Pennisetum macrourum*. This plant was classified as an obligatory wetland species (DWAF, 2005).

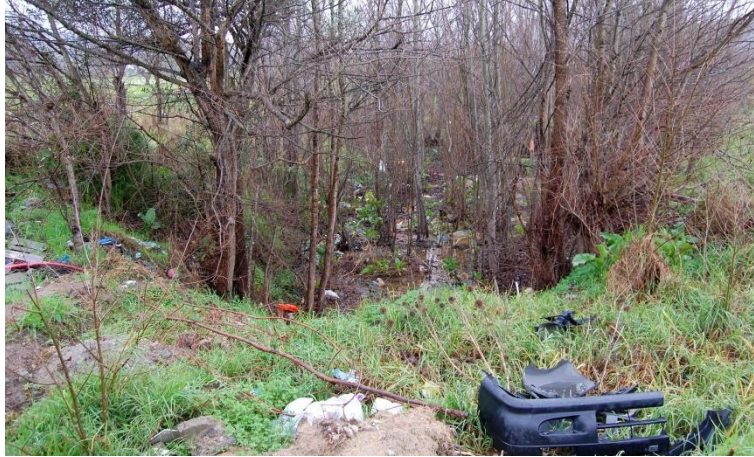
Figure 2. The Trench

Currently a very deeply eroded channel (Figure 2) cuts through the area and probably drains surface and even groundwater much faster than during the time prior to human impact, preventing the maintenance of obvious wetland conditions.

With such a deep incision along the site, it can be expected that ground water would decant into the ditch and that this could contribute to the dryness of the site.

If the wetland's further destruction is to be reversed and should the authorities decide to restore the wetland, it stands to reason that the adjacent trench requires to be filled in. In this event an active, long term rehabilitation process is called for, including the re-establishment of a percentage of the original vegetation. This might prove tedious, expensive and an option not feasible to the municipality.

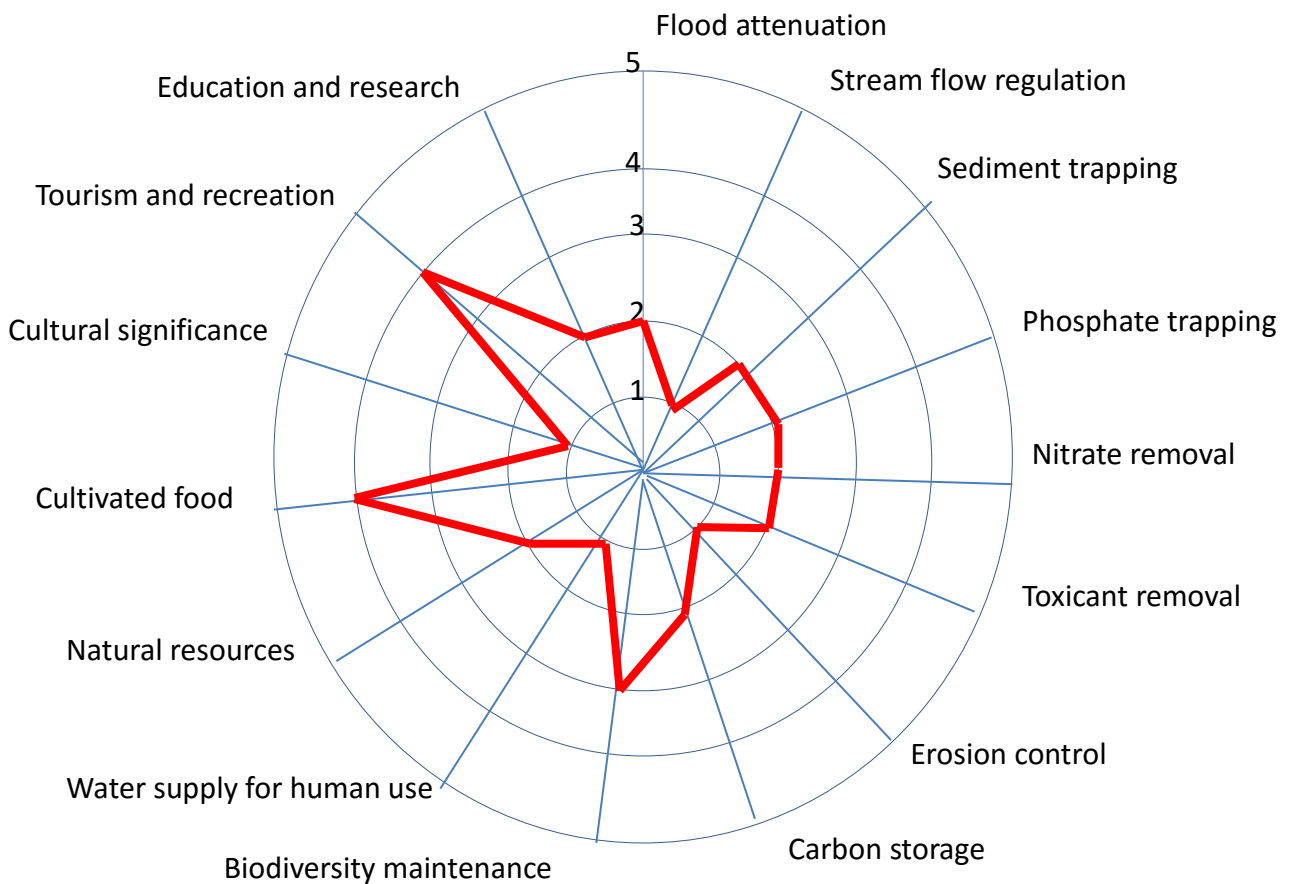
Figure 1. Diagrammatic representation of the Erf 100866 wetland goods and services

The value for tourism stands out because it is located in the most picturesque area of Stellenbosch with its mountains and vineyards. The lupines serve as fodder for livestock, hence the higher score. Stellenbosch has much cultural value, but the erfs on the verge of Idas Valley probably does not share the same attribute.

The diagram (Figure 2) is an accepted manner to visually illustrate the resource economical footprint the wetland.

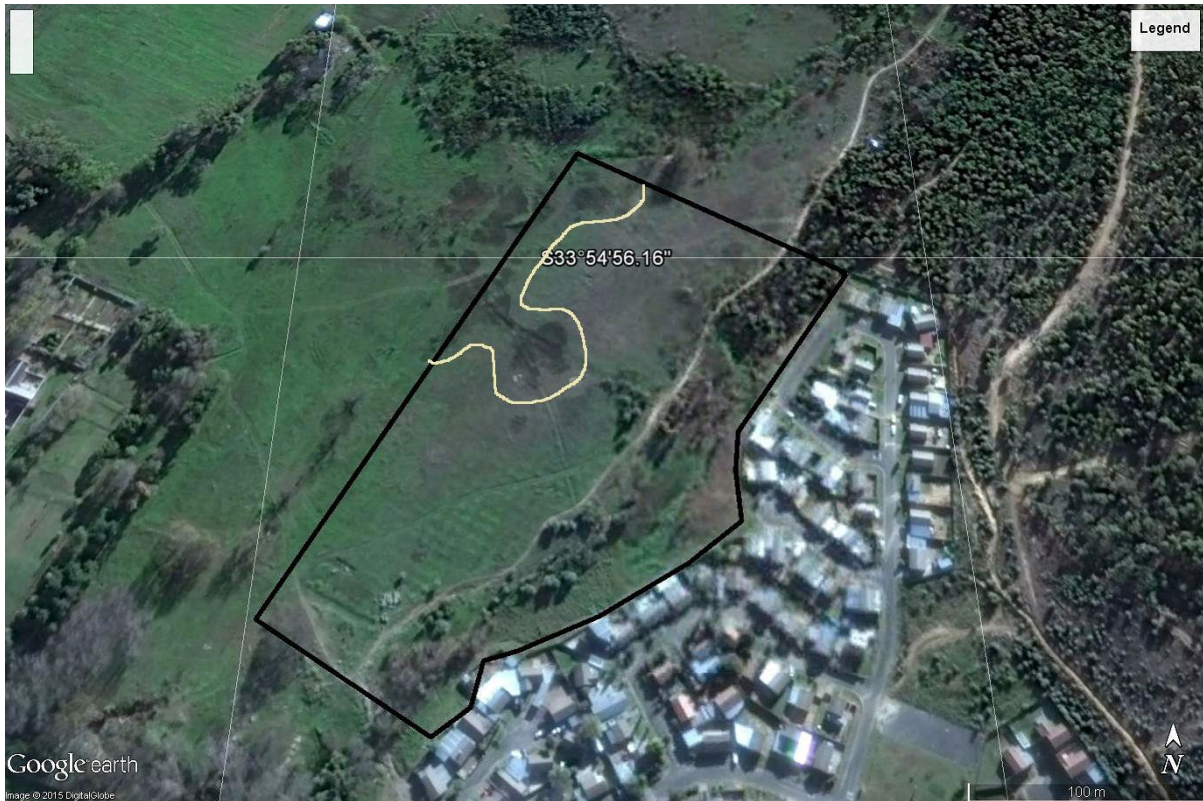
Figure 1. Erf 100866 wetland delineation

The wetland can be demarcated according to the presence of the river bed grass, which is clearly visible on a Google Earth image. A 5 to 10 meter buffer zone is shown in the Figure below. The wetland is marked in the north eastern corner of the site.
