# **Basic Wetland Assessment of Darling Country Club, Erf 401 and Portions 8 & 9 of Farm 577**

**March 2009**

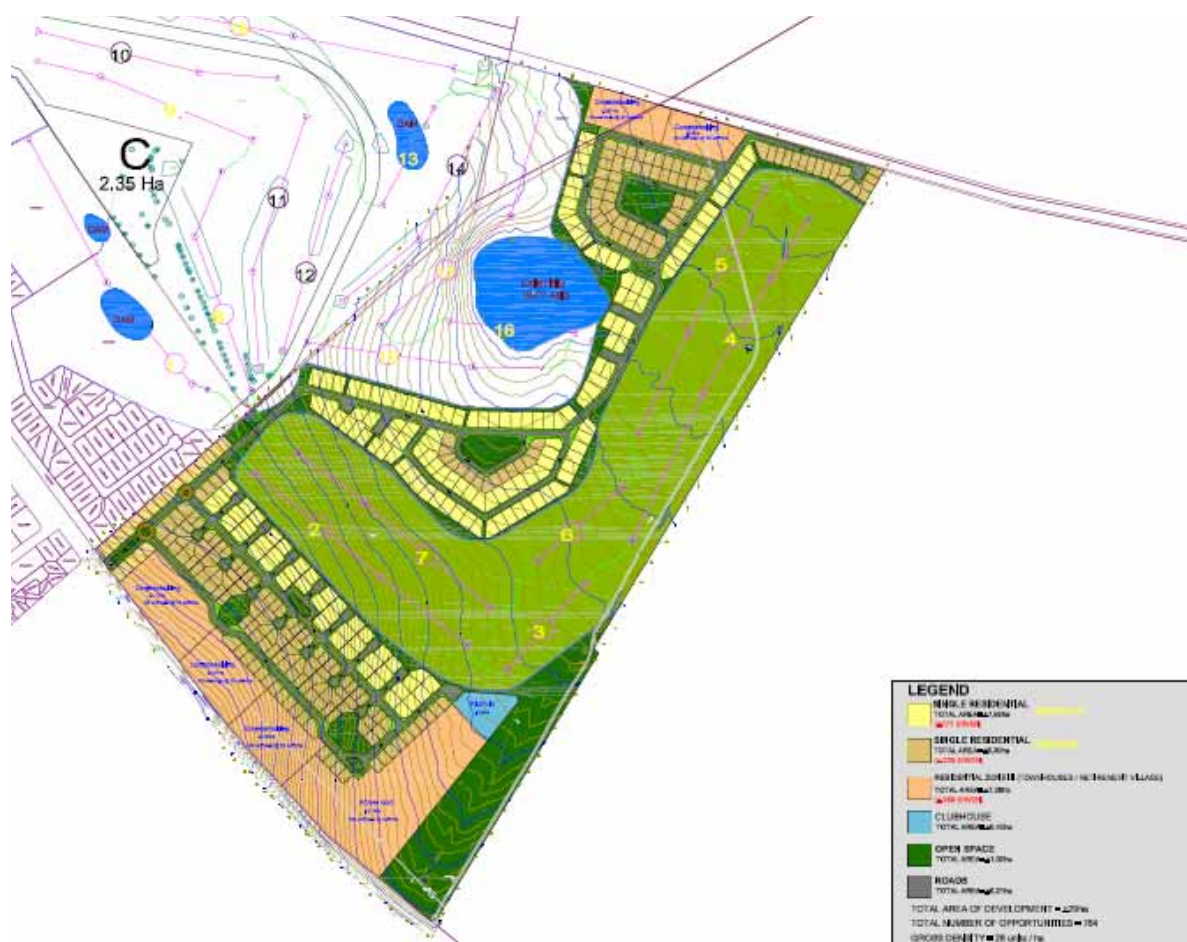
**Figure 1.** The proposed Darling Country Club Development

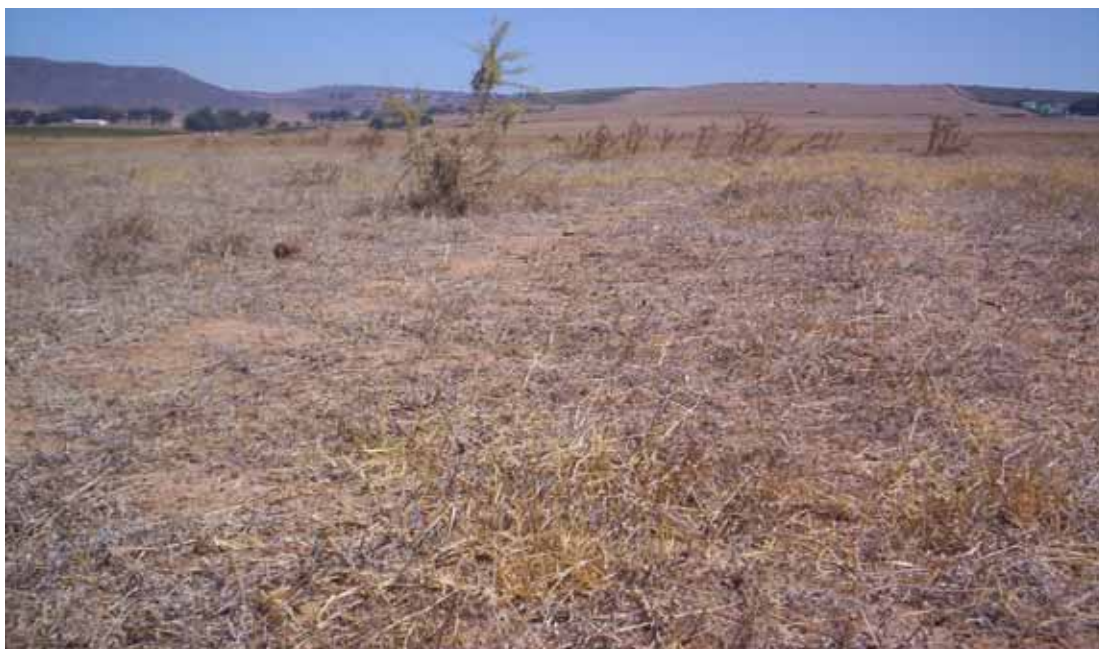
**Figure 2.** View of the site from the railway displaying the weedy vegetation cover, consisting mostly of common grass.

The site itself consists of previously ploughed lands which are now grazed by livestock. The wetland area has been ploughed up to its very edge, but contains some very distinct wetland vegetation along its edge. This vegetation, classified as Cape Vernal Pool in Helme's botanical assessment of the area, is considered to be critically endangered and mostly only occurs in the Swartland. It consists largely of sedges and arum lilies (*Zantedeschia aethiopica*).

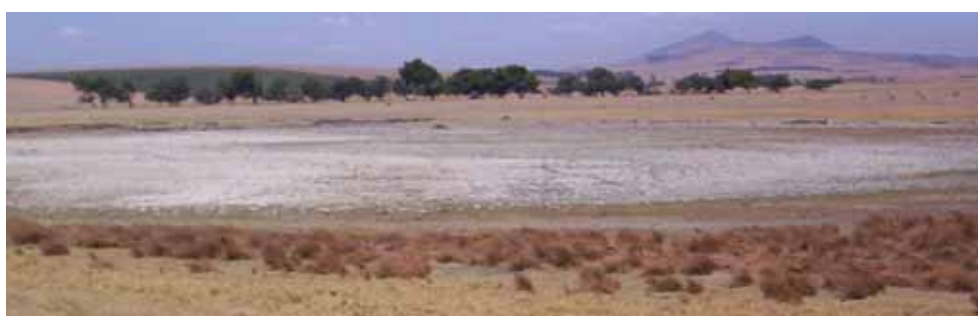
**Figure 4.** View of the wetland from the golf course property during the dry season

On an *ad hoc* classification basis, the Apolisvlei wetland can be described as a depression wetland or pan. It is seasonal, retaining a significant volume of water during the winter rainfall months (Figure 5) and is recharged by surface infiltration and natural seeps following rainfall events. During summer the pan dries up completely (Figure 4).

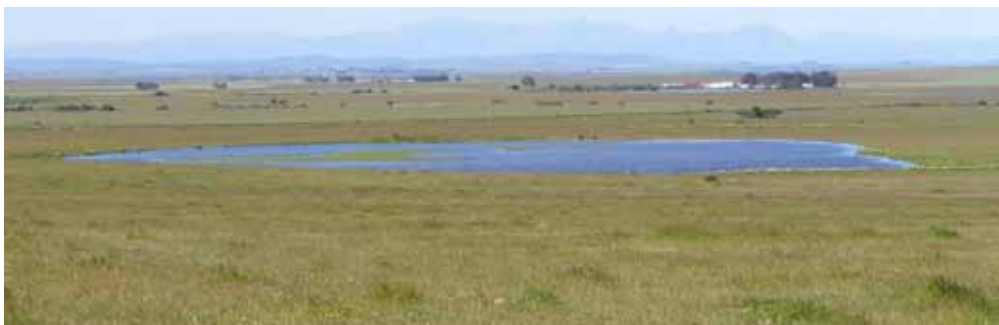
**Figure 5.** View of the wetland from the golf course property during the wet season

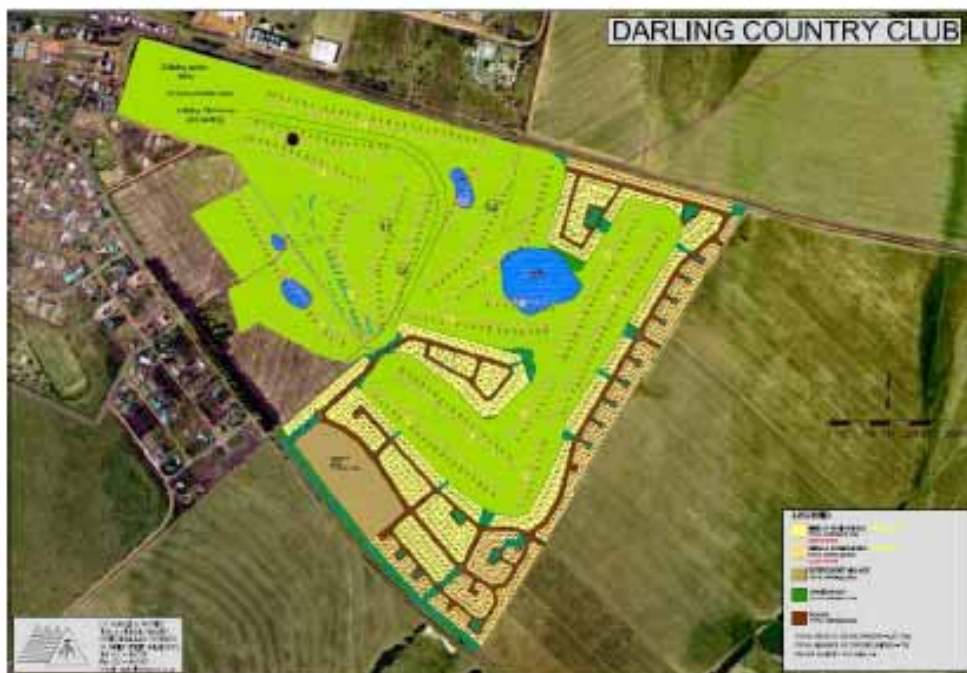
**Figure 7.** Proposed development layout linked with the existing golf course

The proposed development activity ( $\pm 29$  ha in size) includes an extension of the existing golf course,

$\pm 171$  lower density single residential units ( $400 - 500 \text{ m}^2$ ),

$\pm 225$  lower density single residential units ( $250 - 300 \text{ m}^2$ ),

$\pm 368$  erven town houses and a retirement village,

A clubhouse of  $0.4$  ha, and open space of  $1.02$  ha (Figure 7)

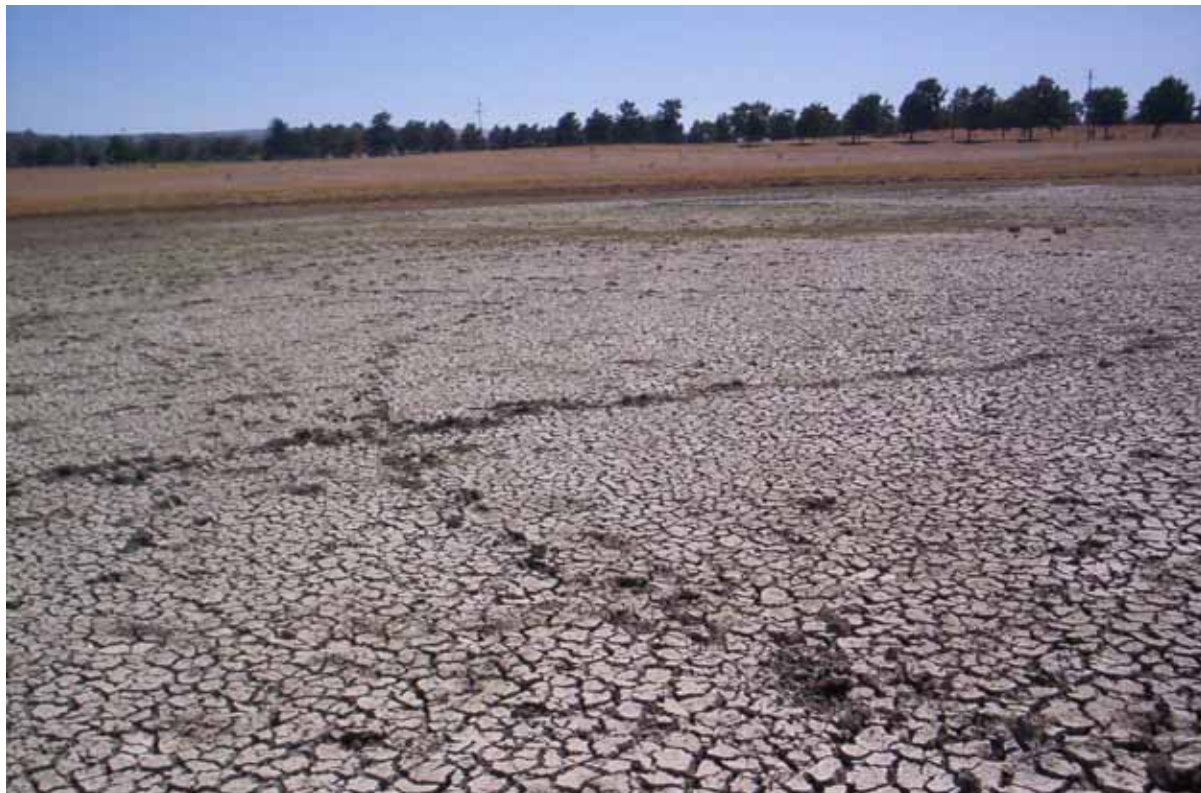
**Figure 9.** Darling Country Club Estate Apolisvlei wetland

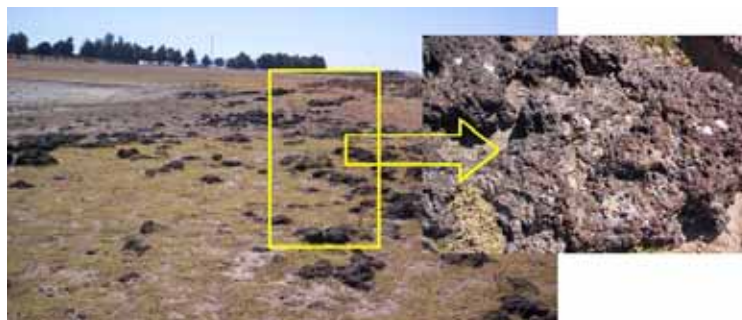
**Figure 11.** A close up view of the scattered ferricretes found in the wetland depression

The wetland, Apolisvlei, on the site for the proposed country estate can be classified as a pan depression seep area (Table 1). The wetland area has been formed by very distinct hydrological, water quality and sediment dynamics that characterizes the plant communities and other biota occurring within the wetland. This includes the ferricretes scattered across the wetland where the weathered porous granite derived features can be clearly seen on these rocks (Figure 11).

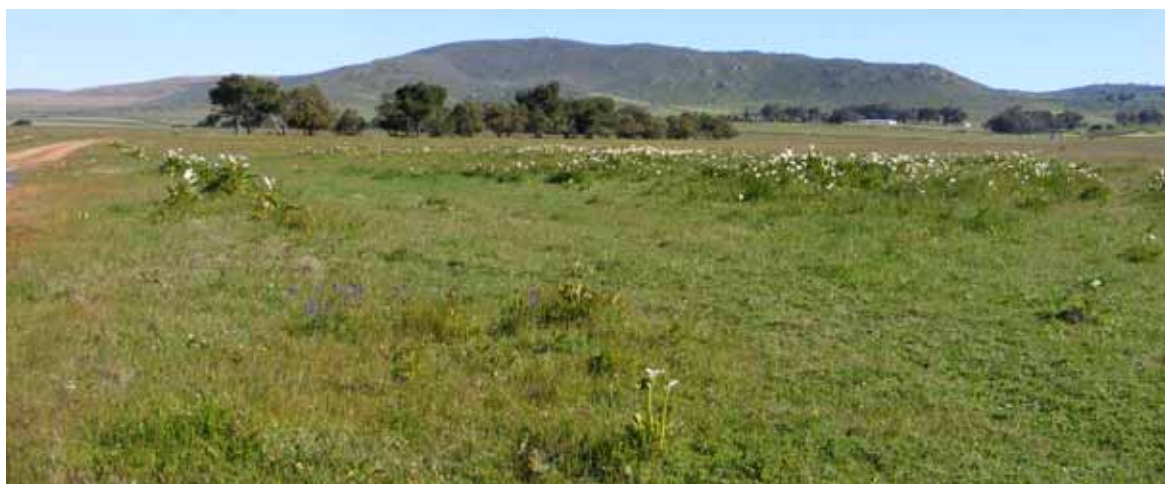
**Figure 13.** Seepage area in the north-east corner of the property

A seepage area with a defined channel was also identified in the north-east corner of the property. This wetland largely results from an elevated water table during winter and is dominated by arum lilies. The wetland area only remains wet for a short period and is very dependent on the height of the water table. The drainage channel was probably man-made in an attempt to drain the water-logged land more quickly as there is little evidence of the wetland having a strong link with surface water runoff. The area is also not considered to be particularly important in terms of the flora and fauna that it supports.
