PROSPECTING RIGHT CLOSURE ON RE AND PORTION 2 OF MELKBOOM 209, PORTION 1 AND 4 OF MATJIESFONTEIN 210, PORTION OF MATJIESDRIFT 329, PORTION OF FARM 323 AND PORTION OF FARM 372

FINAL CLOSURE COMPLIANCE AUDIT REPORT, ENVIRONMENTAL RISK REPORT AND CLOSURE/REHABILITATION PLAN

DMR Ref Nr: WC 30/5/1/1/2/10032PR

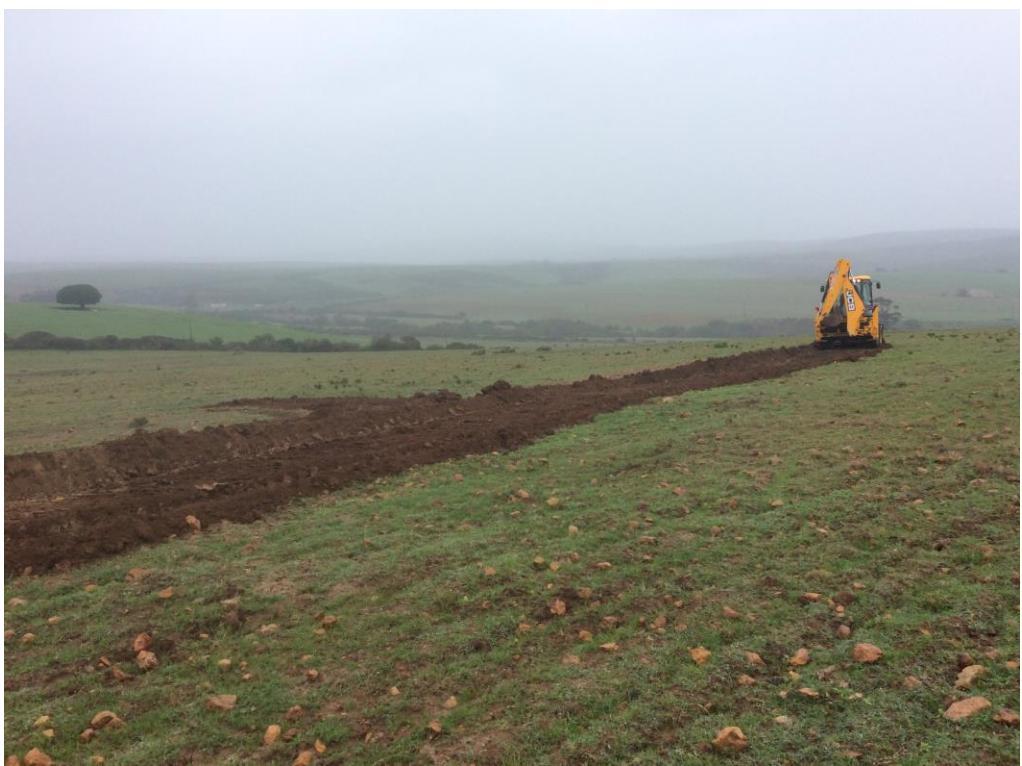
Photo 1: Example of sample trench excavated in cultivated land.

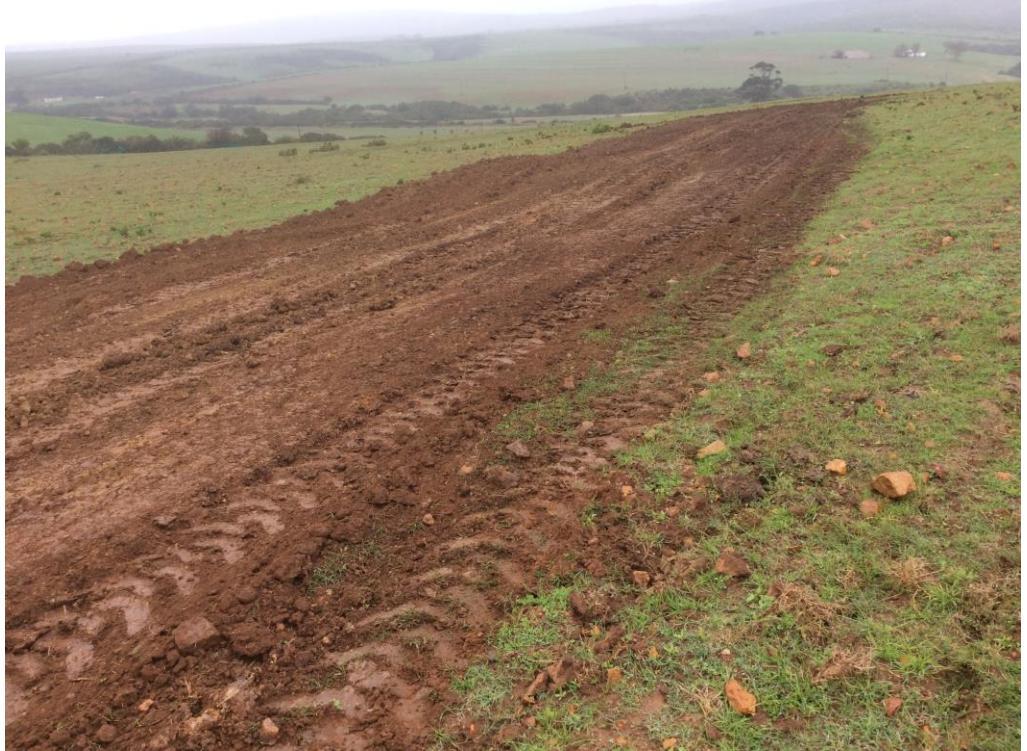
Photo 2: Site 1 – Rehabilitation photo taken 05/09/2018 (infill and topsoil material returned and shaped according to surrounding topography)

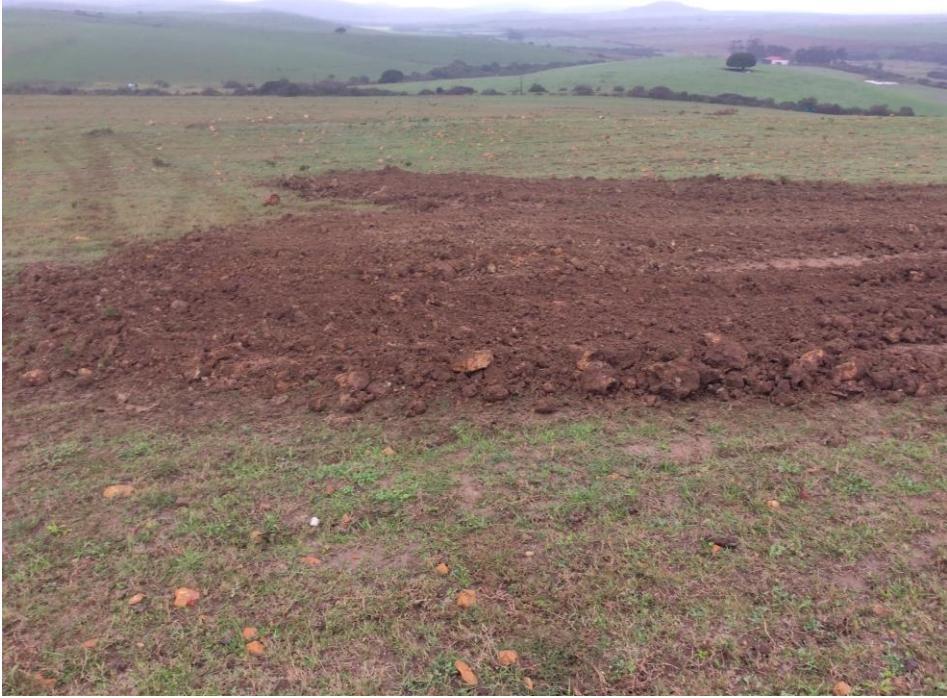
Photo 3: Site 2 – Rehabilitation photo taken 05/09/2018 (infill and topsoil material returned and shaped according to surrounding topography)

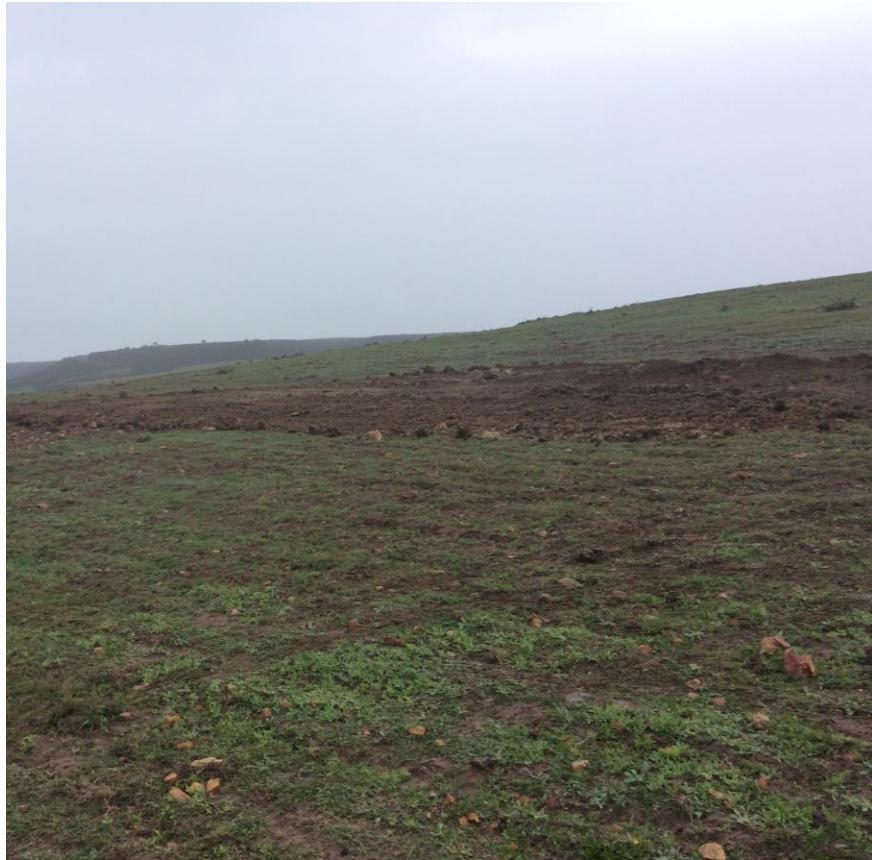
Photo 4: Site 3 – Rehabilitation photo taken 05/09/2018 (infill and topsoil material returned and shaped according to surrounding topography)

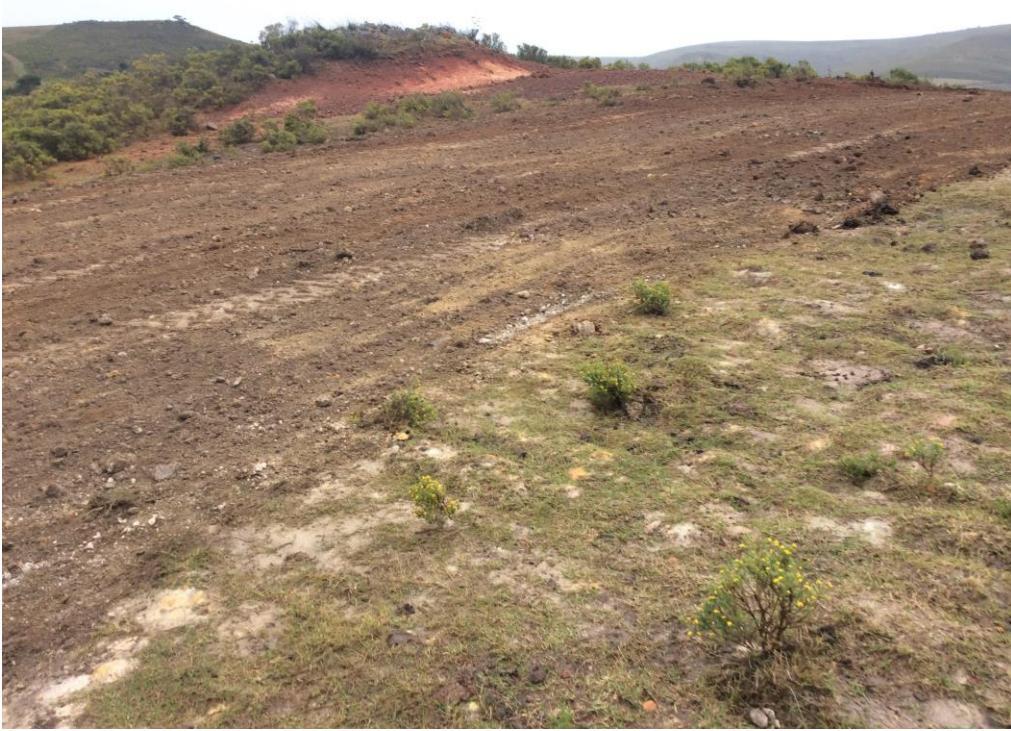
Photo 5: Site 4 – Rehabilitation photo taken 05/09/2018 (infill and topsoil material returned and shaped according to surrounding topography)

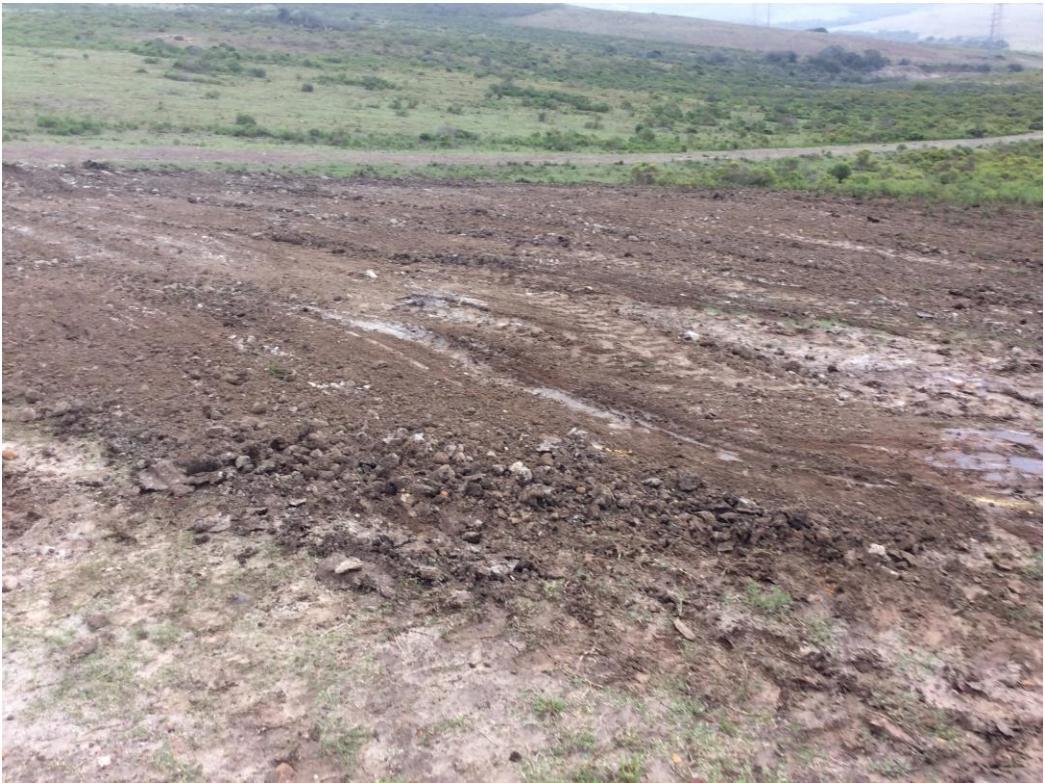
Photo 6: Site 5 – Rehabilitation photo taken 05/09/2018 (infill and topsoil material returned and shaped according to surrounding topography)

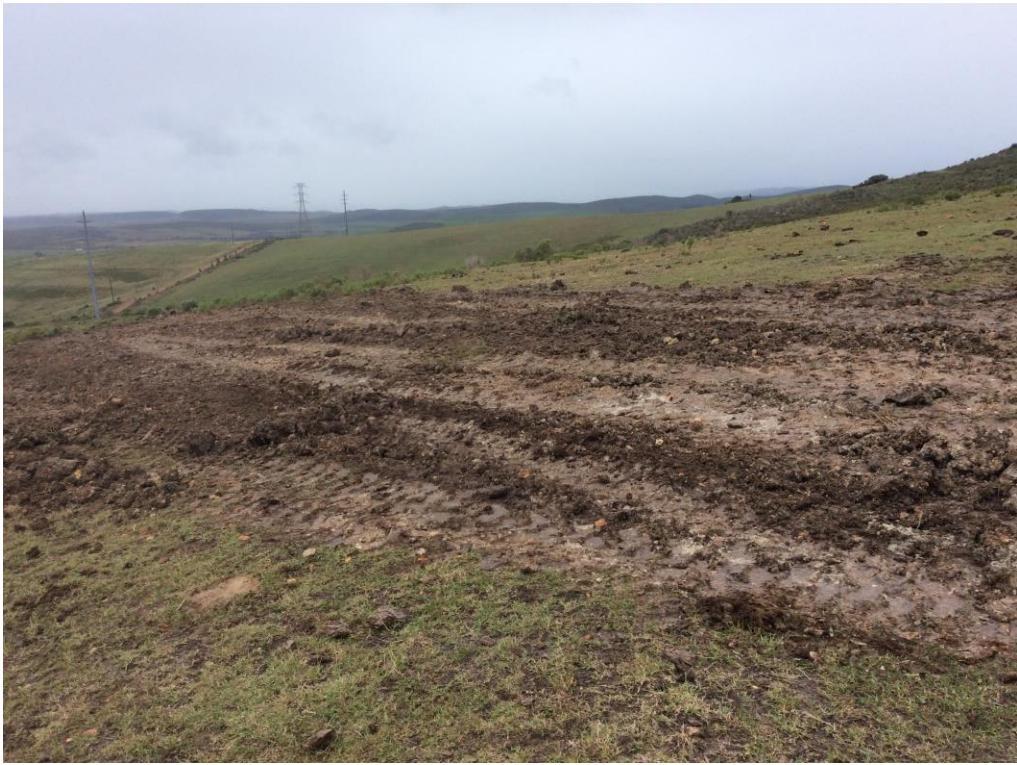
Photo 7: Site 6 – Rehabilitation photo taken 05/09/2018 (infill and topsoil material returned and shaped according to surrounding topography)

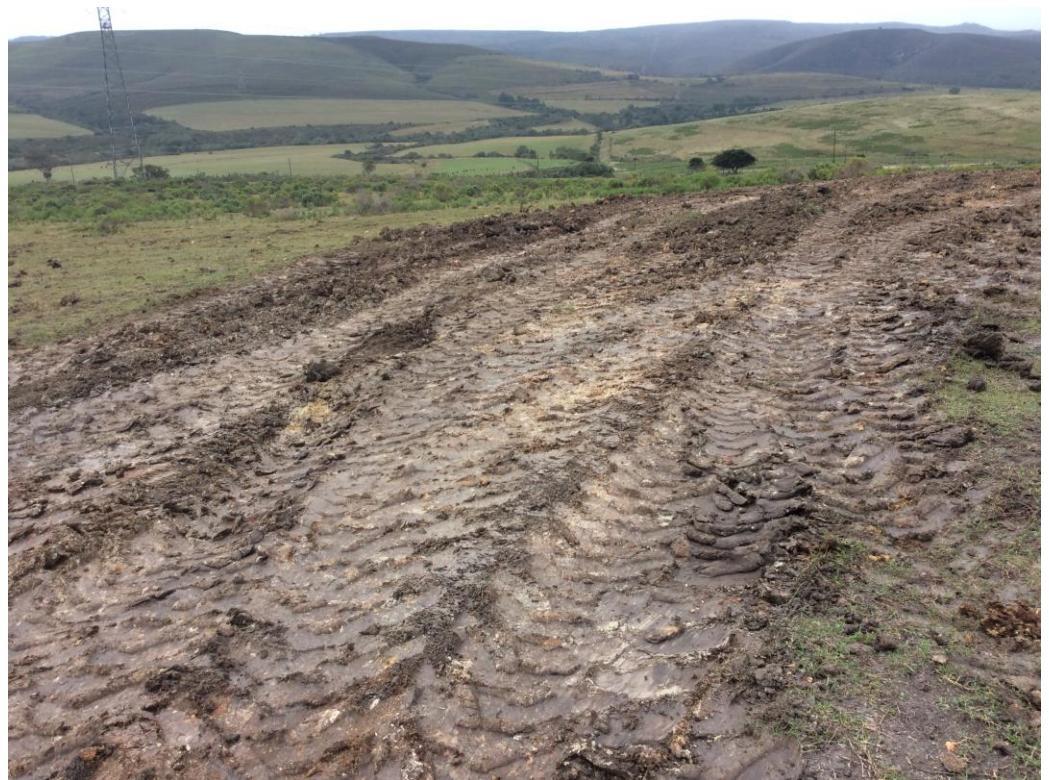
Photo 8: Site 7 – Rehabilitation photo taken 05/09/2018 (infill and topsoil material returned and shaped according to surrounding topography)

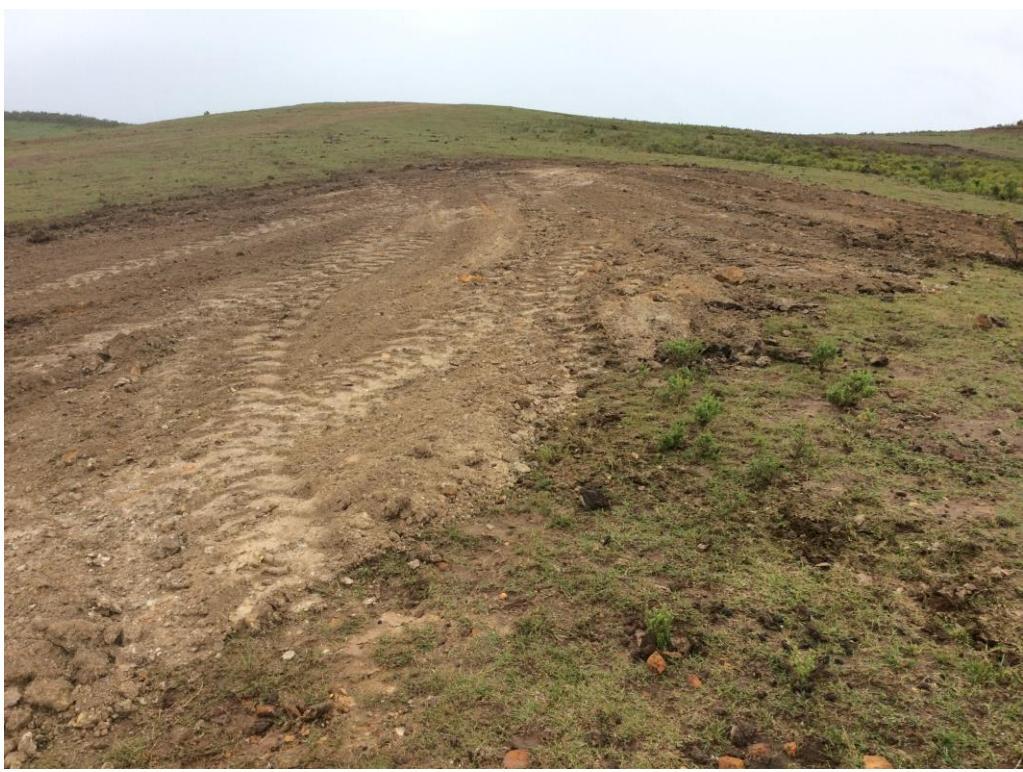
Photo 9: Site 8 – Rehabilitation photo taken 05/09/2018 (infill and topsoil material returned and shaped according to surrounding topography)

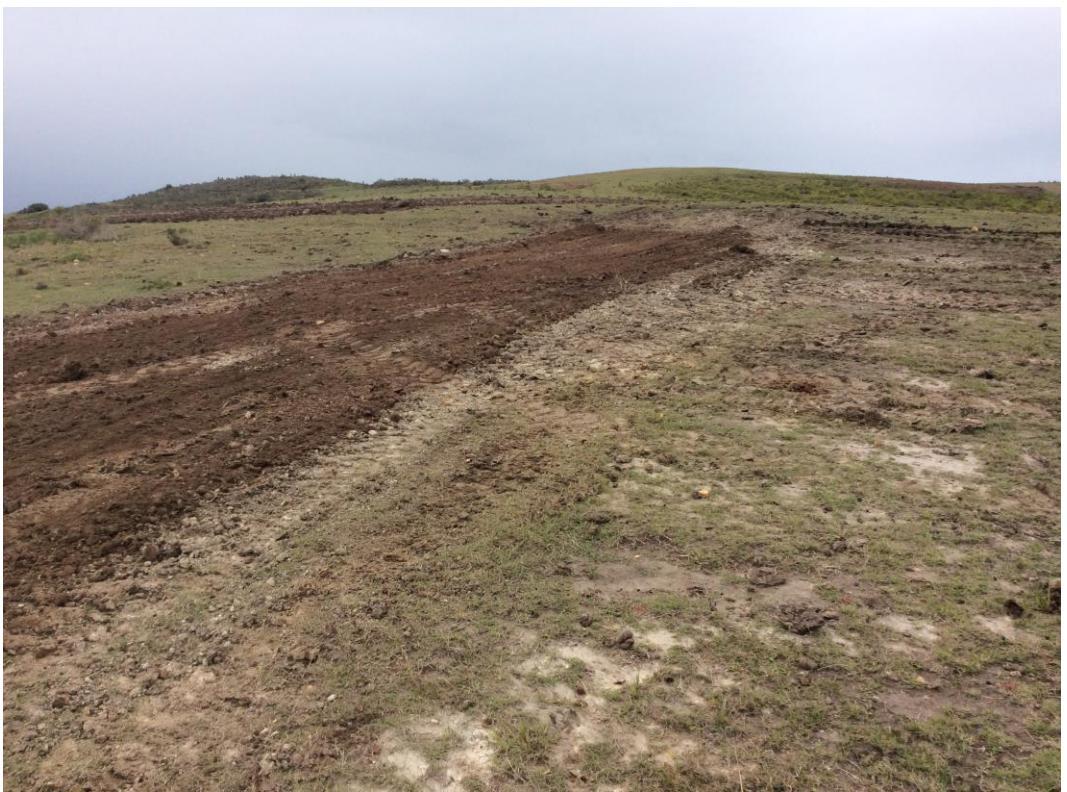
Photo 10: Site 9 – Rehabilitation photo taken 05/09/2018 (infill and topsoil material returned and shaped according to surrounding topography)

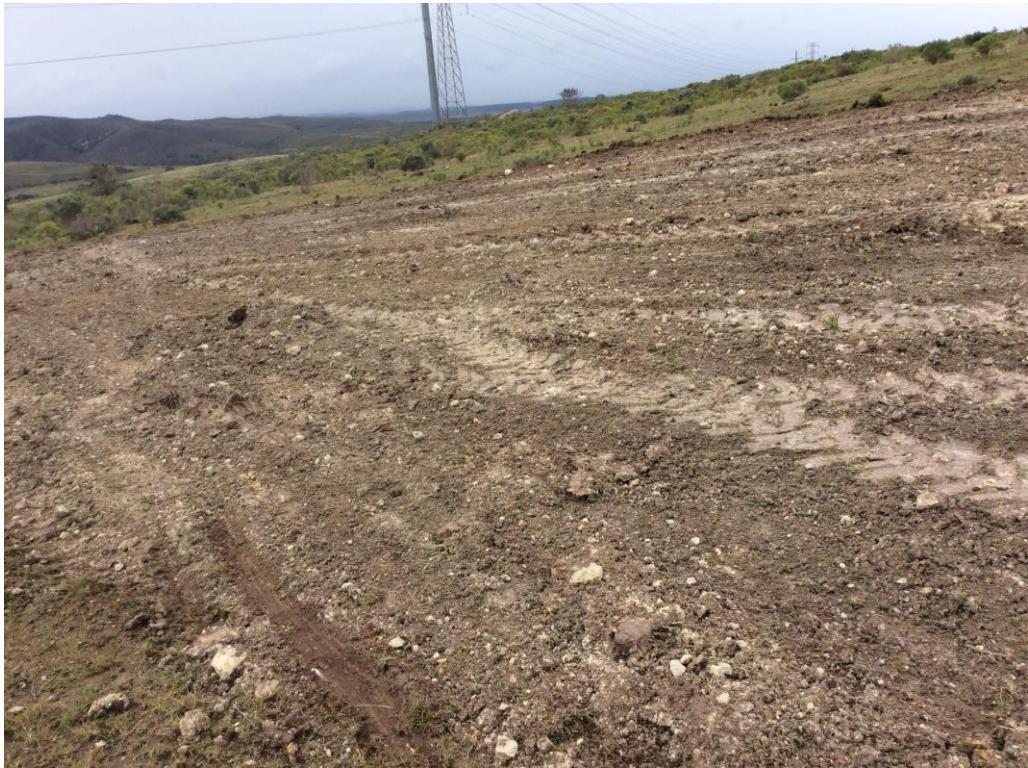
Photo 11: Site 10 – Rehabilitation photo taken 05/09/2018 (infill and topsoil material returned and shaped according to surrounding topography)

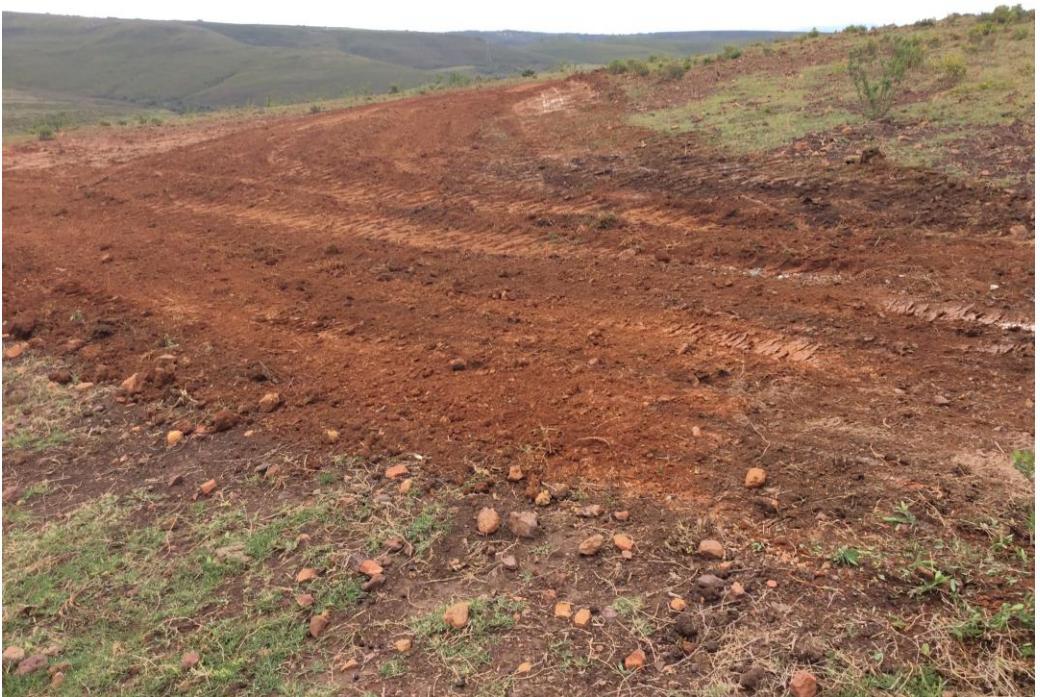
Photo 12: Site 11 – Rehabilitation photo taken 05/09/2018 (infill and topsoil material returned and shaped according to surrounding topography)

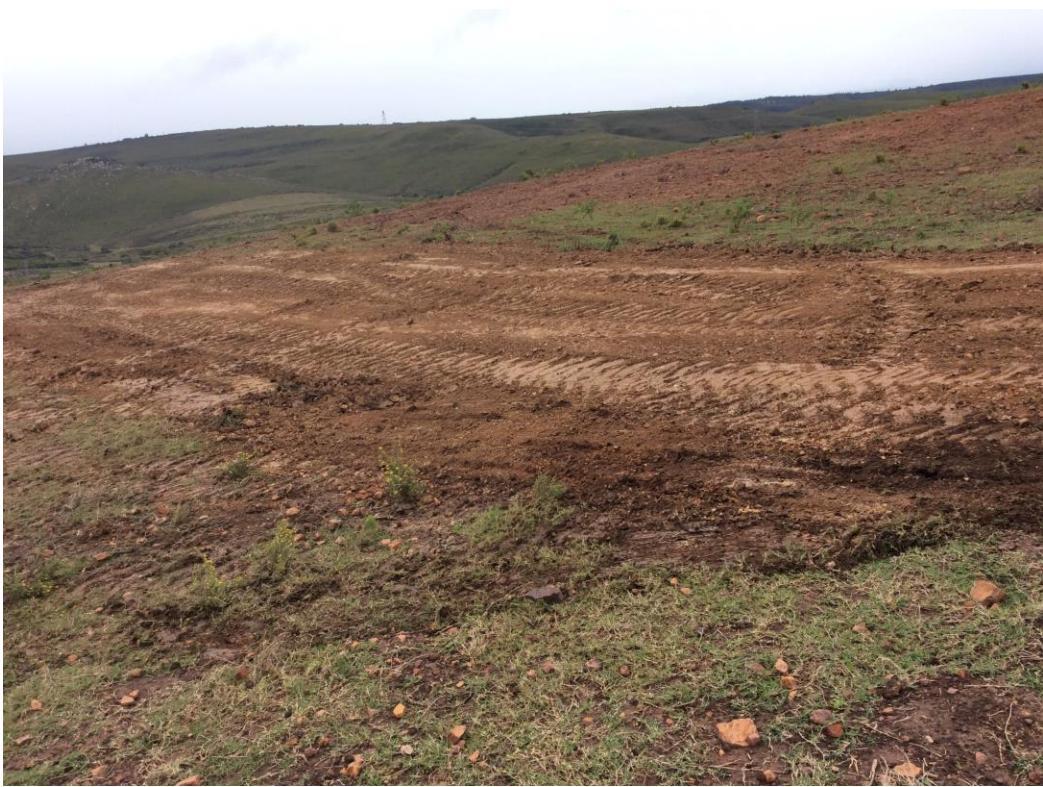
Photo 13: Site 12 – Rehabilitation photo taken 05/09/2018 (infill and topsoil material returned and shaped according to surrounding topography)

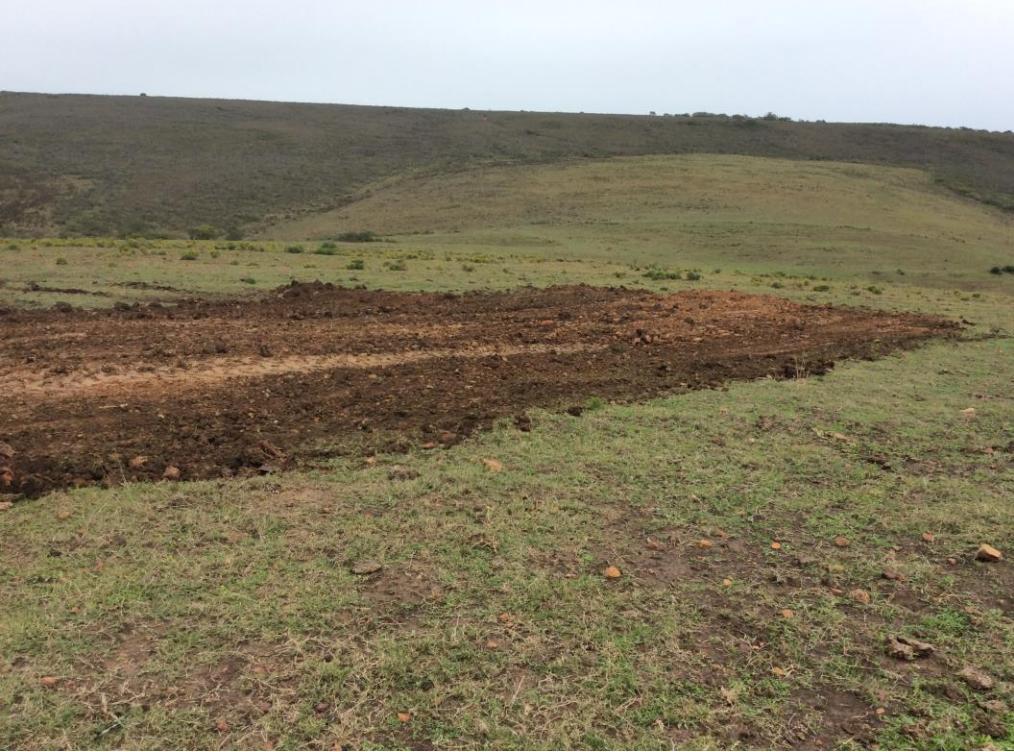
Photo 14: Site 13 – Rehabilitation photo taken 05/09/2018 (infill and topsoil material returned and shaped according to surrounding topography)

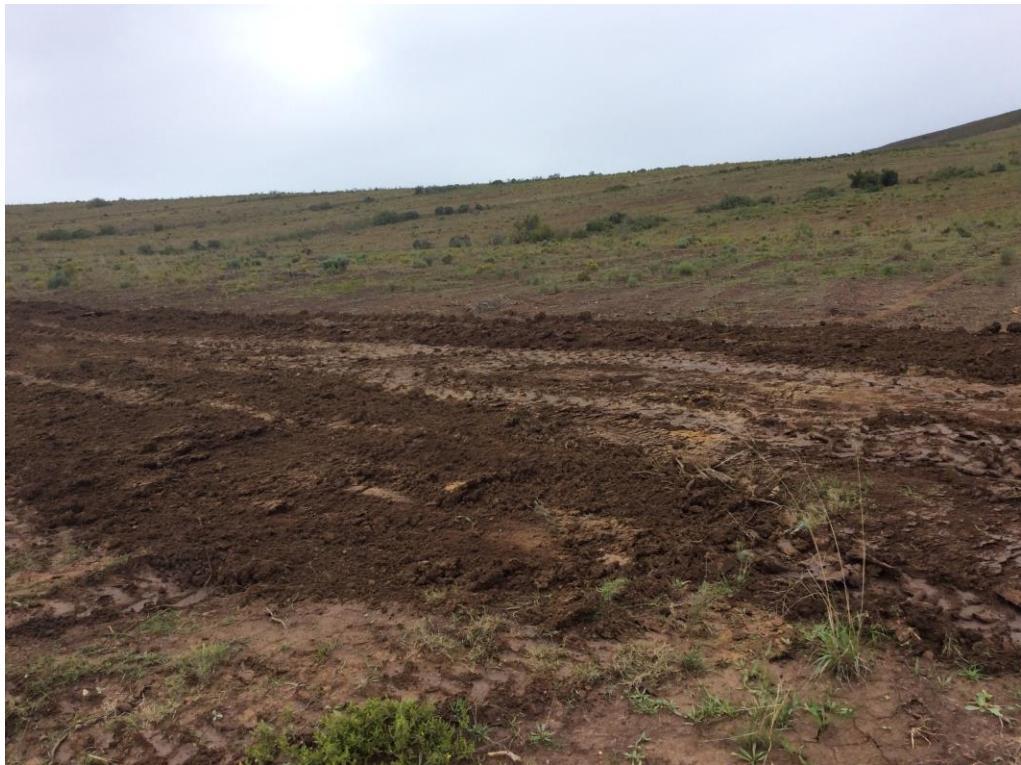
Photo 15: Site 14 – Rehabilitation photo taken 05/09/2018 (infill and topsoil material returned and shaped according to surrounding topography)

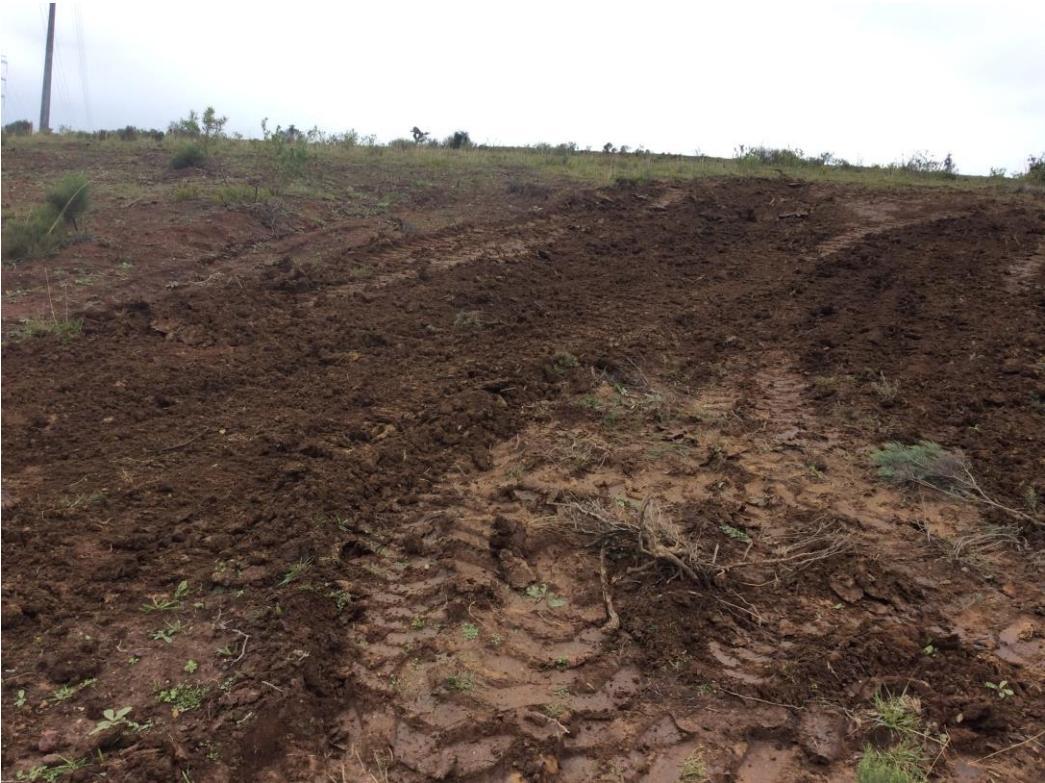
Photo 16: Site 15 – Rehabilitation photo taken 05/09/2018 (infill and topsoil material returned and shaped according to surrounding topography)

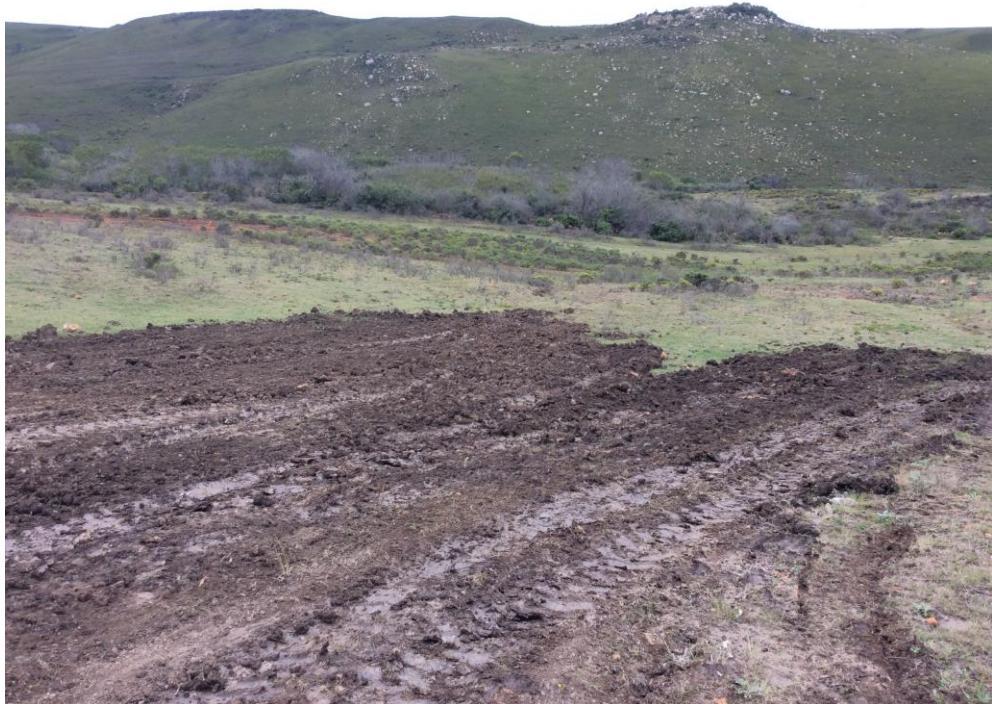
Photo 17: Site 16 – Rehabilitation photo taken 05/09/2018 (infill and topsoil material returned and shaped according to surrounding topography)

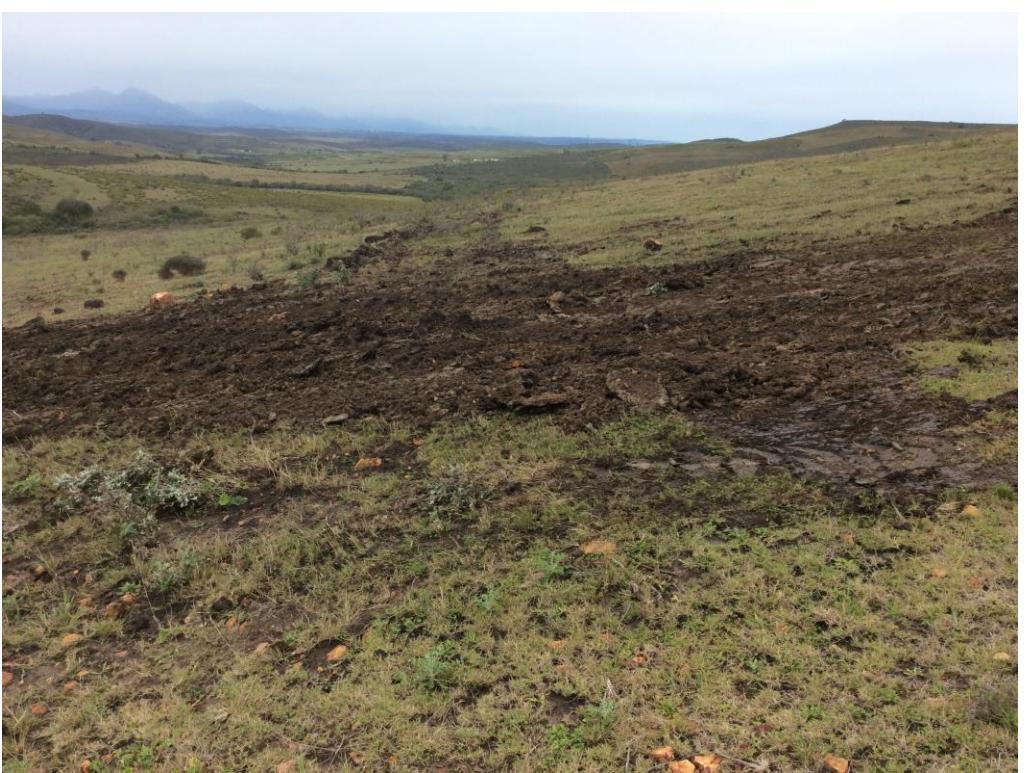
Photo 18: Site 17 – Rehabilitation photo taken 05/09/2018 (infill and topsoil material returned and shaped according to surrounding topography)

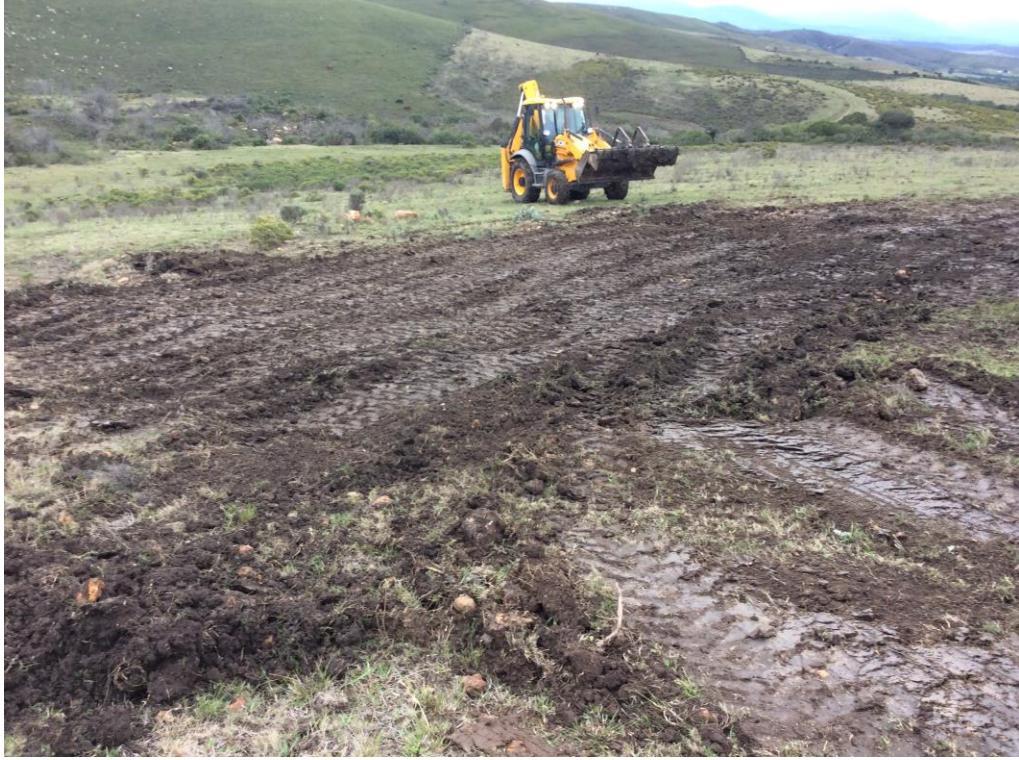
Photo 19: Site 18 – Rehabilitation photo taken 05/09/2018 (infill and topsoil material returned and shaped according to surrounding topography)

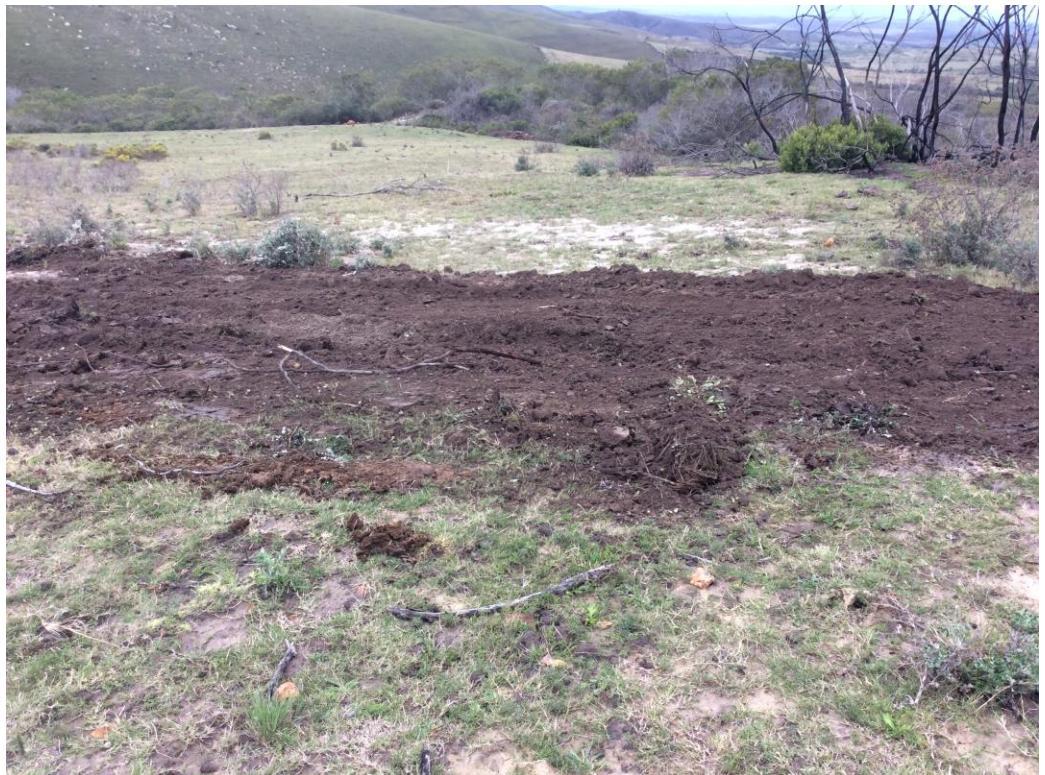
Photo 20: Site 19 – Rehabilitation photo taken 05/09/2018 (infill and topsoil material returned and shaped according to surrounding topography)

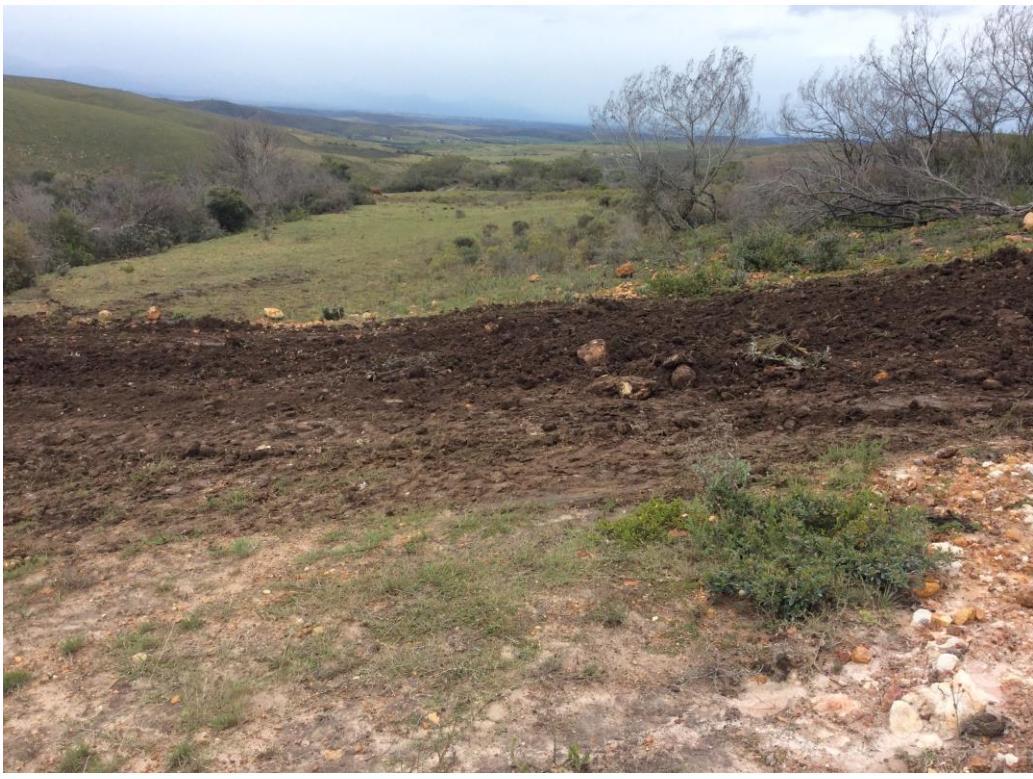
Photo 21: Site 20 – Rehabilitation photo taken 05/09/2018 (infill and topsoil material returned and shaped according to surrounding topography)

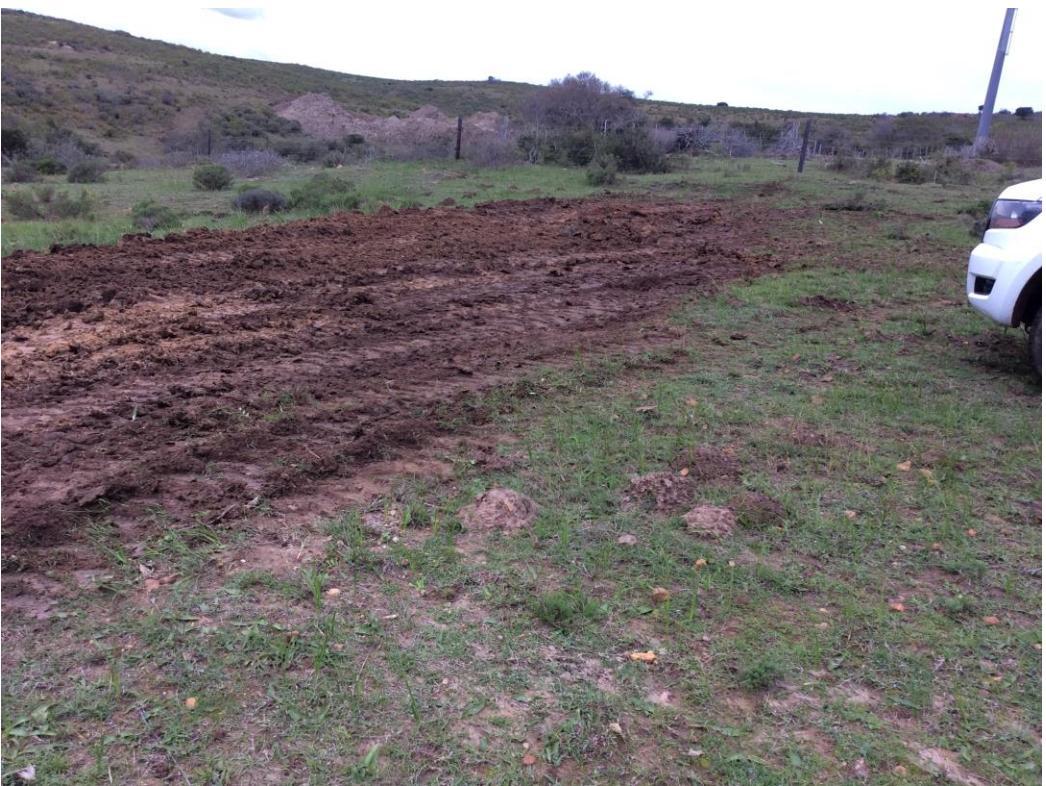
Photo 22: Site 21 – Rehabilitation photo taken 05/09/2018 (infill and topsoil material returned and shaped according to surrounding topography)

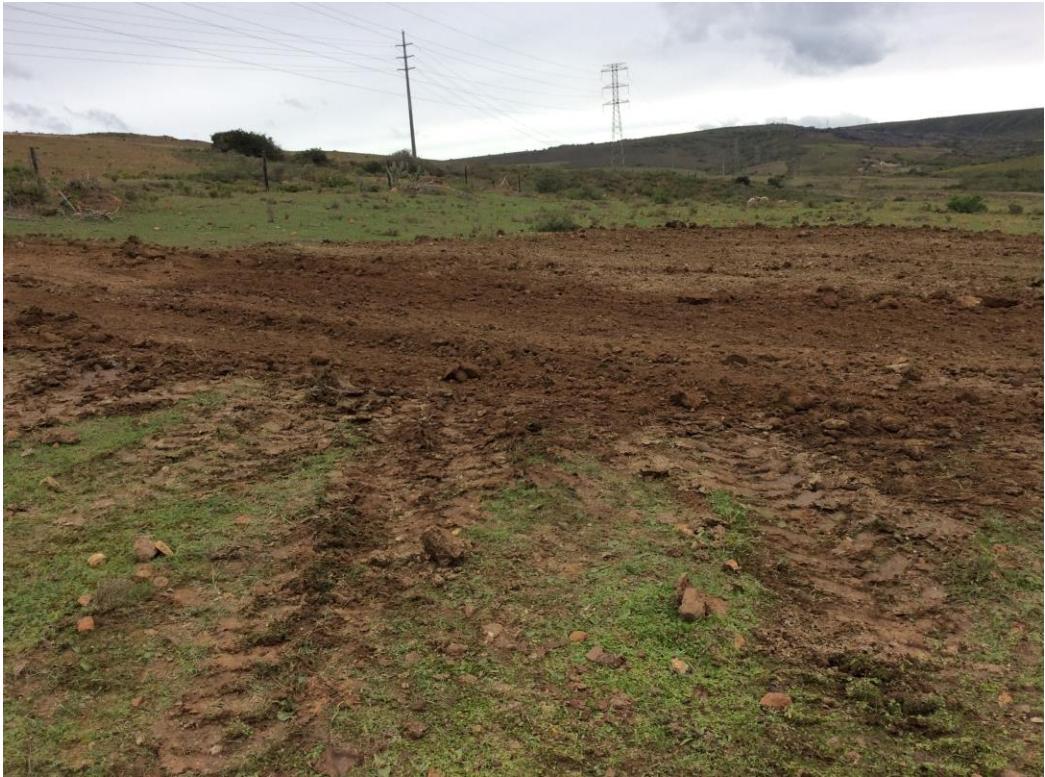
Photo 23: Site 22 – Rehabilitation photo taken 05/09/2018 (infill and topsoil material returned and shaped according to surrounding topography)

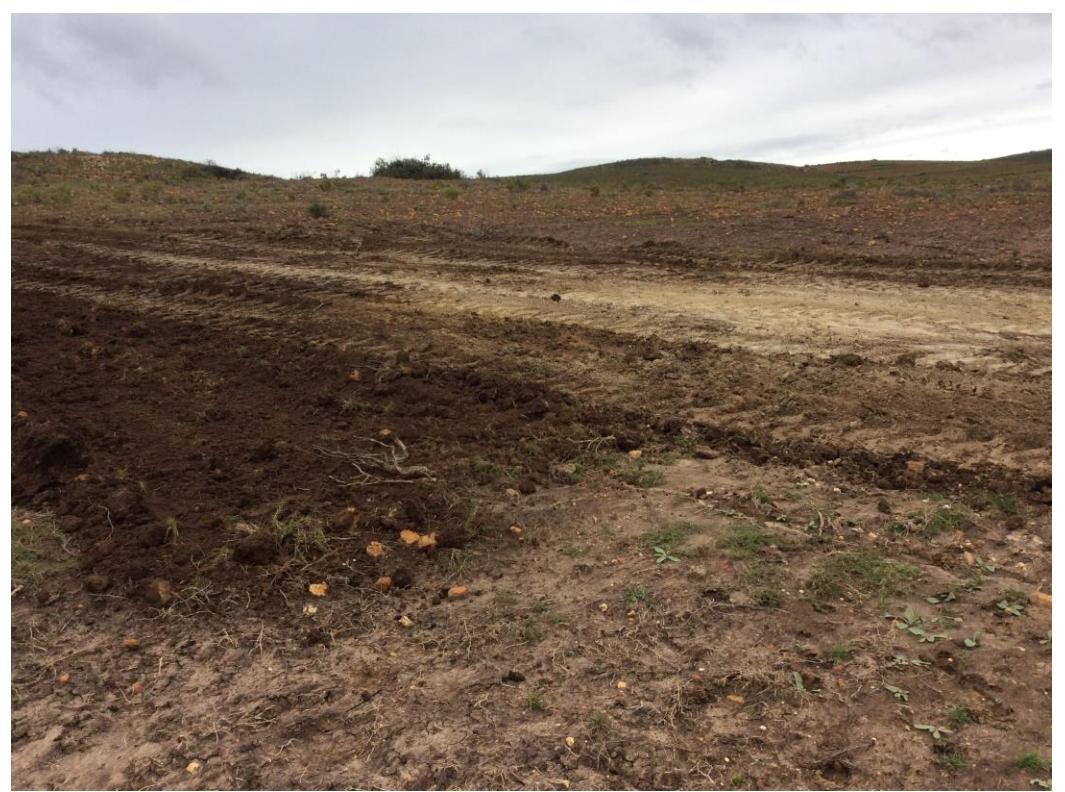
Photo 24: Site 23 – Rehabilitation photo taken 05/09/2018 (infill and topsoil material returned and shaped according to surrounding topography)
