FRESHWATER RESOURCE VERIFICATION AND RISK ASSESSMENT FOR THE PROPOSED DARLING COUNTRY ESTATE ON ERF 401 AND PORTIONS 8 & 9 OF FARM 577, DARLING, WESTERN CAPE

Darling Green Estate (Pty) Ltd

January 2019

Report Reference: Date: Scientific Aquatic Services K. Marais (Pri. Sci. Nat) C. du Preez A. Mileson SAS 219007 January 2019

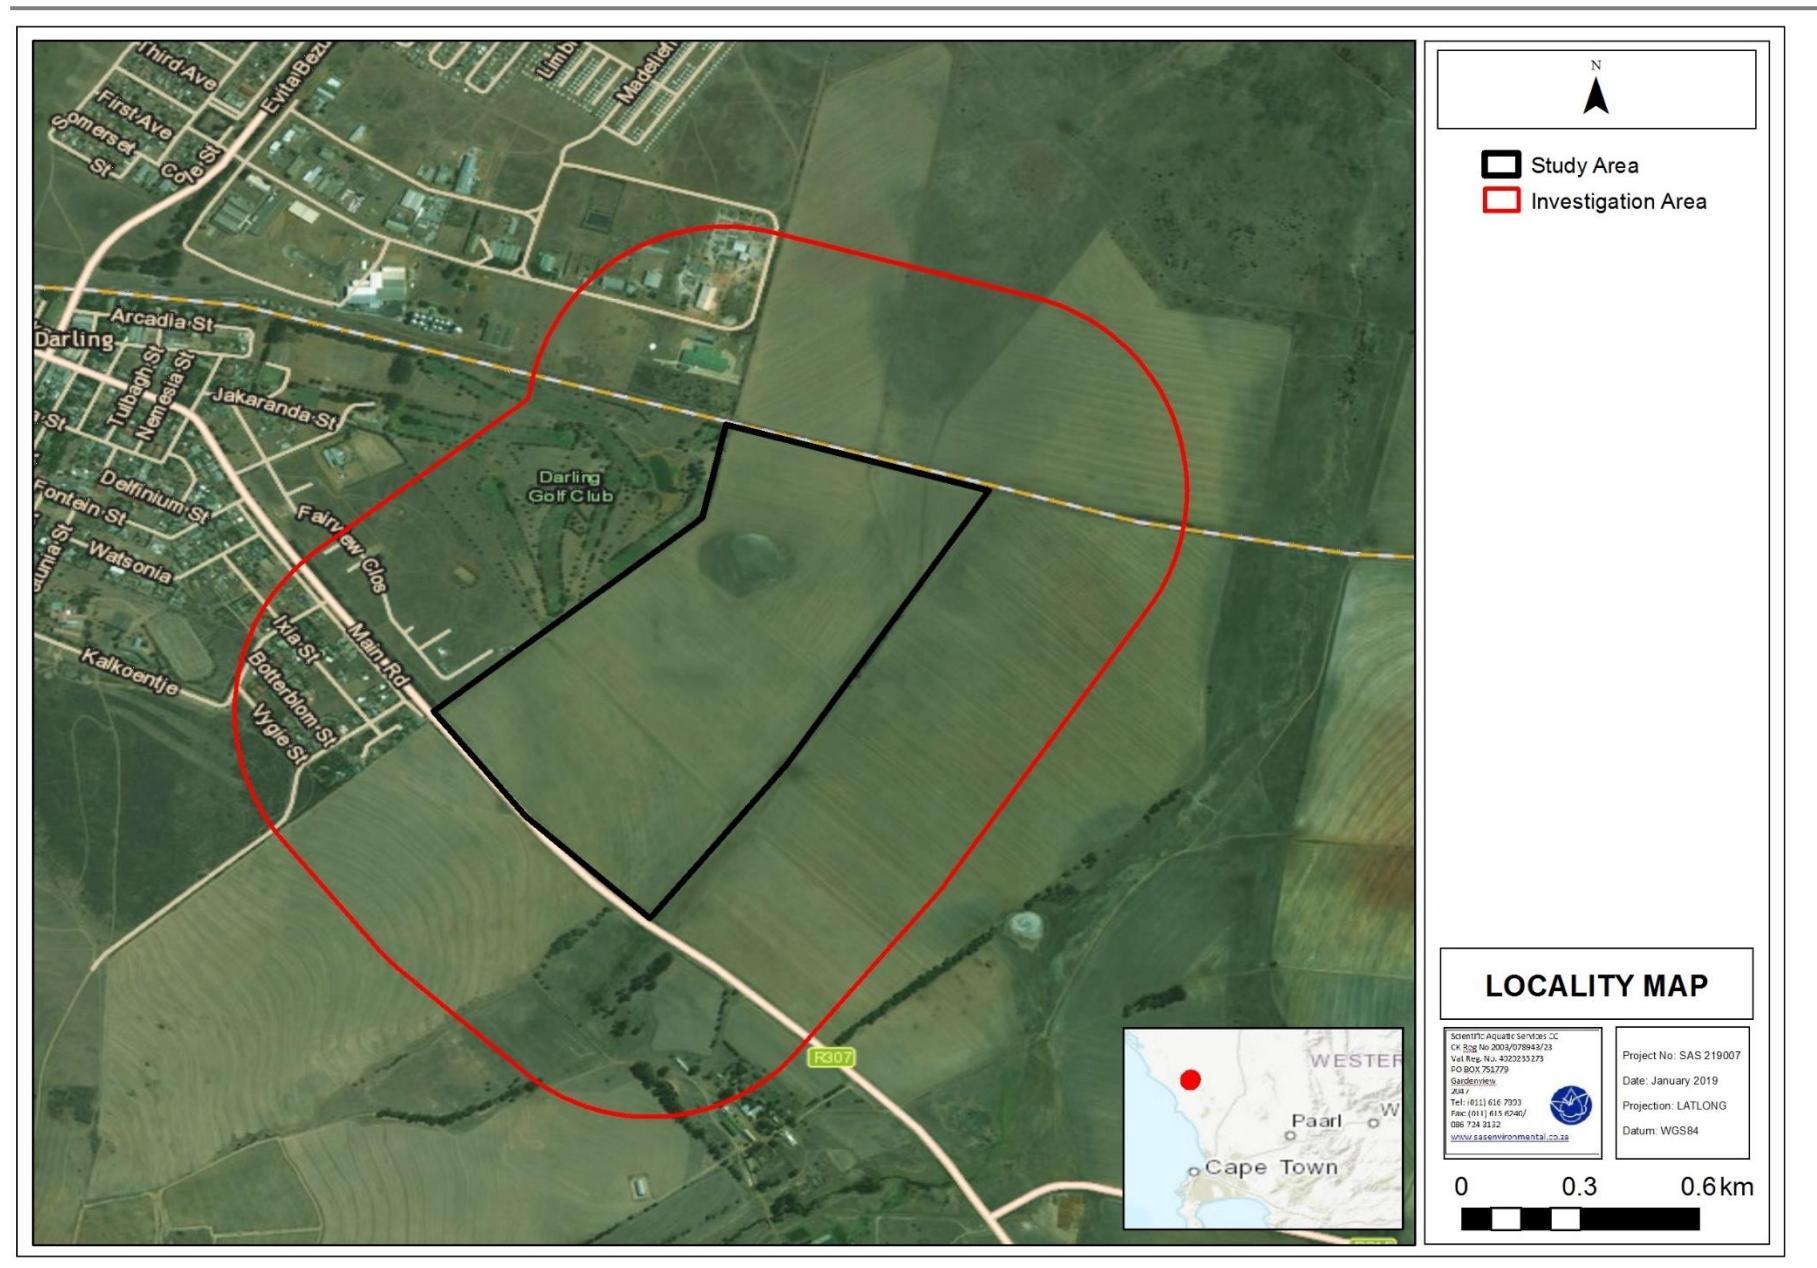
Figure 1: Digital satellite image depicting the study and investigation areas in relation to the surrounding areas.

In order to identify all watercourses that may potentially be impacted by the proposed Darling Eco Estate, a 500m "zone of investigation" around the study area, in accordance with General Notice 509 of 2016 as it relates to the National Water Act, 1998 (Act 36 of 1998) (NWA), was used as a guide in which to assess possible sensitivities of the receiving environment. This area – i.e. the 500m zone of investigation around the study area – was assessed utilising desktop methods only and will henceforth be referred to as the "investigation area" (Figure 1 and Figure 2).

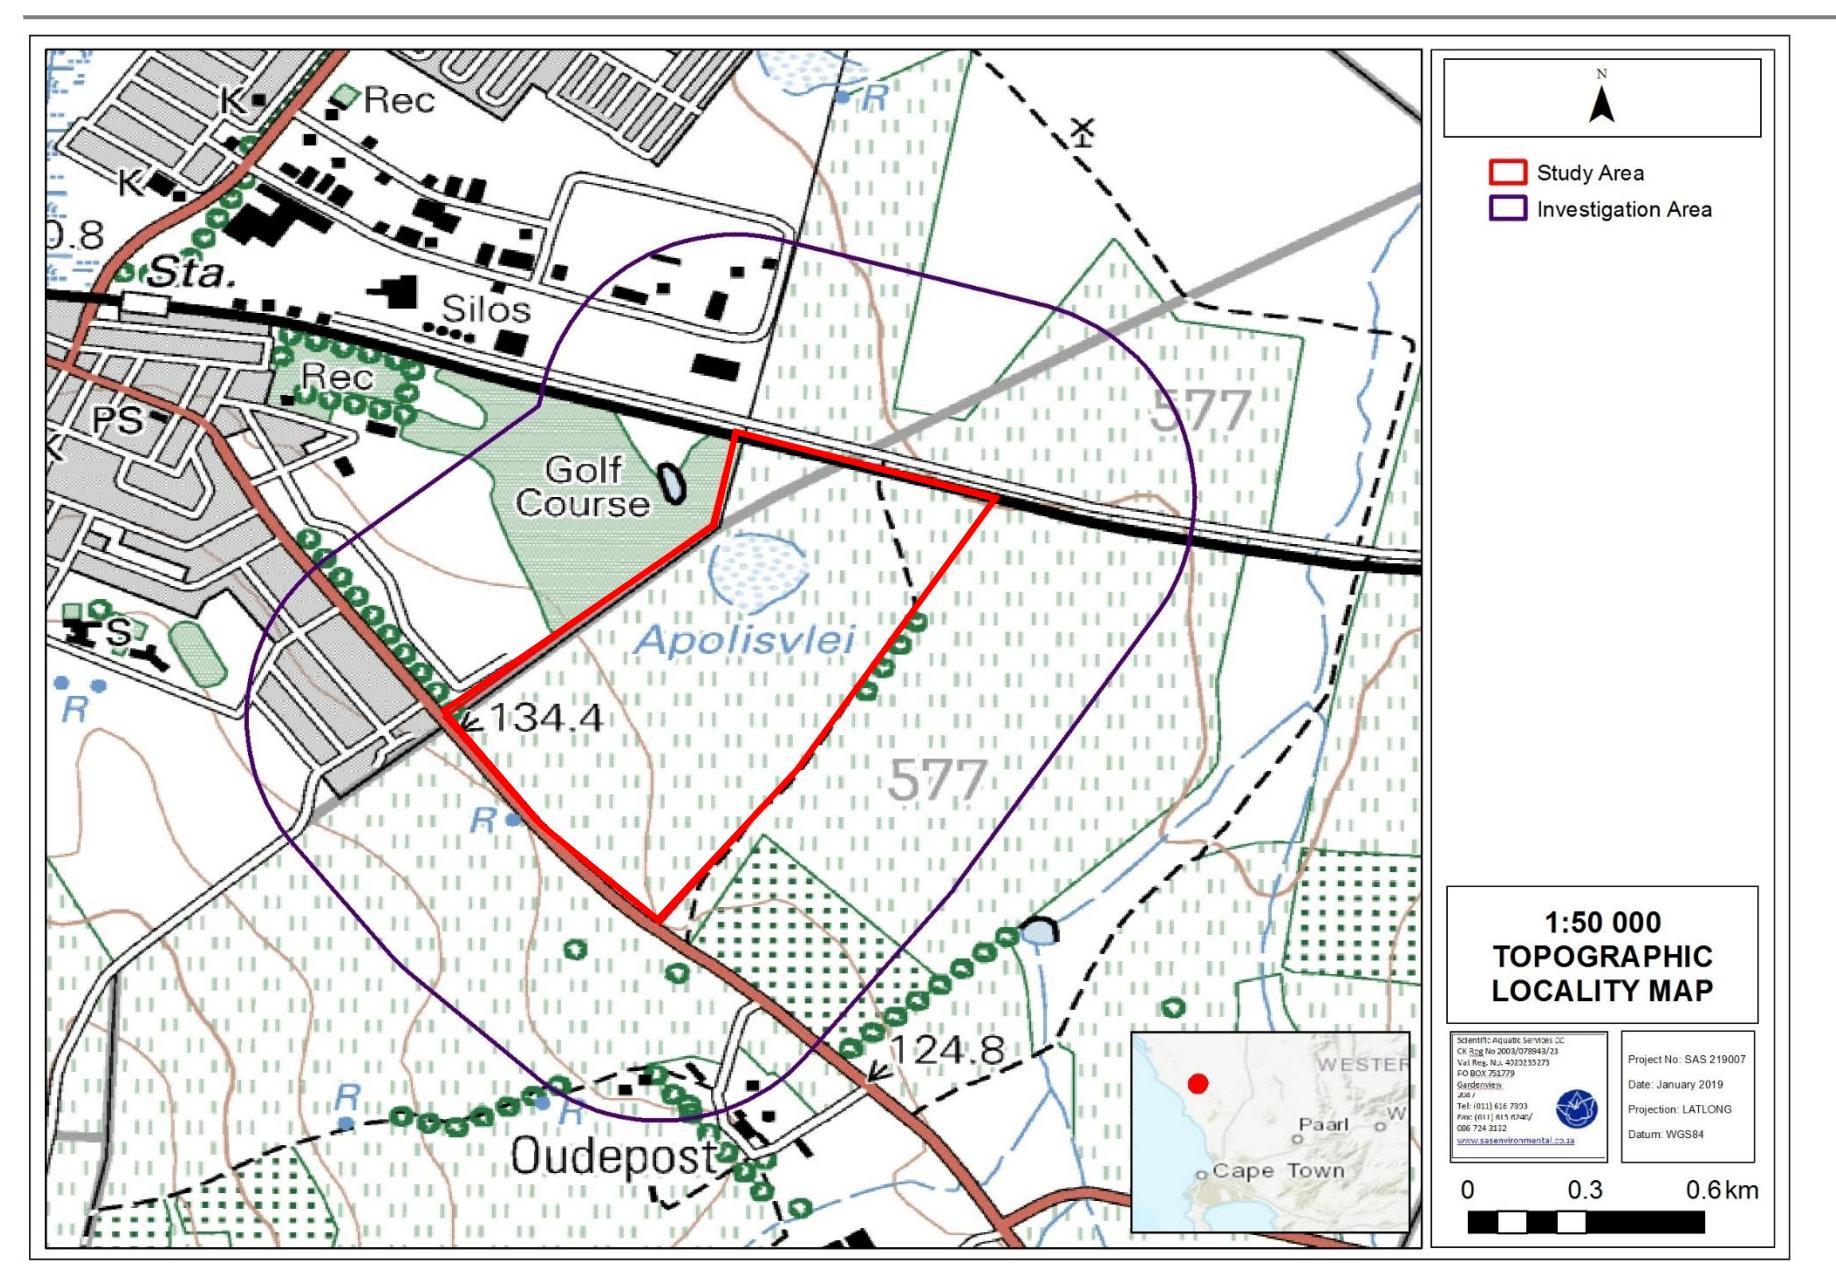
Figure 2: Location of the study and investigation areas depicted on a 1:50 000 topographical map, in relation to surrounding areas.

Bluescience (2009) identified two freshwater resources within the study area, a pan, known as Apolisvlei (please refer to the topographical map – Figure 2) as well as a seepage zone. On review of historical aerial photographs dating back to 1938, the Apolisvlei wetland is clearly visible within the study area (Figure 4). When this historical imagery is compared to the most recent digital satellite imagery (circa 2018), it is clear that the study area has been significantly transformed by the current agricultural and livestock activities within the surrounding area (Figure 4) which has altered the pattern, flow and timing of water in the landscape within the study area and surroundings.

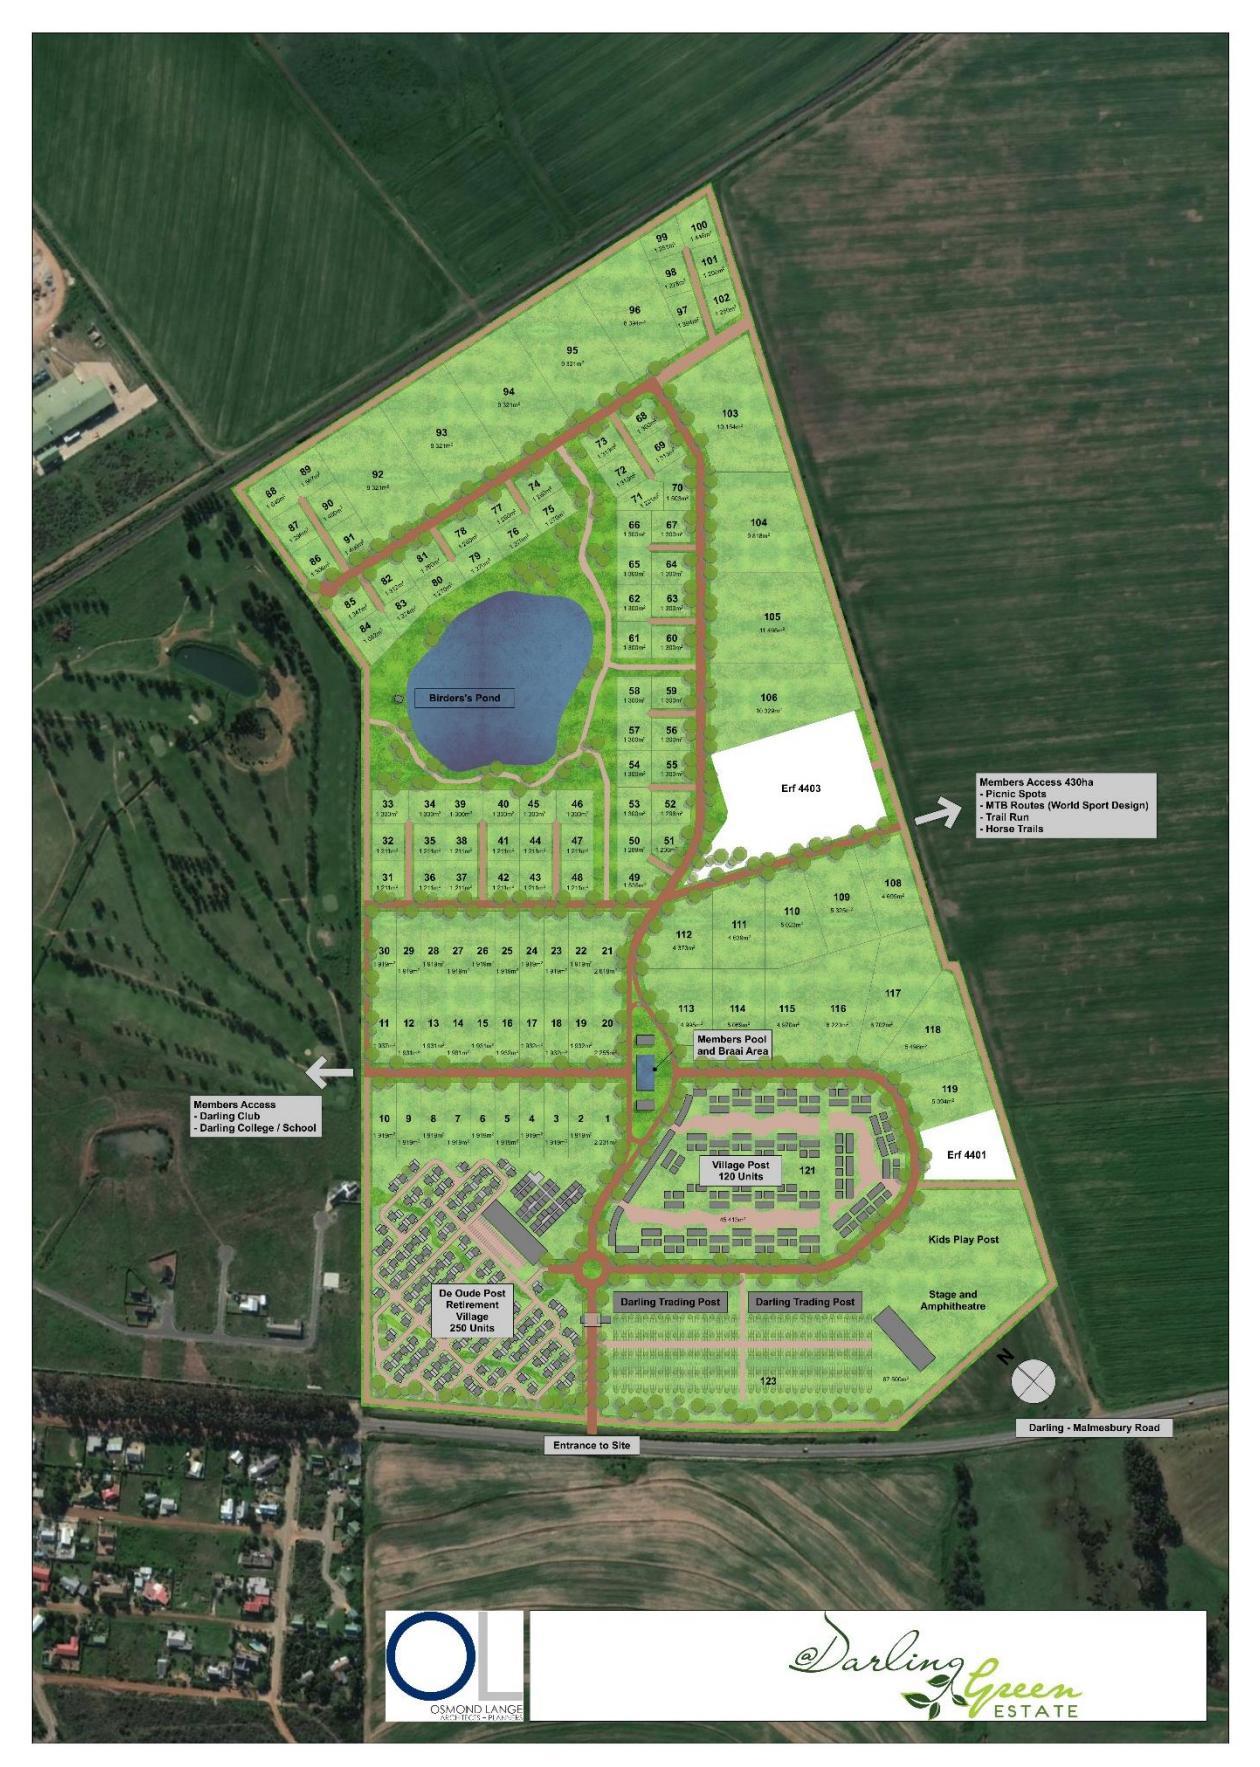
Figure 3: Proposed site layout plan for the Darling Green Estate.

The proposed Darling Green Estate is located on erf 401 and portions 8 and 9 of the Farm 577, in the town of Darling, Western Cape, hereafter referred to as the 'study area'. The study area is bordered by the R307 to the south west, the existing Golf Estate to the north and a railway line to the north east (Figure 1 and 2). The proposed estate will include (refer to Figure 3 for the proposed layout):

- > The construction of 119 large residential erven (ranging between 1,211m² and 11,498m²);
- > 250 unit retirement village;
- 120 unit Village post;
- > Large open space areas for recreational purposes; and
- Internal services including roads.

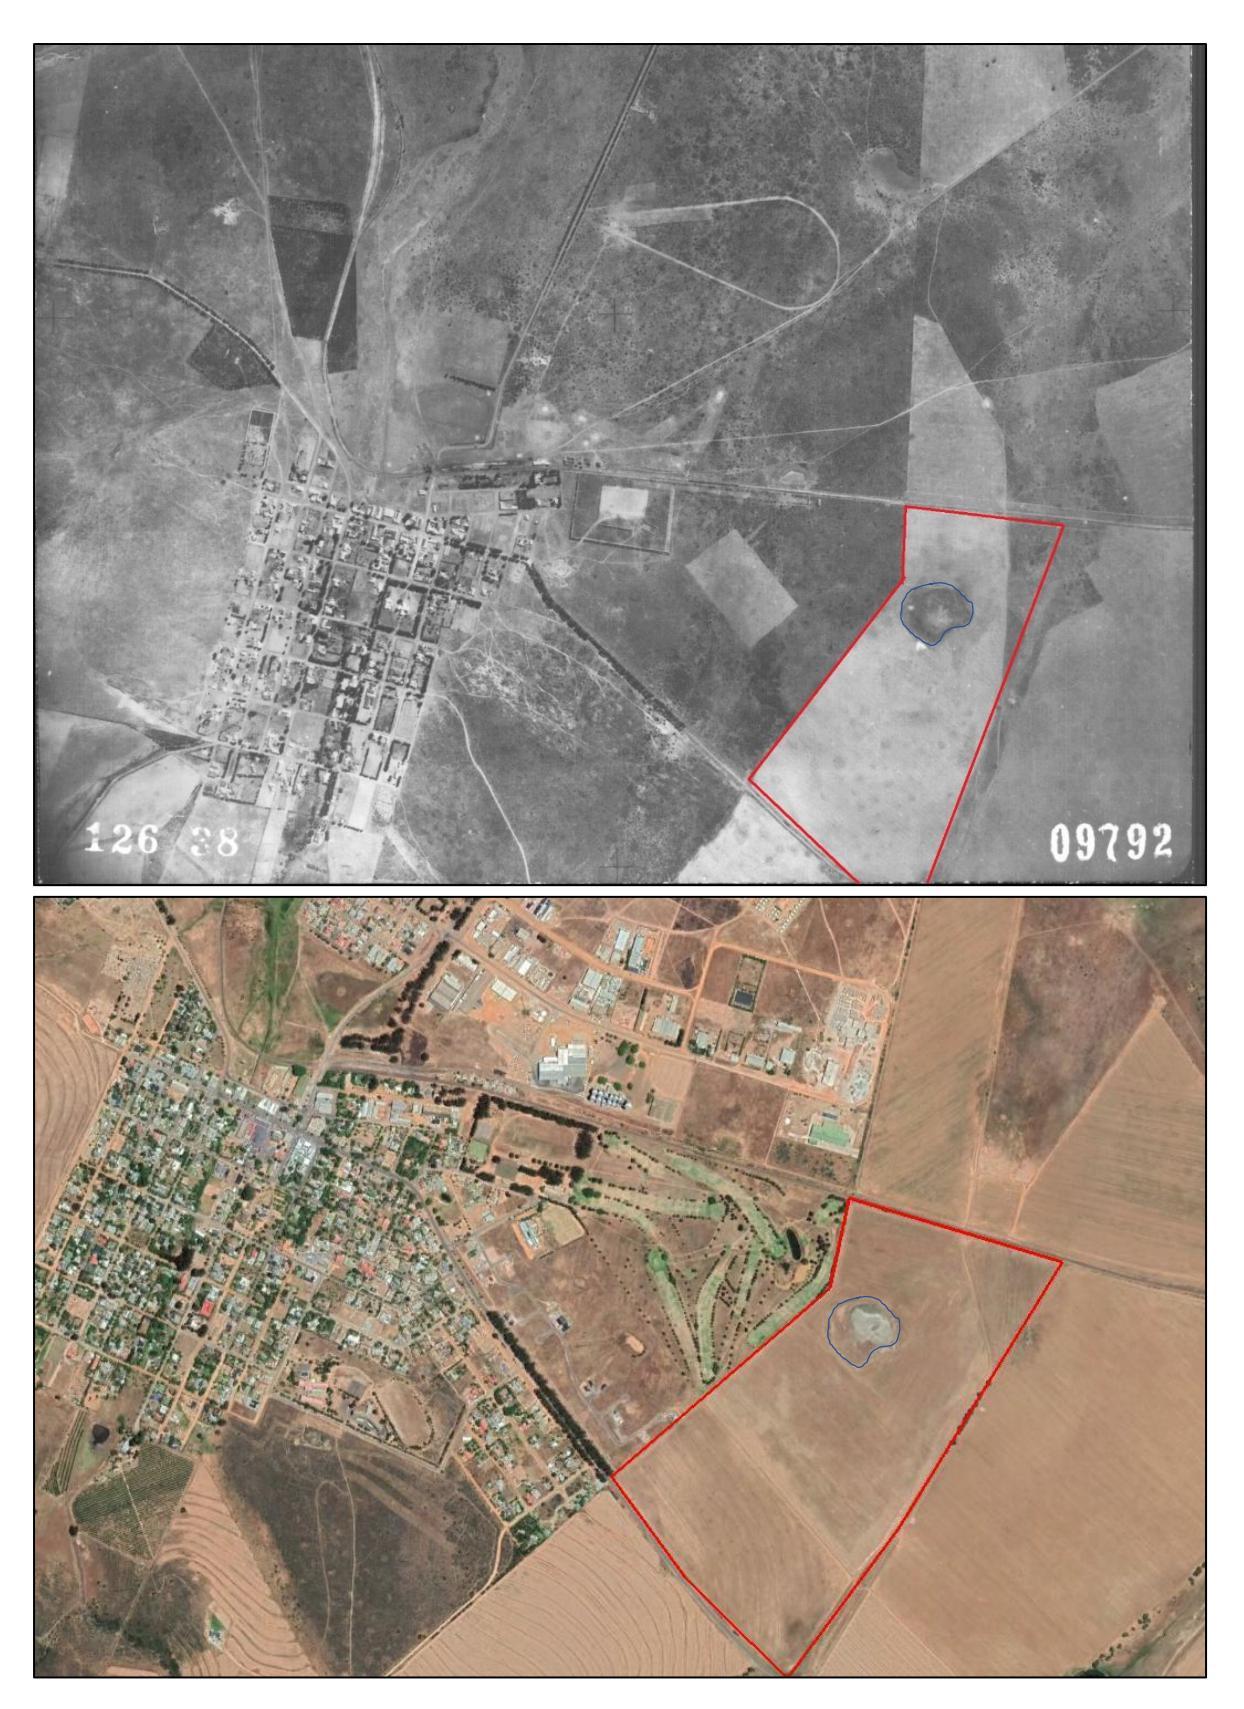
Figure 4: Historical imagery (top - circa 193 Flight plan 12638 of Job 120) indicates that the area surrounding the study area was predominantly agricultural, however, when compared to the most recent digital satellite imagery (bottom - circa 2018) increased urbanisation in the surrounding area is evident. The Apolisvlei remains clearly identifiable (indicated in blue) with limited change to the extent of the system.

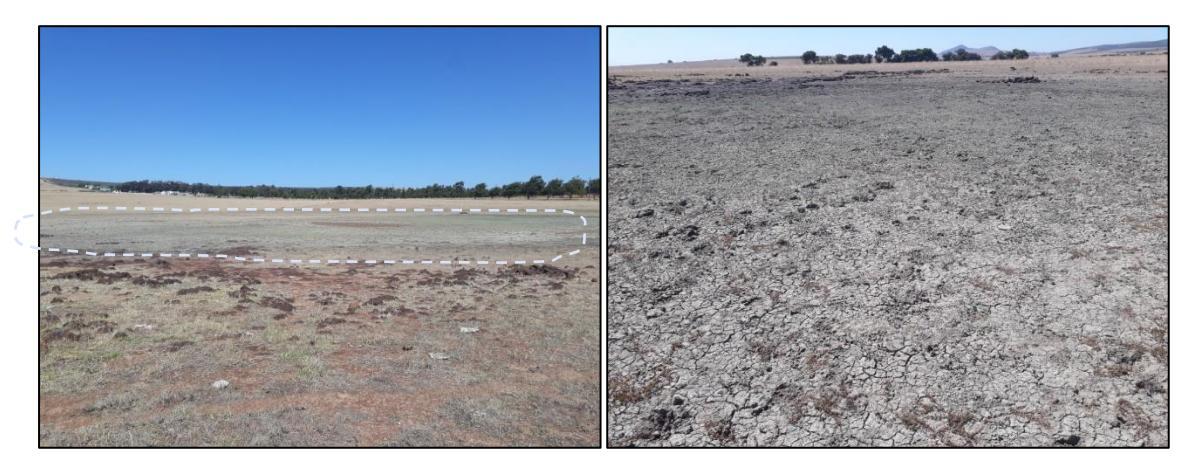
1. As per the ecological study undertaken by Bluescience (2009), the Apolisvlei Wetland is located within the study area. At the time of the 2018 site verification (during the summer season) this wetland was completely dry (Figure 5). SAS agrees with the findings and delineations as provided by Bluescience (2009) for the Apolisvlei Wetland.

Figure 5: Apolisvlei Wetland located within the study area (indicated by the dashed line). No surface water was observed at the time of the field verification.

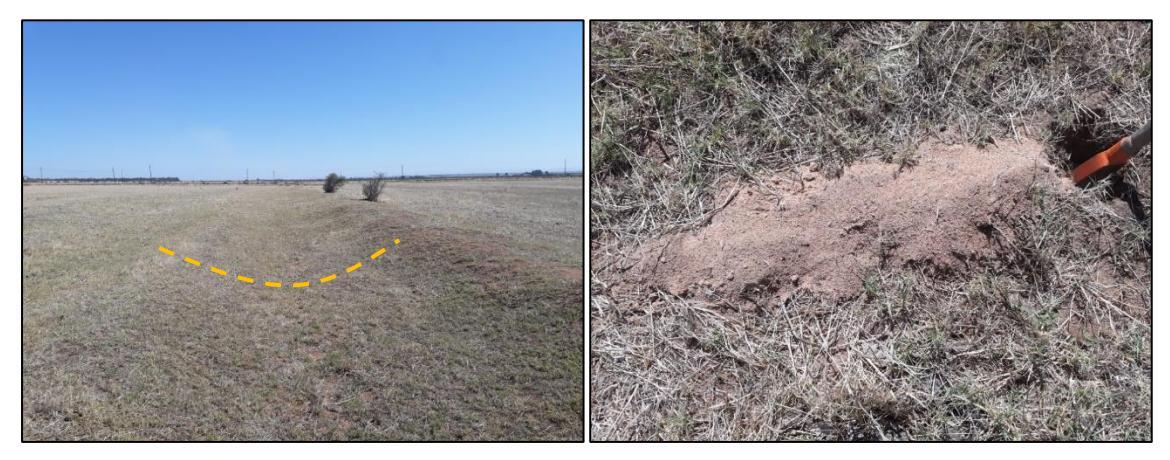
2. Bluescience (2009) also identified a seepage area with a defined channel in the north-eastern corner of the study area. On further investigation, SAS did not identify any obligate or facultative vegetation species, nor were any soil indicators (redoximorphic features such as mottling and gleying) present within the delineated seepage area (Figure 6). A distinct, uniform channel was, however, noted further east of the seepage zone noted by Bluescience (2009). SAS concurs with the statement made by Bluescience (2009) that this channel was likely man-made to drain the land during its use for cultivation.

Figure 6: (Left) uniform channel noted within the north-eastern portion of the study area (distinct channel indicated by the orange dashed line); (right) soil sample taken within the proposed seepage zone indicating dry soils with no redoximorphic features such as mottling and gleying present.

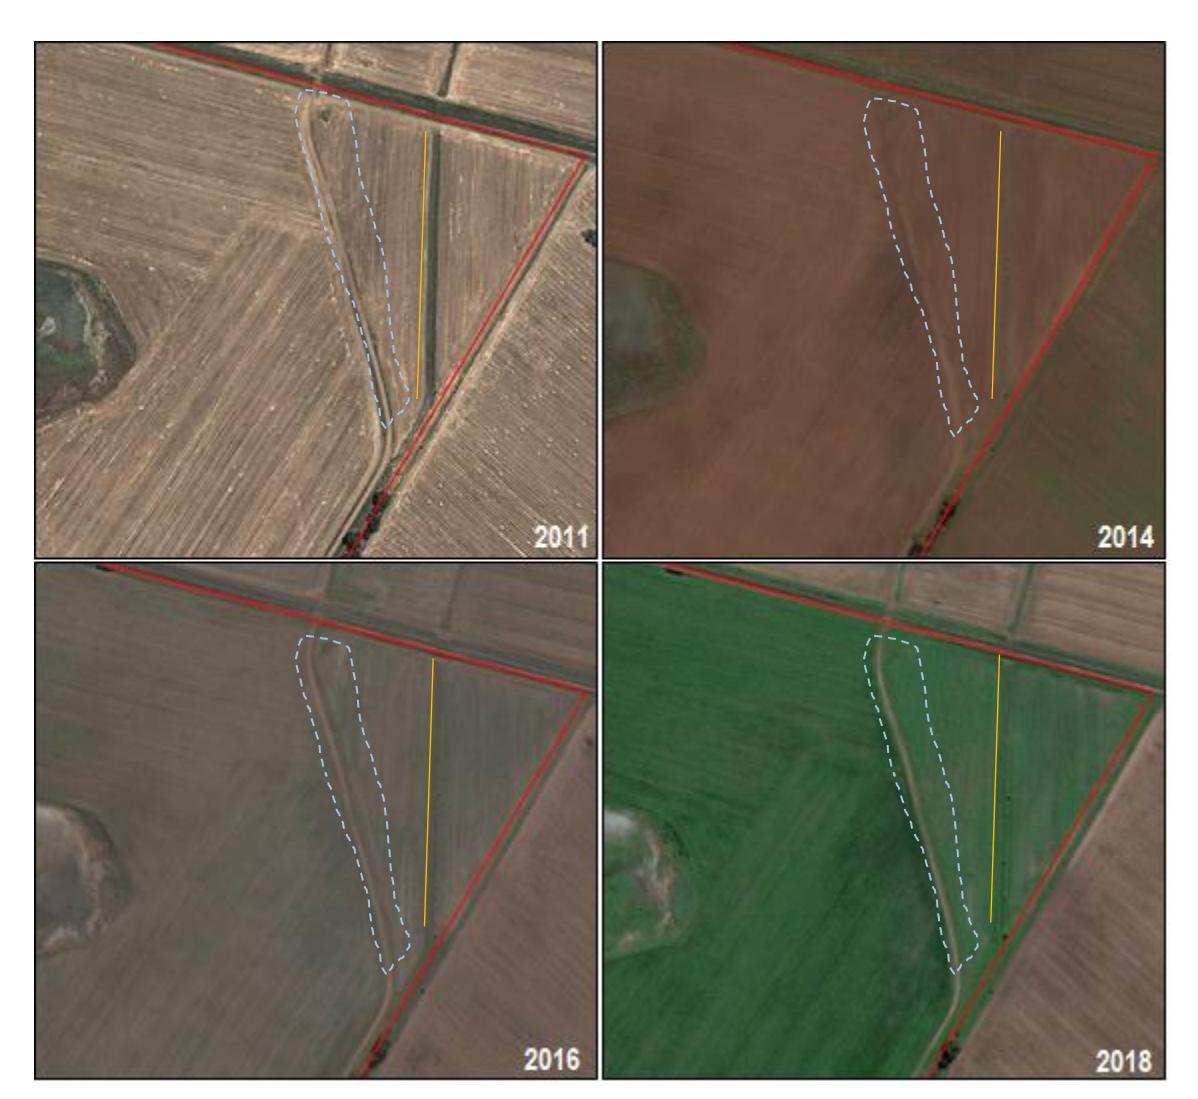
3. On further investigation of the seepage area identified by Bluescience (2009) pipe culverts were noted below the railway line to the north, associated with the excavated channel. These pipe culverts were noted to be heavily sedimented (Figure 7). Due to the limitations of this verification as a result of the field assessment being undertaken during the dry season, use was made of digital satellite imagery to identify if there were any digital signatures over the last 10 years (since the Bluescience assessment was undertaken in 2009) to determine if there is a seasonal wet response within the north eastern corner associated with the proposed seepage zone. Digital imagery was focused on the rainy season (i.e. only imagery within the months of June - September were considered).

Figure 7: Digital satellite Imagery taken during the wet season of the north eastern corner of the study area from various years. The orange line indicates the excavated channel and the blue dashed line indicates the proposed location of the seepage zone, as indicated by Bluescience (2009).

- 4. Based on the digital satellite imagery, greening can be identified within the man-made channel (as indicated by the orange line) but not within the area delineated as a seepage zone by Bluescience (2009) (indicated by the blue dashed area). Based only¹ on analysis of digital satellite imagery, it is likely that the hydropedological processes of the area have been irreversibly altered as a result of the extensive cultivation activities, and possibly the excavated channel identified within the study area and surroundings and therefore, over the last 10 years since the Bluescience investigation was undertaken there has been insufficient recharge of soils to elicit a wetland vegetation response.

- 5. Based on the above rationale, it is the opinion of SAS that the hydrological drivers of the seepage area have been permanently destroyed as there is no evidence that a wetland vegetation response has occurred over the last 10 years. The seepage area delineated by Bluescience (2009) therefore currently does not, and in future will not function as a wetland and therefore does not enjoy protection as a watercourse in terms of the National Water Act, 1998 (Act 36 of 1998). It is, however, recommended that this rationale be supported by a field verification during the wet season since the proposed development layout plan does not make provision to retain this feature.

- 2. It is, however, recommended that this seepage area be field verified during the wet season since the proposed development layout plan does not make provision to retain this feature.

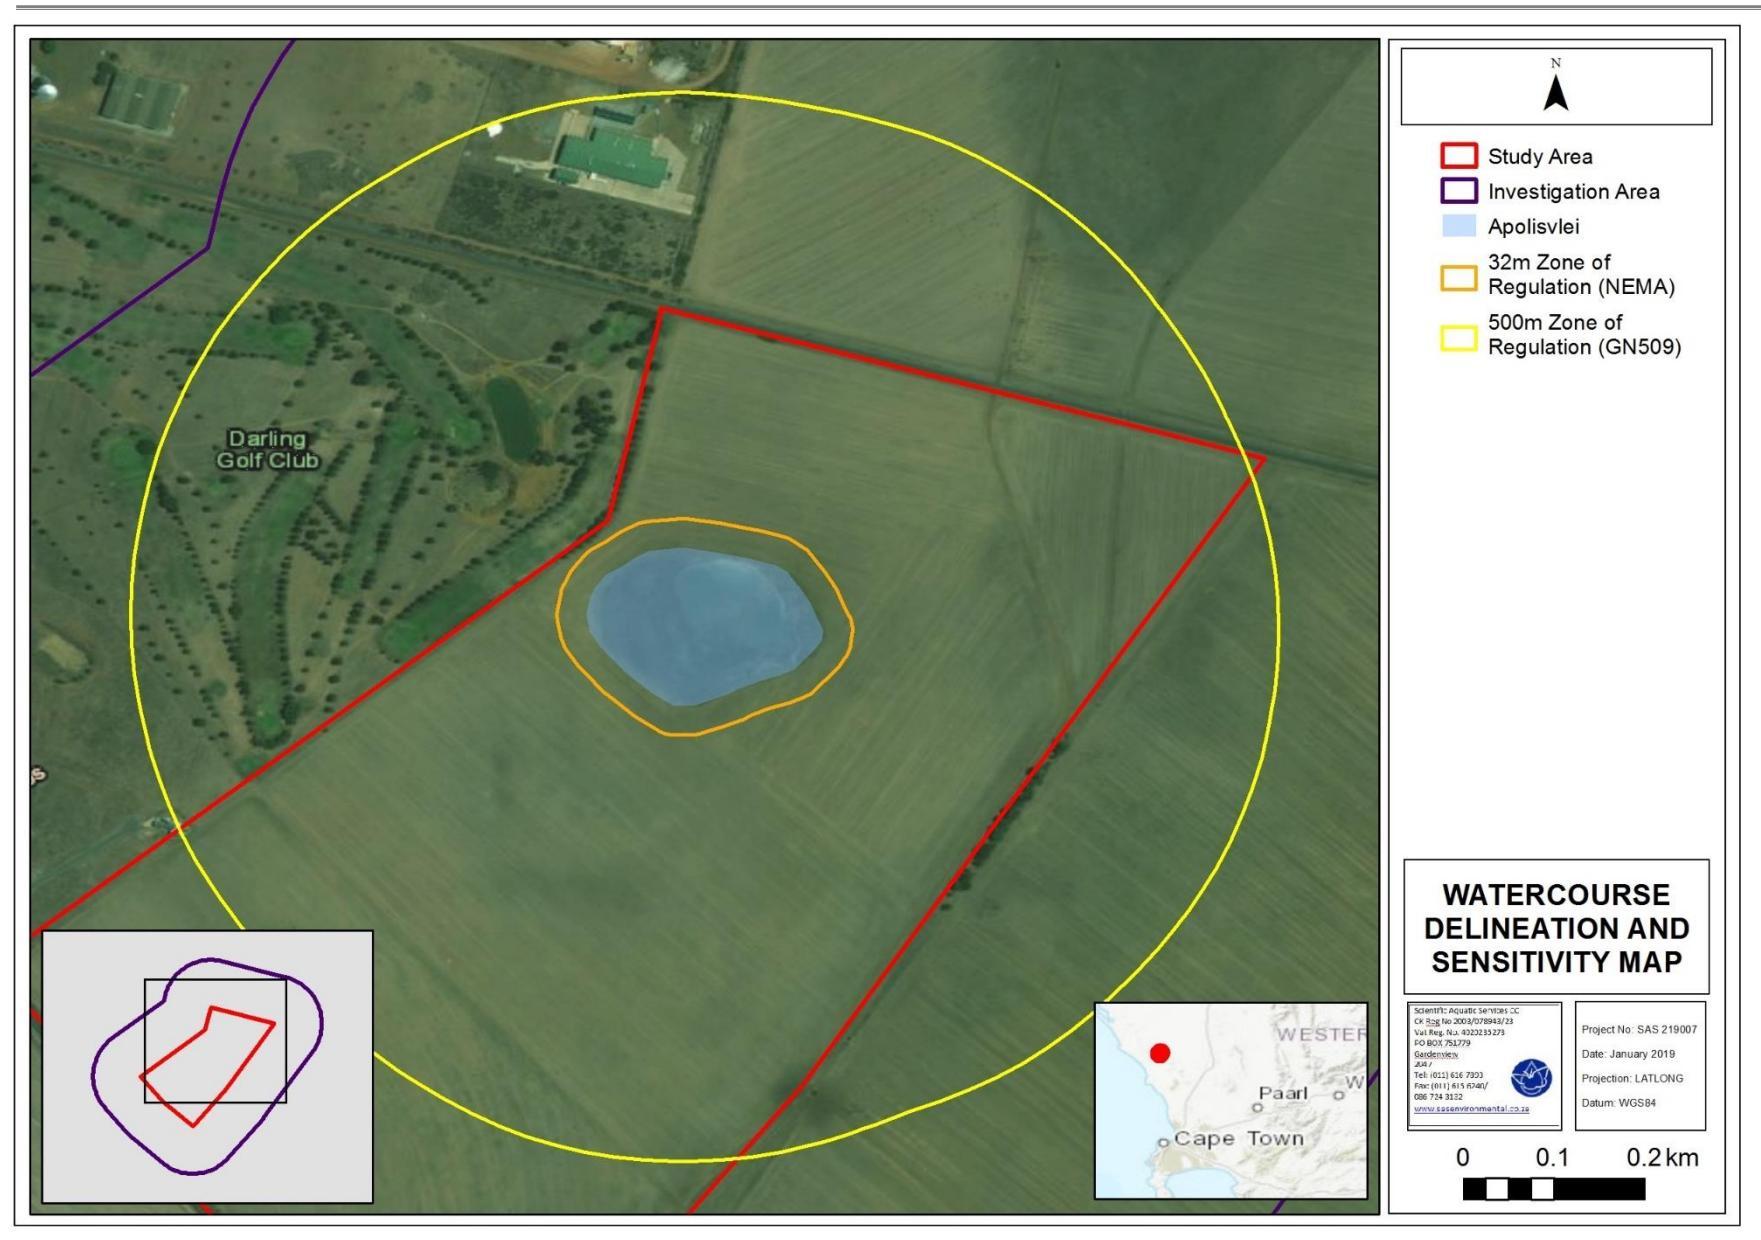
A 500m zone of regulation (ZoR) was therefore implemented around the Apolisvlei Wetland (Figure 8). Consultation and authorisation from the Department of Water and Sanitation, the custodians of water resources in South Africa, will therefore be required for all activities associated with the development since the proposed development falls within the 500m ZoR. The DWS Risk Assessment Matrix was compiled (please refer to Section 5 below) to ascertain the proposed risk of the proposed Darling Eco Estate on the Apolisvlei wetland.

It should further be noted that activities within the 32m Zone of Regulation in accordance with the National Environmental Management Act, 1998 (Act 107 of 1998) will potentially be triggered should the recommendation that this be considered a buffer area not be implemented. It should be noted that it is the opinion of the freshwater specialist that this 32m Zone of Regulation should not be impeded upon and should be considered as a conservation buffer area for the protection of the Apolisvlei wetland.

Figure 8: Applicable Zones of Regulation in accordance with the NWA and the NEMA associated with the Apolisvlei identified within the study area.

Similarly, it is strongly advised that the 32m buffer zone be revegetated with fynbos species from the Swartland Granite Renosterveld vegetation type within which the study area is located. A suitably qualified botanist should be appointed to assist with this rehabilitation and reinstatement. In line with the development layout plan (Figure 3) pedestrian walkways can be constructed within the buffer area. It is advised that all walkways comprise of permeable surfaces, with raised wooden boardwalks with railing to ensure no disturbance to the reinstated habitat. The boardwalks should not be located closer than 5m from the edge of the delineated Apolisvlei wetland to reduce impacts to this wetland feature.
